## W-0358 – Derailment – West Falls Church Rail Yard Lead – July 1, 2023

<b>Date of Event:</b>	July 1, 2023
<b>Type of Event:</b>	Derailment
<b>Incident Time:</b>	03:10 hours
<b>Location:</b>	West Falls Church Yard (K99) Yard Lead (YL) 015+00
<b>Time and How received by SAFE:</b>	04:37 hours/MAC Call
<b>WMSC Notification Time:</b>	04:35 hours
<b>Responding Safety Officers:</b>	Office of Emergency Preparedness (OEP) Office of Safety Investigations (OSI)
<b>Rail Vehicle:</b>	Hi-Rail Vehicle Unit ID CR5971
<b>Injuries:</b>	None
<b>Damage:</b>	Minor infrastructure damage
<b>Emergency Responders:</b>	The Office of Track and Structures (TRST) Metro Transit Police (MTPD) The Office of Rail Transportation (RTRA) The Office of Capital Delivery (CAPD) The Office of Safety and Readiness (SAFE) The Office of Vehicle Program Services (CENV)
<b>SMS I/A Number</b>	20230701#109604

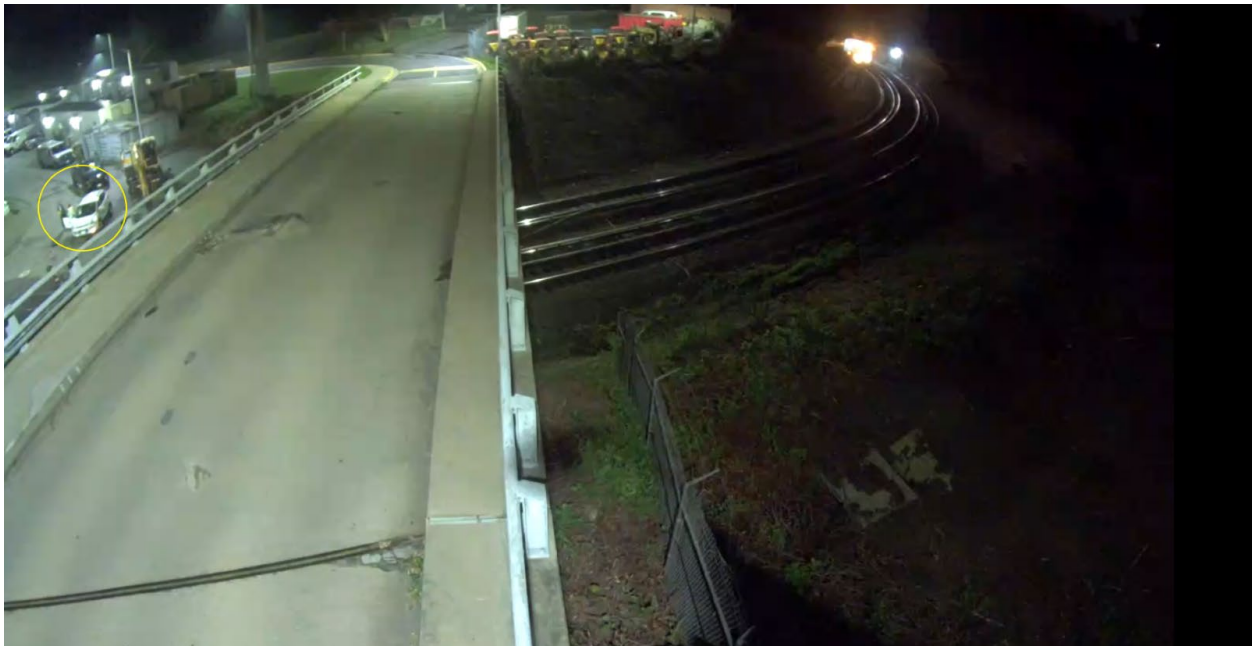
Figure 2 – Multiple WMATA personnel arrive on the scene at 03:47 hours.

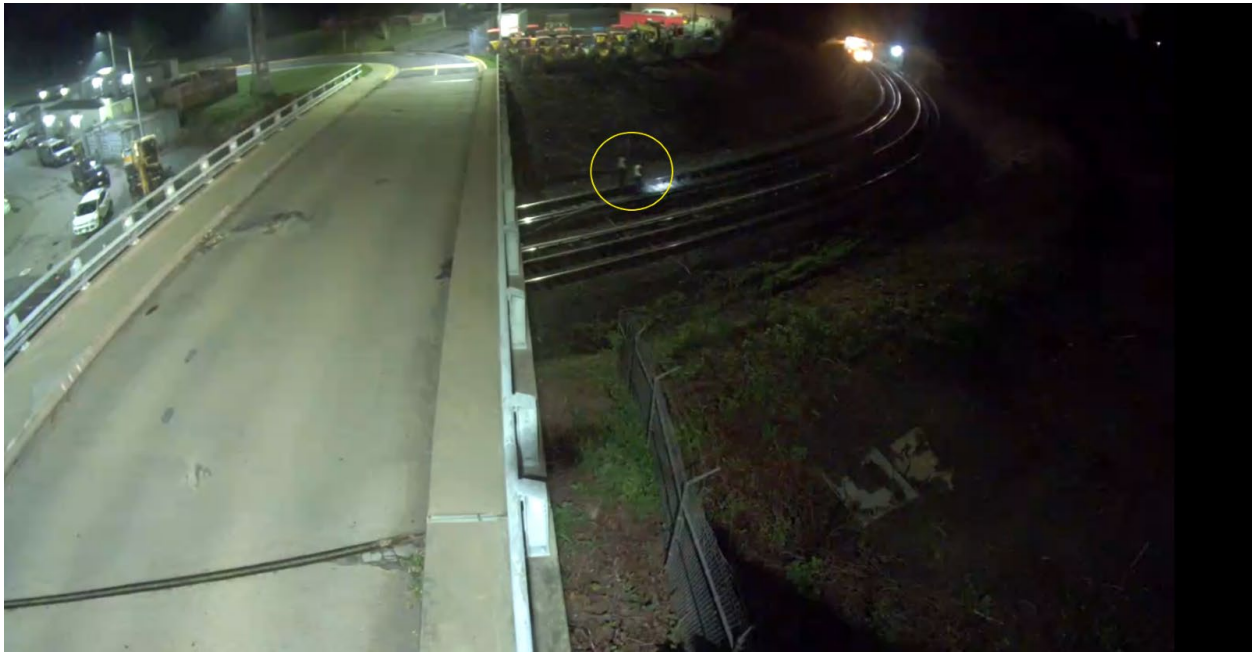
*Figure 3 – Multiple WMATA personnel are observed walking the track to the derailment at 03:48 hours.*

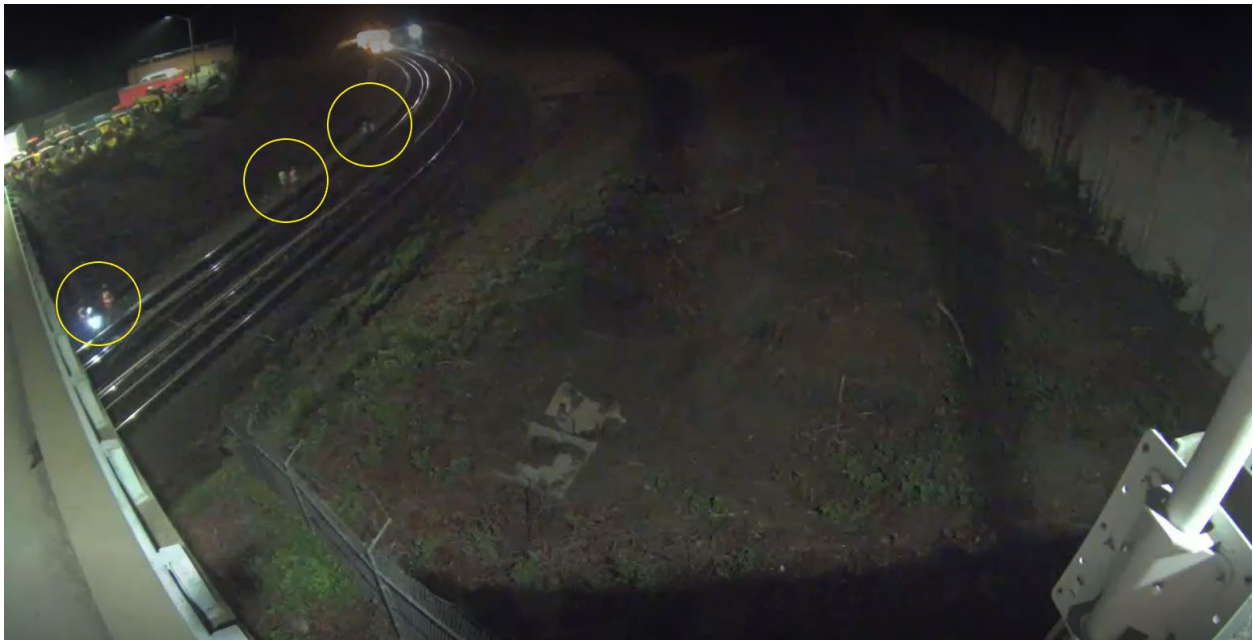
Figure 4 –WMATA and Contractor personnel are observed moving towards the derailment at 04:34 hours.

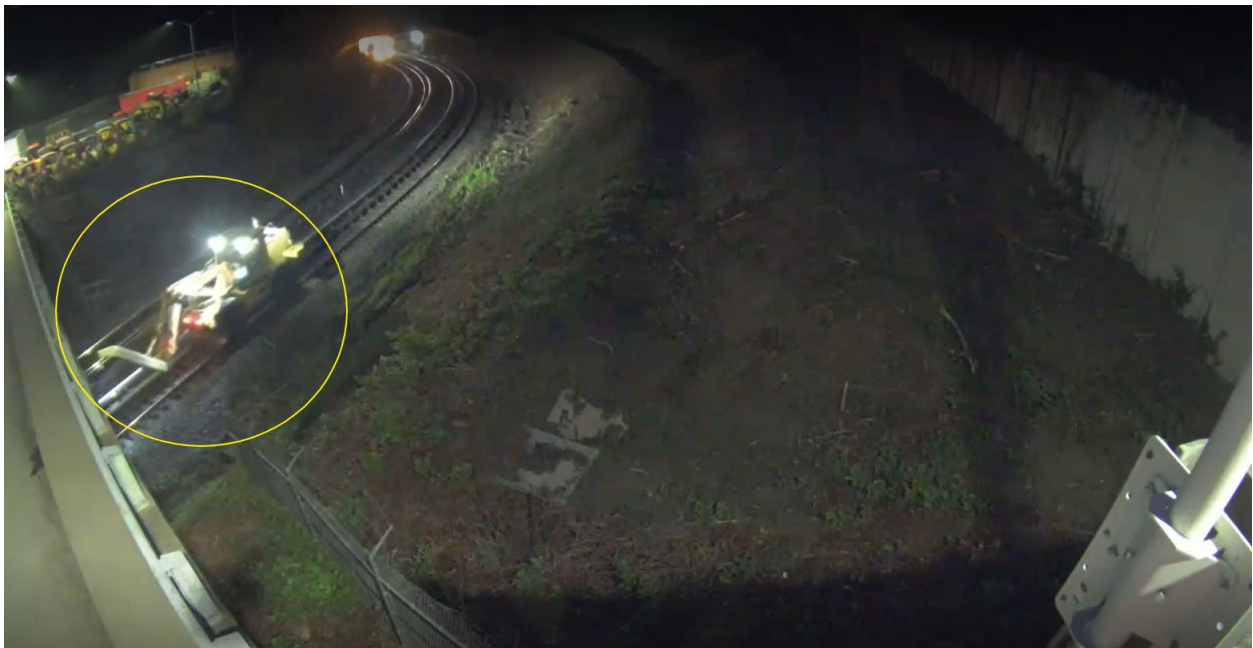
Figure 5 –The WMATA re-railing equipment arrived on the scene at 05:10 hours on YL 1.

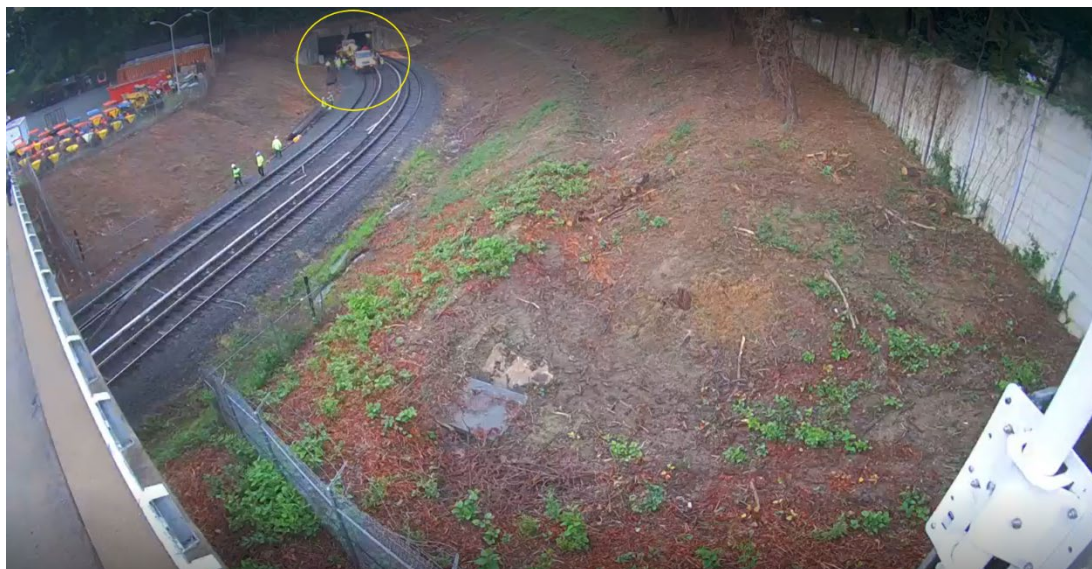
*Figure 6 – The WMATA re-railing equipment can be observed lifting Unit ID CR5971's rear wheels and pushing the Unit along YL2 into West Falls Church Yard at 06:26 hours.*

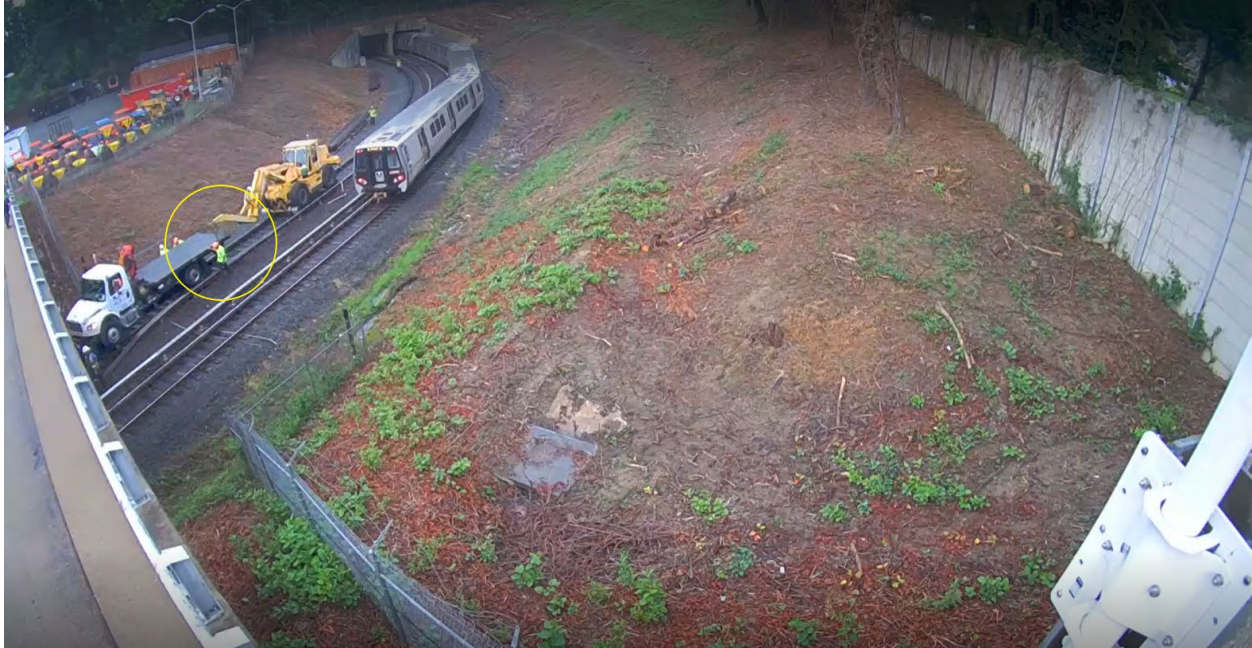
Figure 7 –The WMATA re-railing equipment can be observed lifting Unit ID CR5971's rear wheels and pushing the Unit along YL2 into West Falls Church Yard at 06:28 hours. Note YL 1 was utilized to dispatch revenue trains during the event.

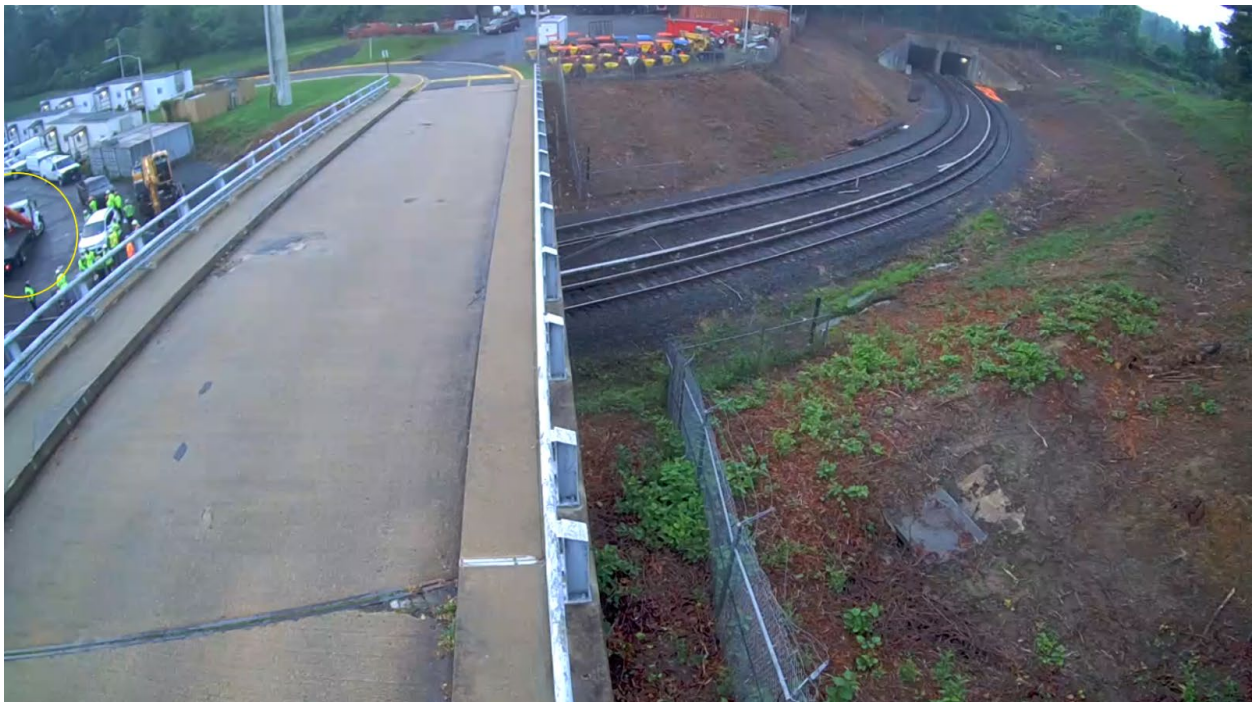
Figure 8 –Hi-Rail Unit ID CR5971 is observed engaging its road wheels and moving off YL2 at Signal K99-68 at 06:32 hours.

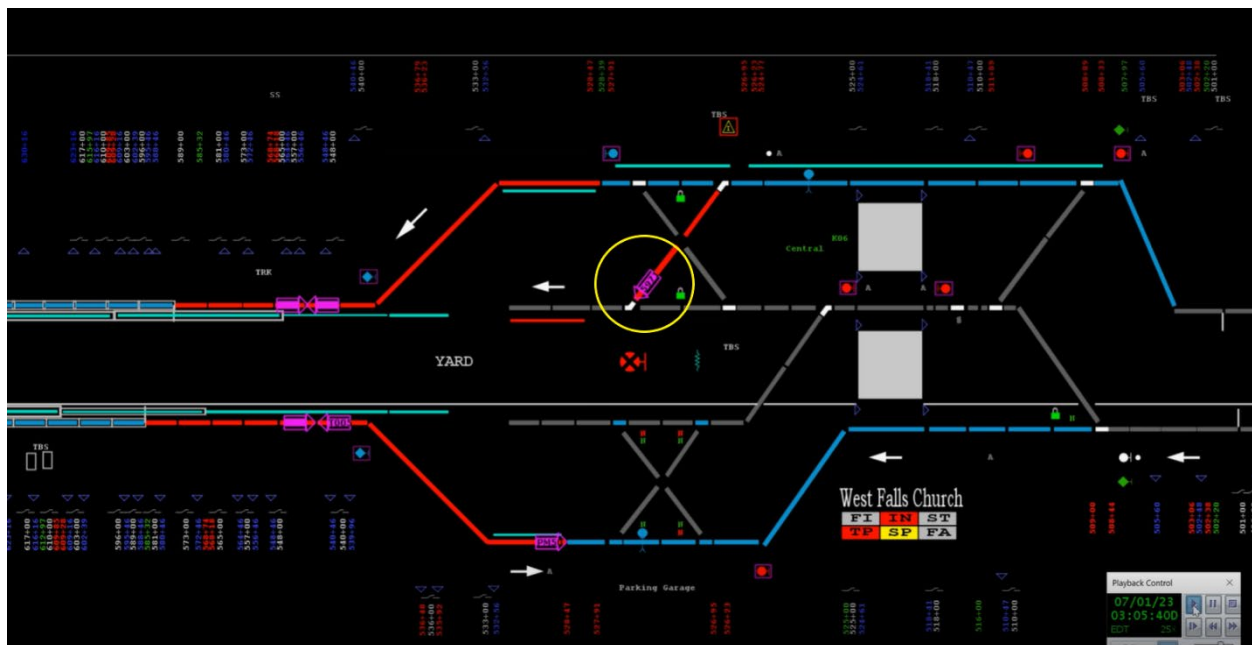
Figure 11 – AIMS depicting Unit CR5971 en route from West Falls Church Station to West Falls Church Yard at approximately 03:05 hours.
