Evacuation for Life Safety Reasons

**At or Near L'Enfant Plaza Station, Foggy Bottom Station,
Eisenhower Avenue Headquarters and Benning Road Station
April 1, 2024, May 18, 2024, July 2, 2024 and July 22, 2024**

Document Purpose

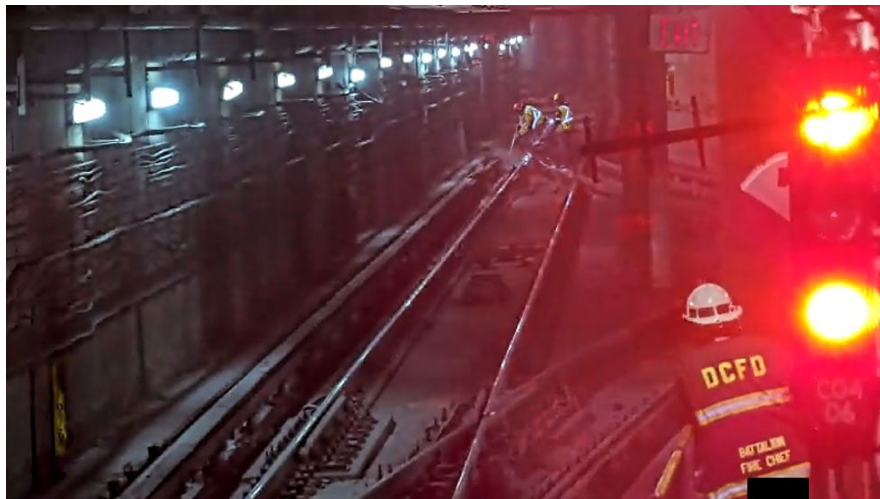
At 13:08 hours, ERT informed the MTPD Forward Liaison that they had identified the source of the fire and smoke on track 2 to be debris in contact with the third rail near the interlocking near signal 08. They reported no active fire at the time and did not request any assistance from DCFEMS. The ERT stated they would be cleaning up the debris and went to retrieve trash bags and shovels. At 13:21 hours, after being informed that the incident was a maintenance issue,

Figure 6 - depicts ERT clearing the debris from the roadway as DCFEMS remains within the confines of the continuous handrail.

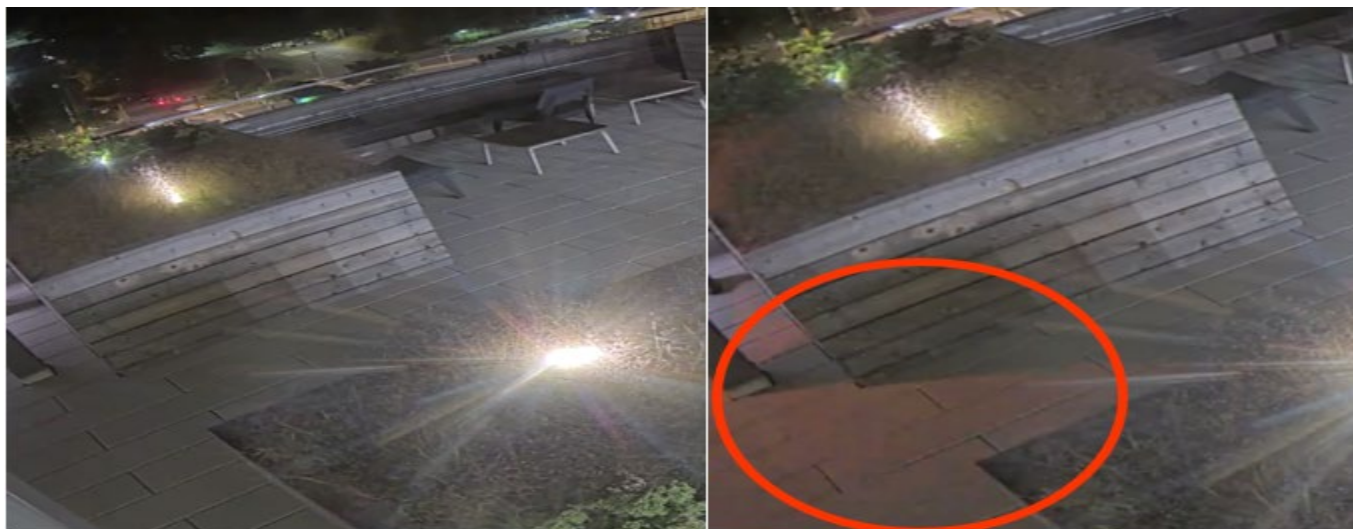
Image 3 – Left side image depicting the area without the glow of an ignitor, and Right side image of the glow of an ignitor.

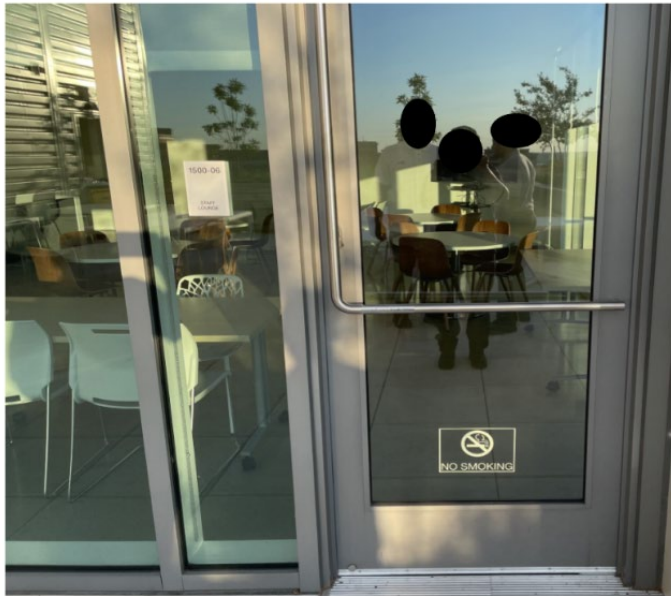
Image 13: Penthouse door displaying a no smoking sign leading to the kitchen (post-fire).
