**W-0368 – Employee Injury at West Falls Church Rail Yard – March 8, 2024****Document Purpose**

Washington Metropolitan Area Transit Authority
Department of Safety (SAFE)
Office of Safety Investigations (OSI)
FINAL REPORT OF INVESTIGATION A&I E24178

West Falls Church Yard – Employee Injury

March 8, 2024

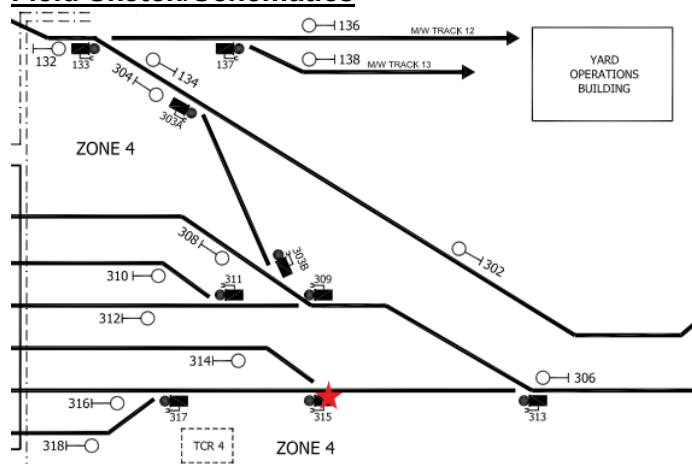
Field Sketch/Schematics

Prior to the event, the ATCM Tower Mechanic was in the Tower with the Interlocking Operator when they requested that the Interlocking Operator demonstrate how to route a switch. During the explanation, the Interlocking Operator physically demonstrated the process and exercised Switch 315, where the ATCM work crew were located which caused the switch to close.

West Falls Church Yard, Switch 315

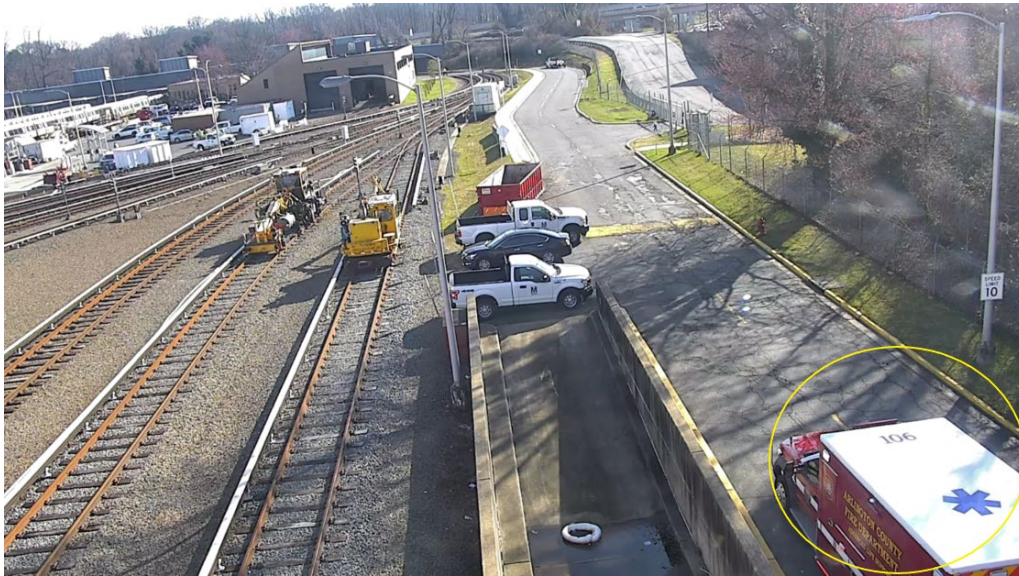
Image 3: Arlington County Fire Department Ambulance arrived on the scene at 09:17 hours.
