## **Improper Door Operation**

### **Glenmont, Silver Spring, Braddock Road and Innovation stations**

**May 9, 2024, September 1, 2024, September 3, 2024, September 23, 2024 and September 24, 2024**

# Improper Door Operation – Glenmont Station

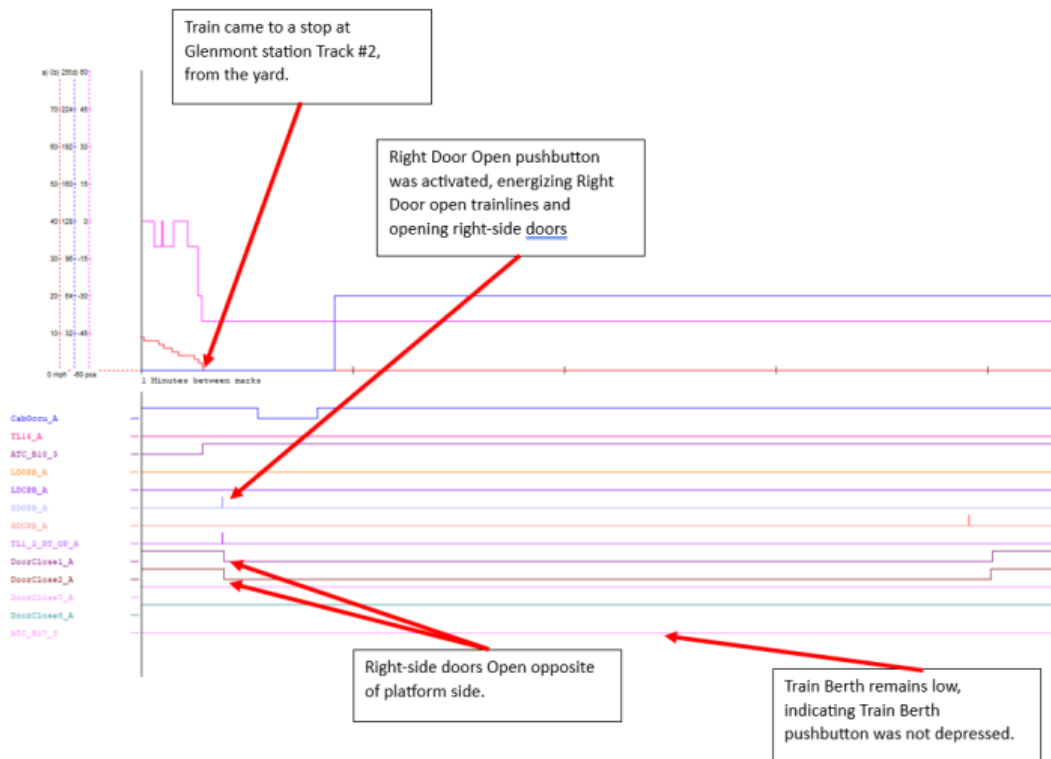
Figure 3 – Lead Car 3130 VMS Event Recorder data.

The CMOR-IIT determined that based on the VMS data, there was no mechanical failure observed that could have contributed to this incident. The VMS data recorded the right open doors pushbutton was activated that open and close doors opposite side of the platform. The berth button was not pressed.

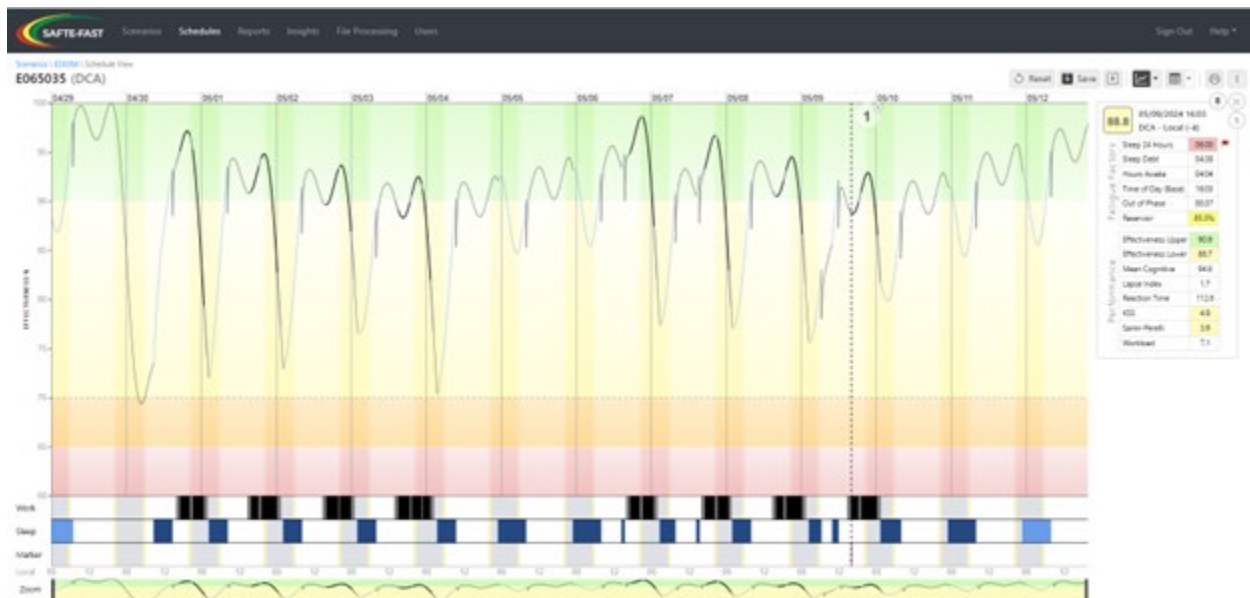
**Figure 4 – Biomathematical Fatigue Modeling using SAFTE-FAST Console**

A biomathematical fatigue modeling application (SAFTE-FAST Console) was used to further evaluate fatigue risk factors that may have been present in the Train Operator's schedule. The analysis was based on the Train Operator's work schedule, reported sleep from the day before the incident, and reported habitual sleep durations. The estimated performance effectiveness at the time of the incident was 88.8%. There were no major risk factors for fatigue identified.

Modeling analysis output shows estimated performance effectiveness during the incident work shift and for the week leading up to the work shift, based on the Train Operator work and reported sleep schedule. Estimates were based on the Train Operator's work schedule, reported sleep from the day preceding the incident, and reported habitual sleep durations (6 hours a day). Bold portions of the modeled curve show work (in black) and sleep times (in blue). Effectiveness is shown on the vertical axis, with colored fields in the chart background signifying ranges of effectiveness scores including high effectiveness (>90%) in green, and low effectiveness (<65%) in red. Time is shown on the horizontal axis. Markers for work and sleep times are shown in the lanes above the time of day on the horizontal axis.

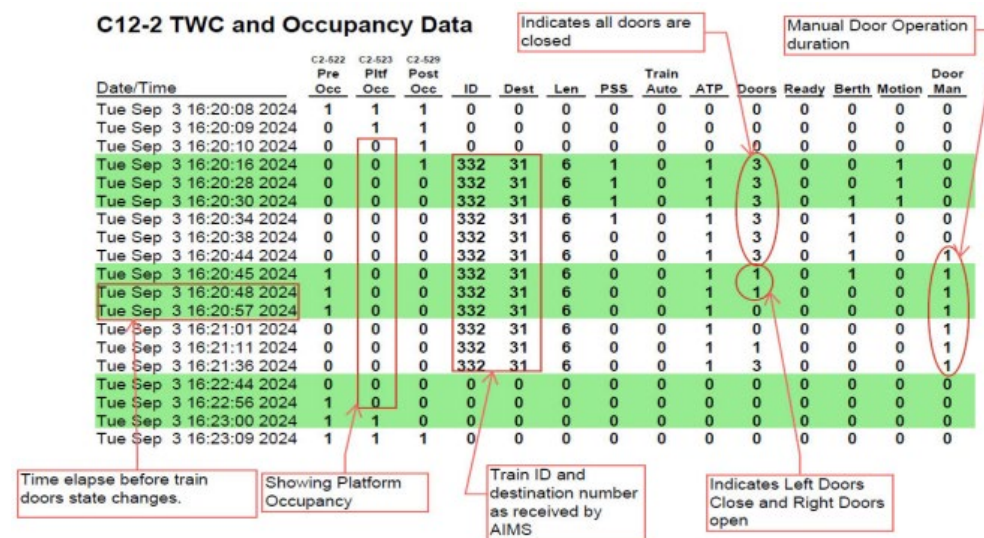
Figure 1 – TWC and Occupancy Data indicating Train ID 332

According to the COSI/SEI report, based on the Train to the Wayside Communication (TWC) and Occupancy Data, Train ID 332 doors were opened manually on the right, non-platform side, for approximately 10 seconds before train doors state changed, closing the right side doors and then opening the left side doors (platform side).

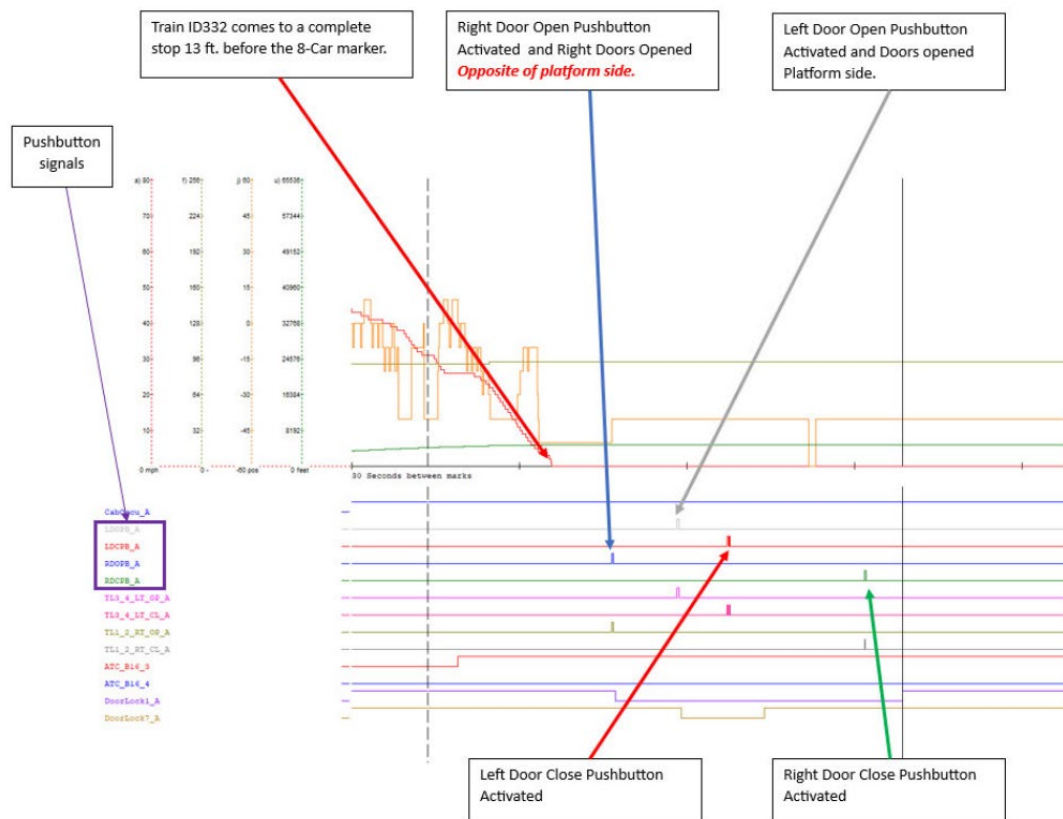
Image 2: Train ID 332 ER data

16:20:28	DCKR signal goes HIGH, indicating All Doors fully closed and Locked.
16:22:58	The Master Controller was placed in a P5 Power position and the train began to move in the direction of King Street.

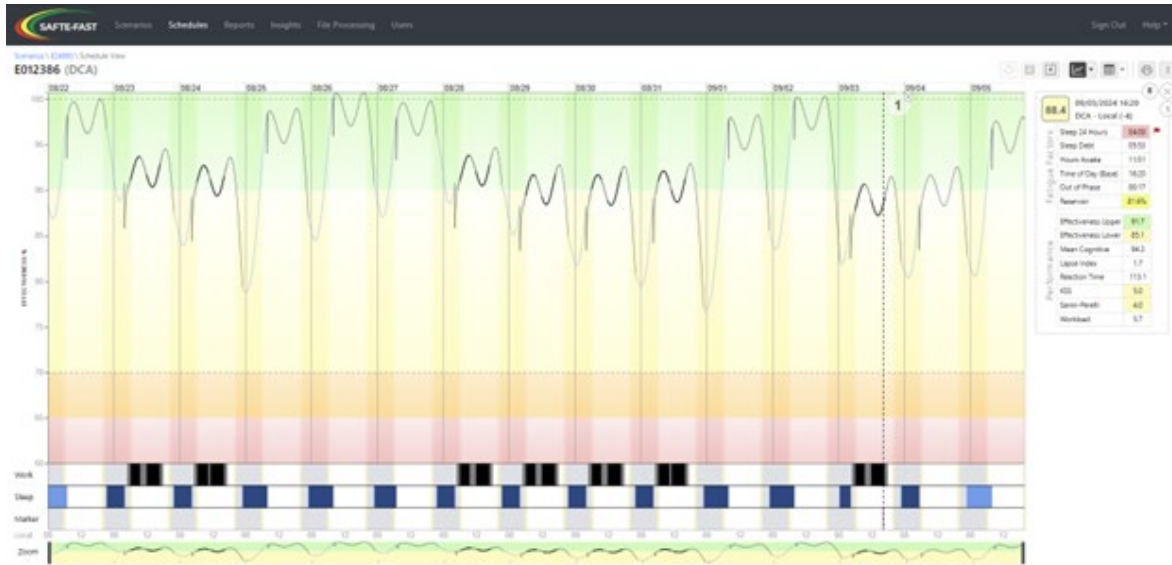
A biomathematical fatigue modelling application (SAFTE-FAST WebSFC) was used to further evaluate fatigue risk factors that may have been present in the RVO's schedule. The analysis was based on the RVO's work schedule, reported sleep from the day before the incident, and reported habitual sleep durations. Estimated performance effectiveness at the time of the incident was

88.4%. Specifically, the analysis identified short sleep duration in the last 24 hours as a factor contributing to an increased risk of fatigue at the time of the incident.

Modeling analysis output shows estimated performance effectiveness during the incident work shift and for the week leading up to the work shift, based on the employee work and reported sleep schedule. Estimates were based on the RVO's work schedule, reported sleep from the day preceding the incident, and reported habitual sleep durations (6.5 hours a day). Bold portions of the modeled curve show work (in black) and sleep times (in blue). Effectiveness is shown on the vertical axis, with colored fields in the chart background signifying ranges of effectiveness scores including high effectiveness (>90%) in green, and low effectiveness (<65%) in red. Time is shown on the horizontal axis. Markers for work and sleep times are shown in the lanes above the time of day on the horizontal axis.

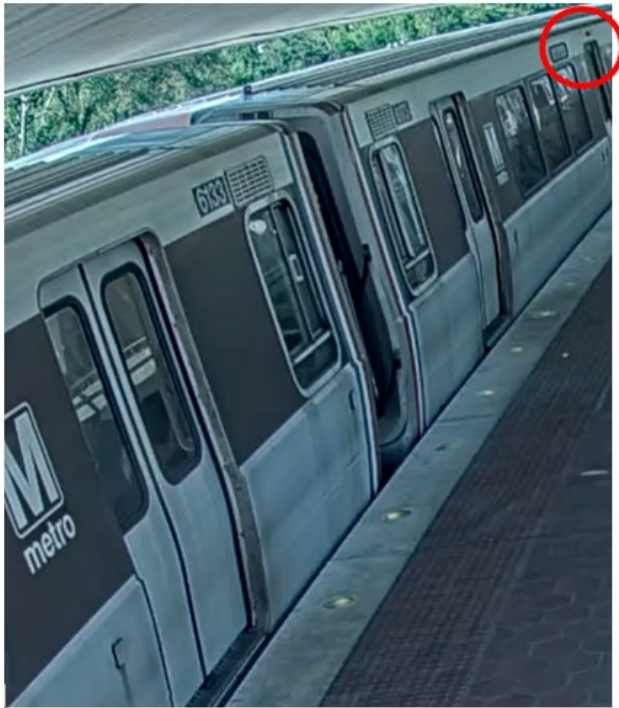
16:21:09 – the platform side doors were closed, but the door lights were still illuminated.

16:21:35 Door lights off.

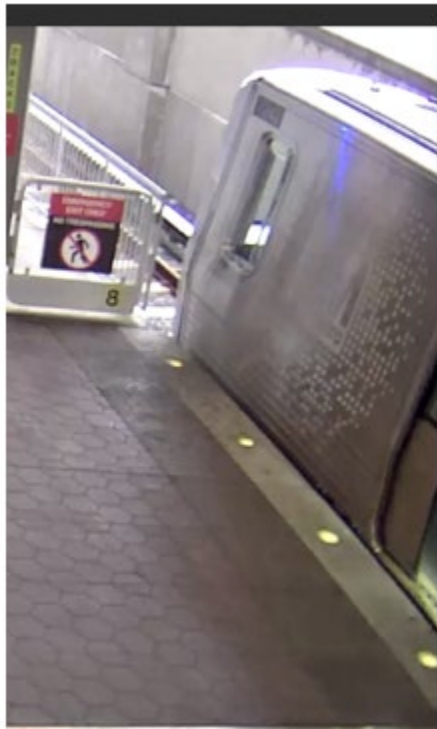
11:15:35 hours - platform side doors were opened.

11:16:13 hours doors were closing.

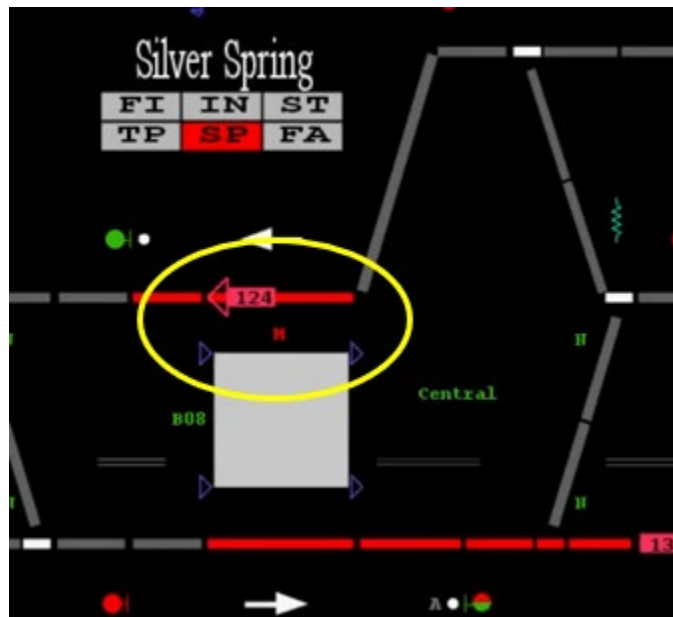
Figure 2 - (Yellow circle) depicts a view of a prior train within platform limit with proper door operation.

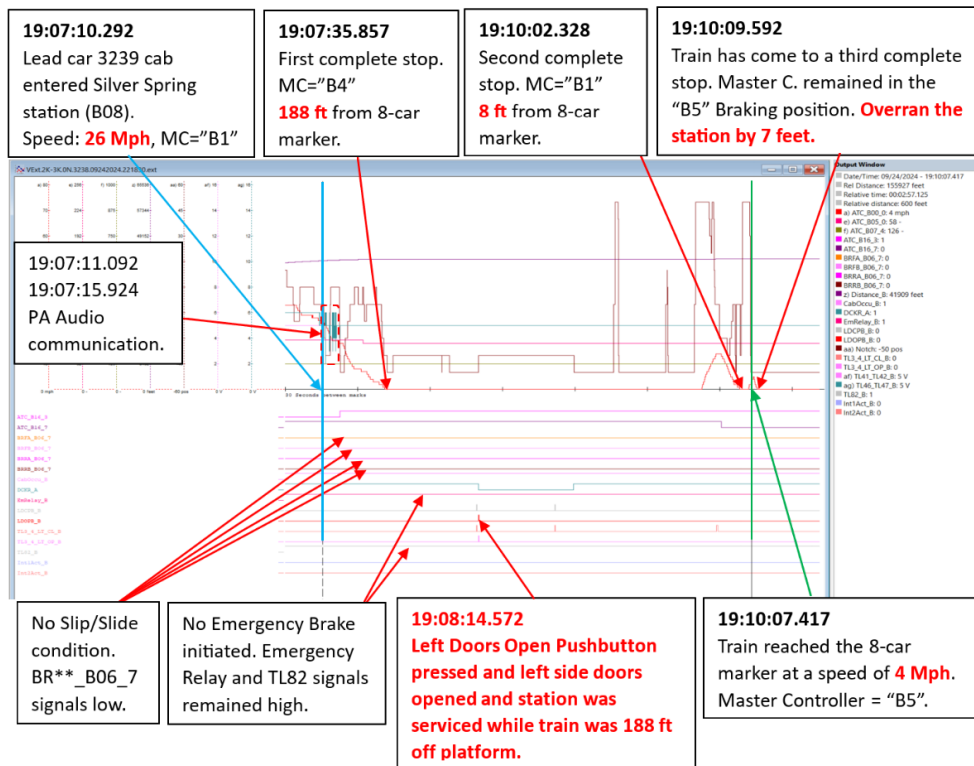
Figure 4 – 3238 VMS Graph Analysis..

19:10:09.592	The Consist came to a complete stop while the MC remained in the "B5" Braking position. Overran the station by 7 feet.	0 MPH	B5	-7 feet
