**W-0396 – Derailment – near Ronald Reagan National Airport Station – April 16, 2024****Document Purpose:**

Washington Metropolitan Area Transit Authority  
Department of Safety (SAFE)  
Office of Safety Investigations (OSI)  
**FINAL REPORT OF INVESTIGATION A&I E24301**

# National Airport – Derailment

April 16, 2024

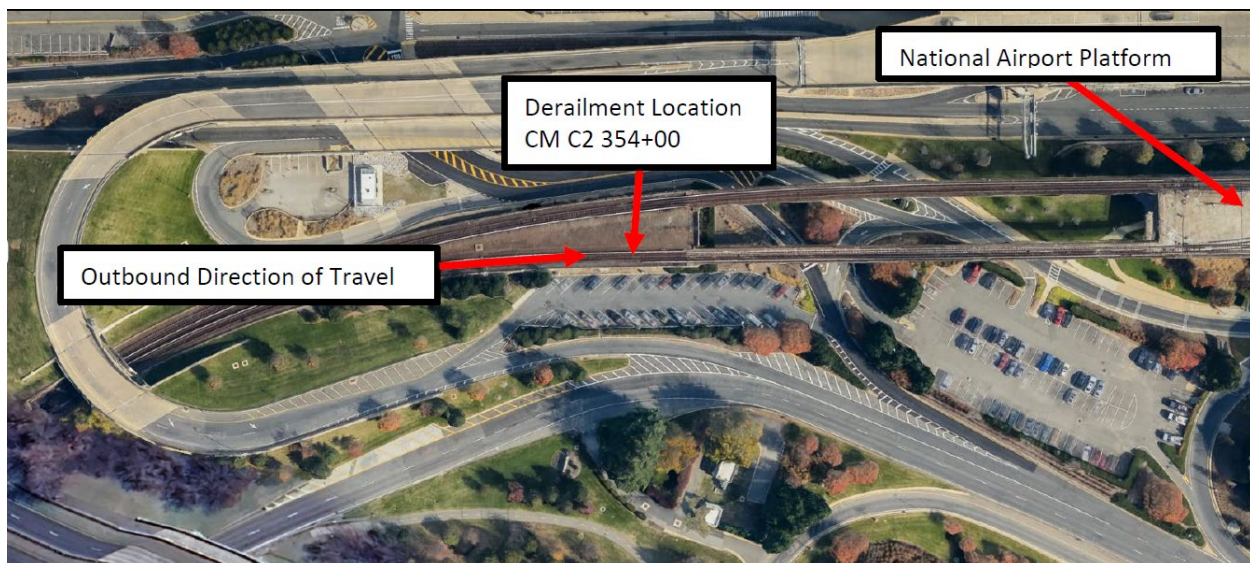
*Figure 1 - Aerial view of derailment location*

National Airport Station Chain Marker (CM) C2 354+00

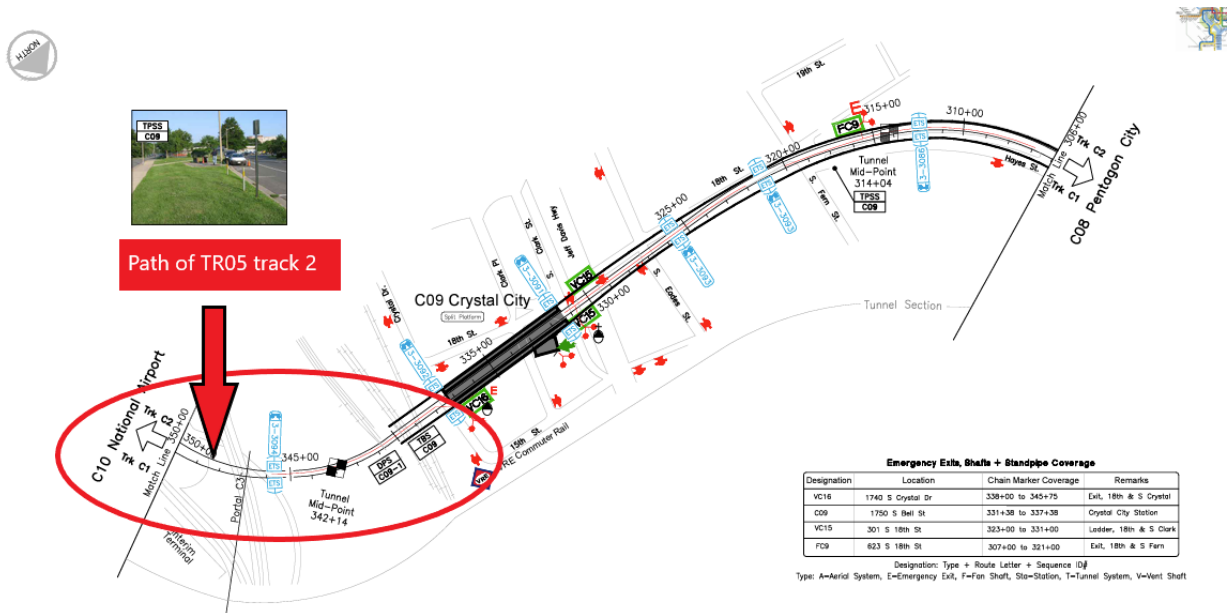
Figure 2 - Path of travel for TR-05 at Crystal City (C09), track 2 towards National Airport (C10)

Leading up to this incident, TR-05 was unable to negotiate the incline coming out of the Crystal City station in Travel mode. The 4% incline combined with an 800-foot radius required more tractive effort than was available. Although the operator was requesting full power to the wheels, TR-05 decelerated. Switching to Work mode allowed TR-05 to continue up the incline. The difference between Travel mode and Work mode is limited to the suspension, with propulsion remaining unaffected. Vehicle Program Services, Rail Fleet, has not, at this point, been able to define track conditions, either singularly or sum-total, that will result in a derailment or the reason why additional tractive effort is available in Work mode.

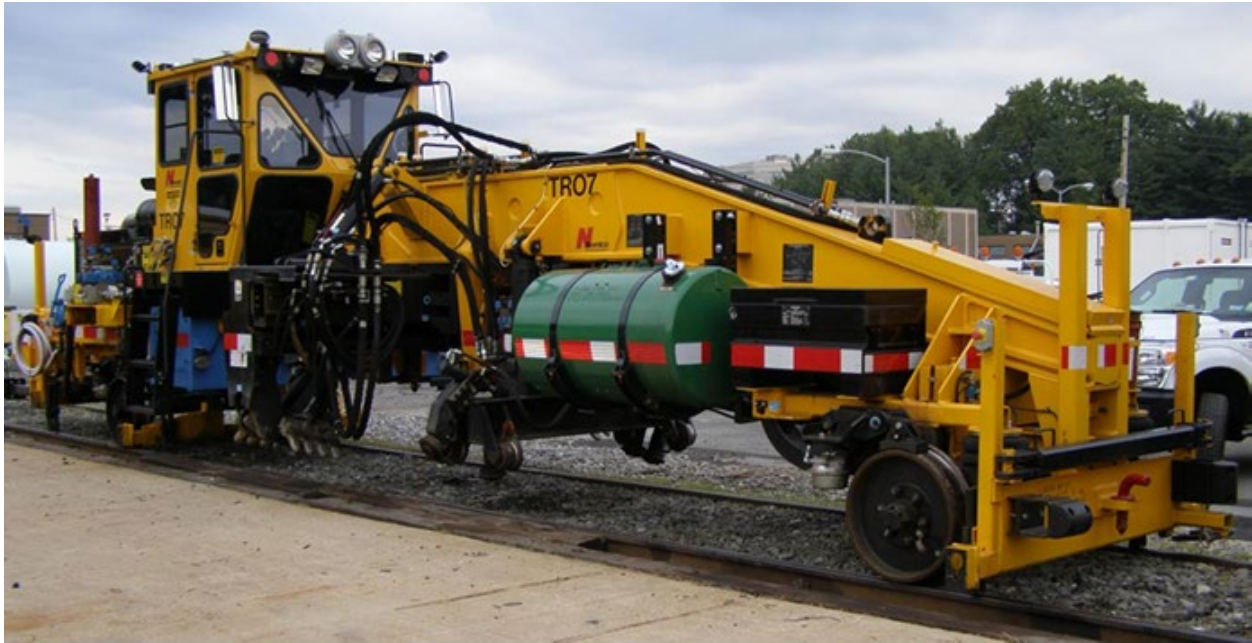
Figure 4 - TRIPP Machine

The probable cause of the derailment at National Airport Station on April 16, 2024, was due to a design issue of the TRIPP Machines. Specifically, TR05 was not designed to navigate the steep inclines/declines, tight radius, superelevation, and spirals of the WMATA rail system. To increase the torque to the wheels, CENV reconfigured and added additional traction motors to the TRIPP machines to assist with navigating WMATA's rail system, but there are still challenges navigating in travel mode.

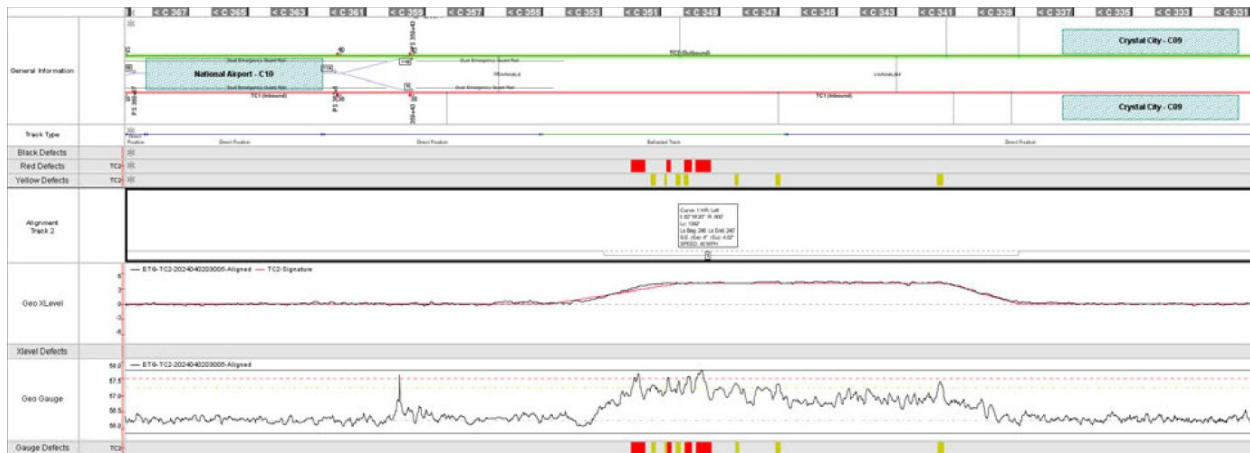
Figure 7 -TGV Report from April 2, 2024

The scheduled work was to address gauge defects between Crystal City and National Airport.

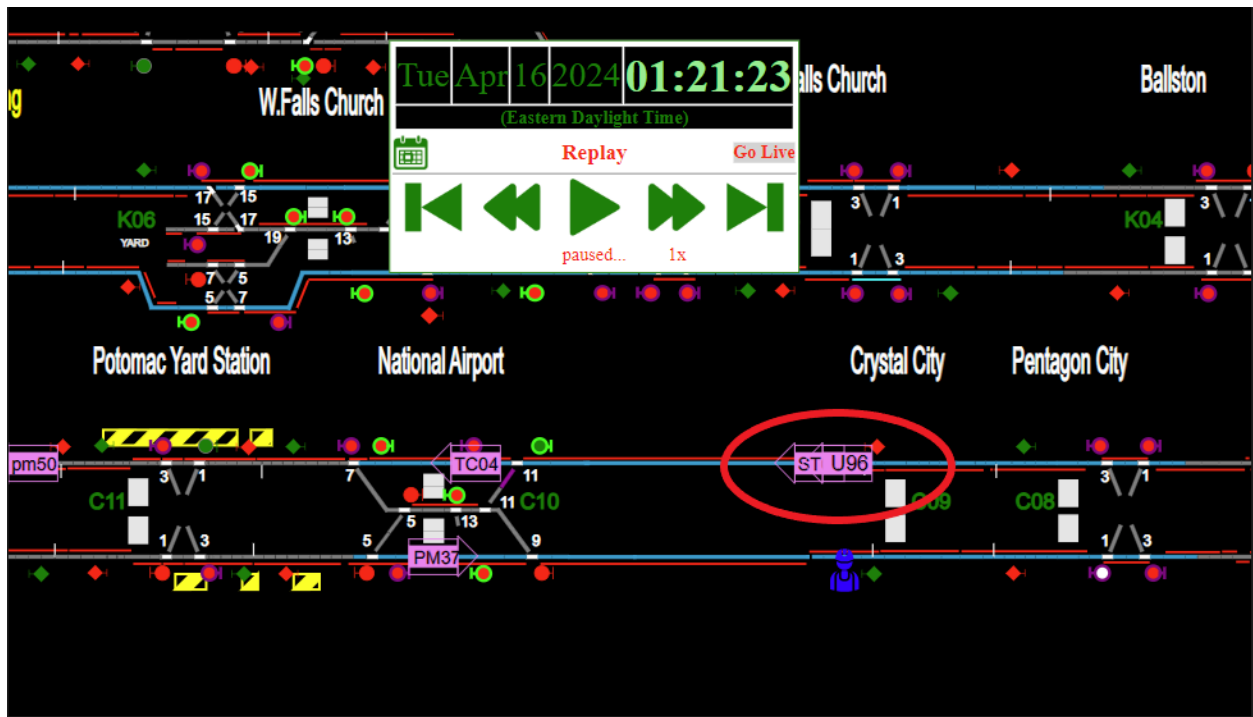
Figure 11 - Depicts convoy on track 2 towards National Airport

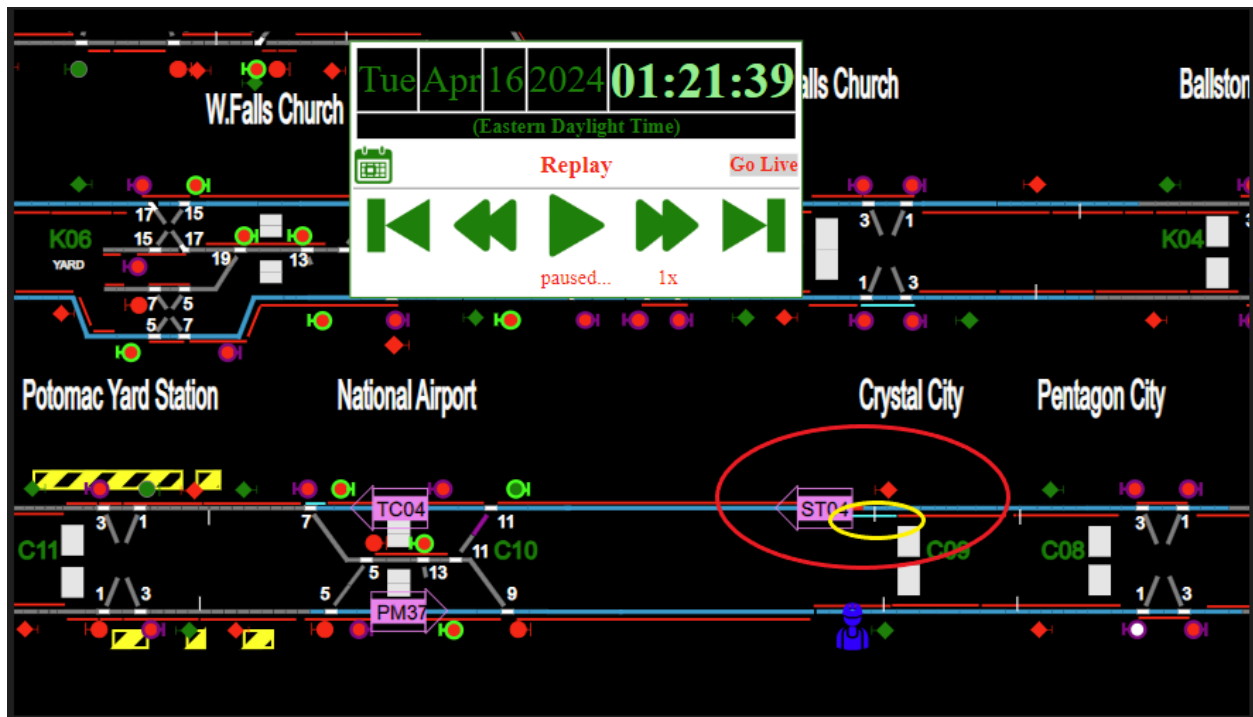
Figure 12 - Depicts Third Rail Power de-energized shortly before the derailment occurred.

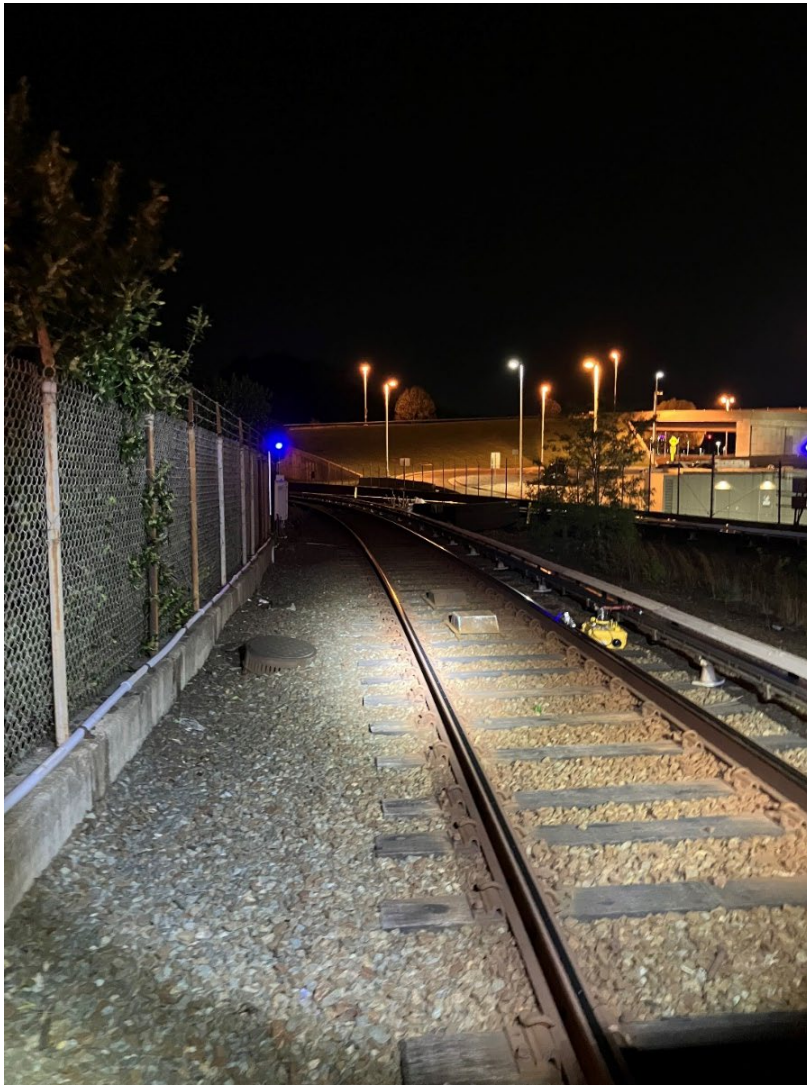
*Figure 20 - Depicts the approach path TR-05 traveled to the Point of Derailment (POD).*

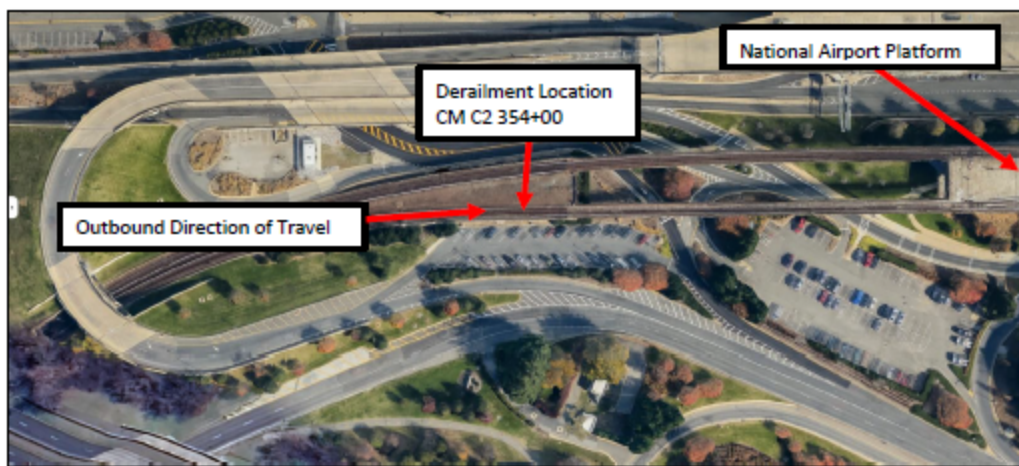
Figure 1. Location of TR05 Derailment

On the morning of 04/16/2024, at approximately 0121 hours, TRIPP Machine TR05 traveling outbound, derailed near National Airport (C10) at chain marker C2 354+00 (Figure 1). Car Track Equipment Maintenance, Rail Fleet was notified and mechanics were dispatched for rerailment. TR05 was successfully rerailed by approximately 0352 hours, and towed by PM37 to Alexandria Maintenance Yard. TR05 cleared mainline at approximately 0412 hours. No damage to TR05 or injuries to personnel were reported. Damage to the third rail and an insulator was reported.

Analysis from the data recorder reveals that TR05 encountered difficulty ascending an incline in Travel mode approximately two minutes prior to the derailment. After failing to maintain speed, TR05 was placed in Work mode. Forward travel resumed in Work mode for approximately 725 feet before derailling.

In work mode, the vehicle's rigid condition is not optimized for navigating cross-level and other track anomalies. The exact conditions between TR05 and the rail that contributed to this incident has not been determined, however the cause of the derailment is believed to be a combination of traveling in work mode and track conditions.

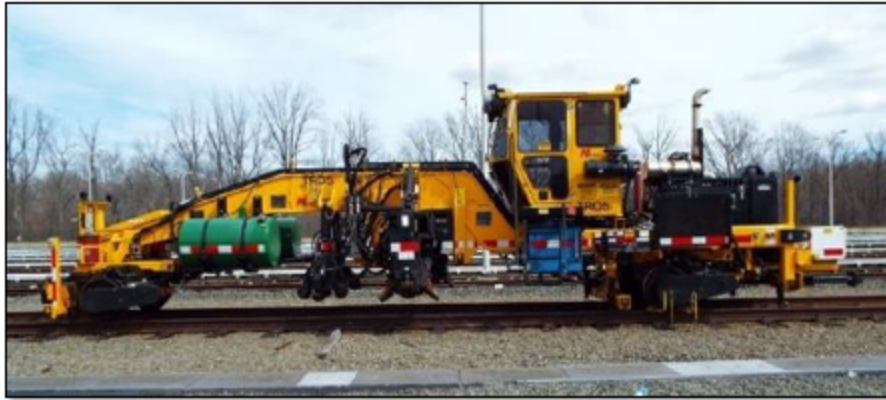
**Figure 2. TRIPP Machine**

WMATA utilizes the TRIPP machine to carry out system maintenance on the WMATA rail system. TR05 is one of the four WMATA-owned TRIPP machines. The TRIPP machines are long-wheelbased (314 inches), single-axle (non-trucked) platforms (Figure 2).

TRIPP machines have two suspension modes. When working, a solid platform is required to resist the forceful action of removing and inserting track ties. But the rigid configuration is not suitable for the cross levels found in spirals and the long wheelbase and the single axle design causes high wheel flange attack angles to occur in curves. Therefore, in Work mode the speed is restricted to 5 mph. To allow for travel through the WMATA system at a reasonable speed, TRIPP machines have an air suspension system that inflates in Travel mode. The flexible suspension accommodates varying track conditions at higher speeds. Service Bulletin SBX005, issued in January 2019, restricts single-axle vehicles to 15 mph. Before the release of SBX005, TRIPP machines were operated at the operator's discretion.
