**W-0399 Collision at Benning Road Station – December 10, 2024****Document Purpose**

**FINAL REPORT OF INVESTIGATION A&I E24983**

# Benning Road Station – Collision

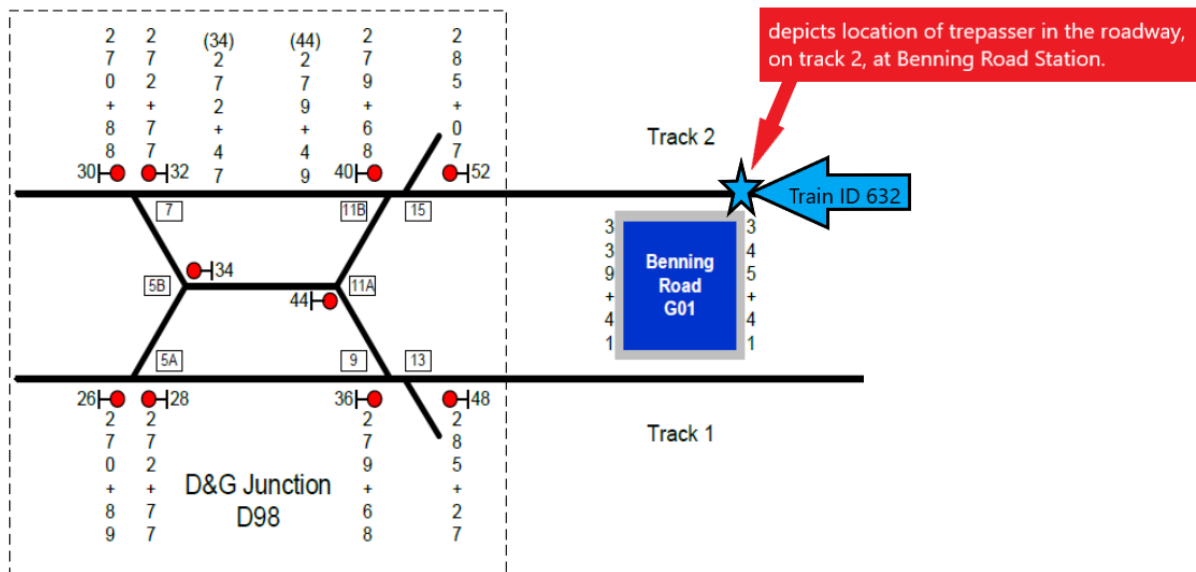
## Field Sketch/Schematics

Benning Road Station is a below-ground station with a center platform. There are direct fixation tracks and an interlocking towards the inbound direction.
