W-0410 – Improper Roadway Worker Protection at L'Enfant Plaza Station – December 12, 2024

FINAL REPORT OF INVESTIGATION A&I E24988

L'Enfant Plaza Station – Improper RWP

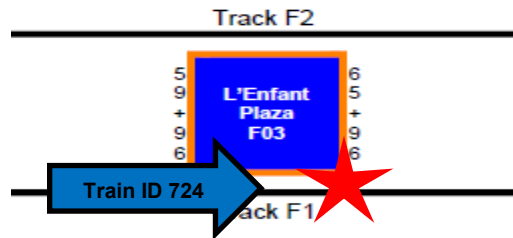
Field Sketch/Schematics

L'Enfant Plaza Station is an indoor station with dual levels that serves the Blue, Orange, and Silver lines on the lower level. The Green and Yellow lines serve the upper level. On the lower level, there is a center platform. This event occurred on the lower level on track number one.
