Improper Vehicle Movement
At or Near Shady Grove Station and Union Station
March 25, 2025 and March 28, 2025

FINAL REPORT OF INVESTIGATION A&I E25437

Shady Grove – Improper Rail Vehicle Movement

Union Station – Improper Rail Vehicle Movement

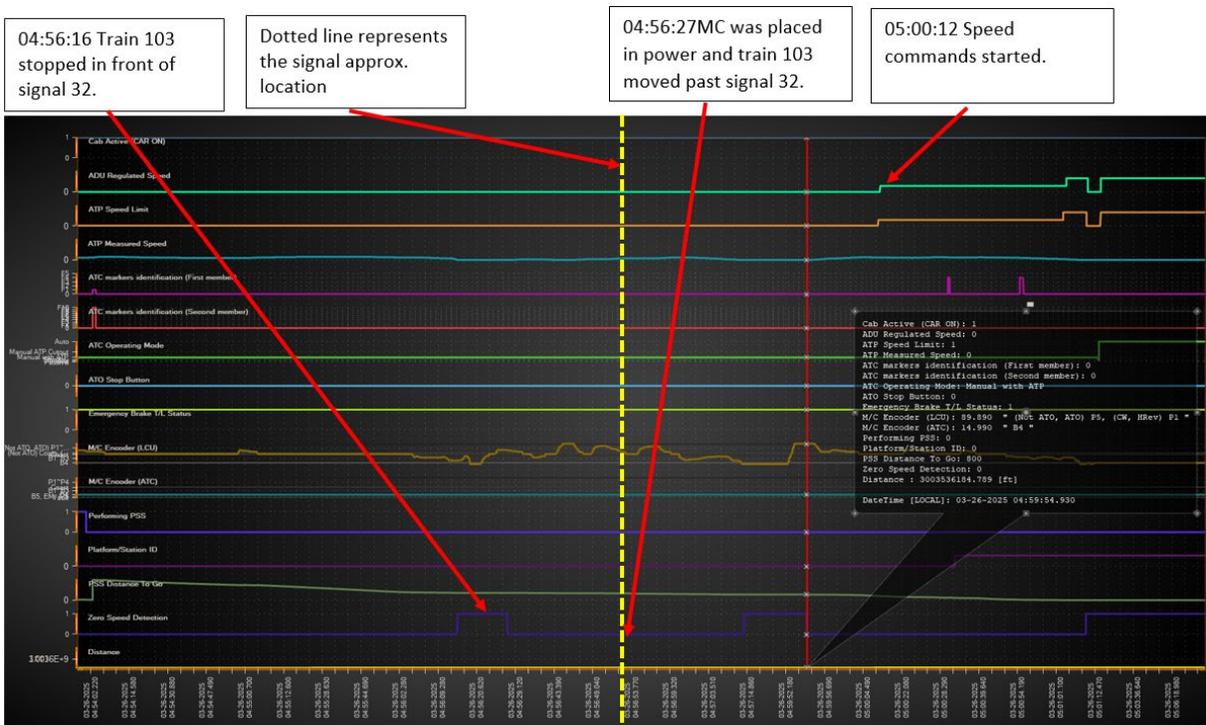
Time	Description
04:56:56 hours	MC was placed in power, and train 103 moved past signal 32.
04:57:13 hours	Train 103 stopped after signal 32.
04:59:54 hours	Train 103 resumed operation and moved to the platform on track 1.
05:00:12 hours	Speed commands started once the train entered the platform block.

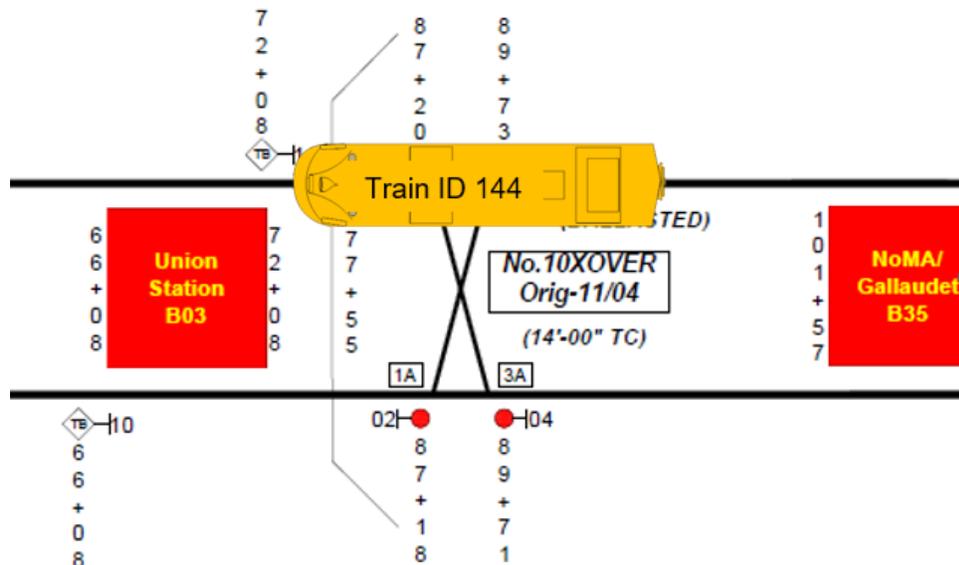
Field Sketch/Schematics

The RVO proceeded to move the train manually to Union Station platform without speed commands and without receiving permission from the Radio RTC. After servicing the station, a Rail Operations Supervisor (ROS) boarded the train and observed the RVO's operation towards Shady Grove Station, where the RVO was subsequently removed from service.

Union Station, track 2 Chain Marker 72+08
