## **W-0418 – Evacuation for Life Safety Reasons at Potomac Avenue Station – March 20, 2025**

**FINAL REPORT OF INVESTIGATION A&I E25417**

# Potomac Avenue Station – Evacuation for Life Safety Reasons

March 20, 2025

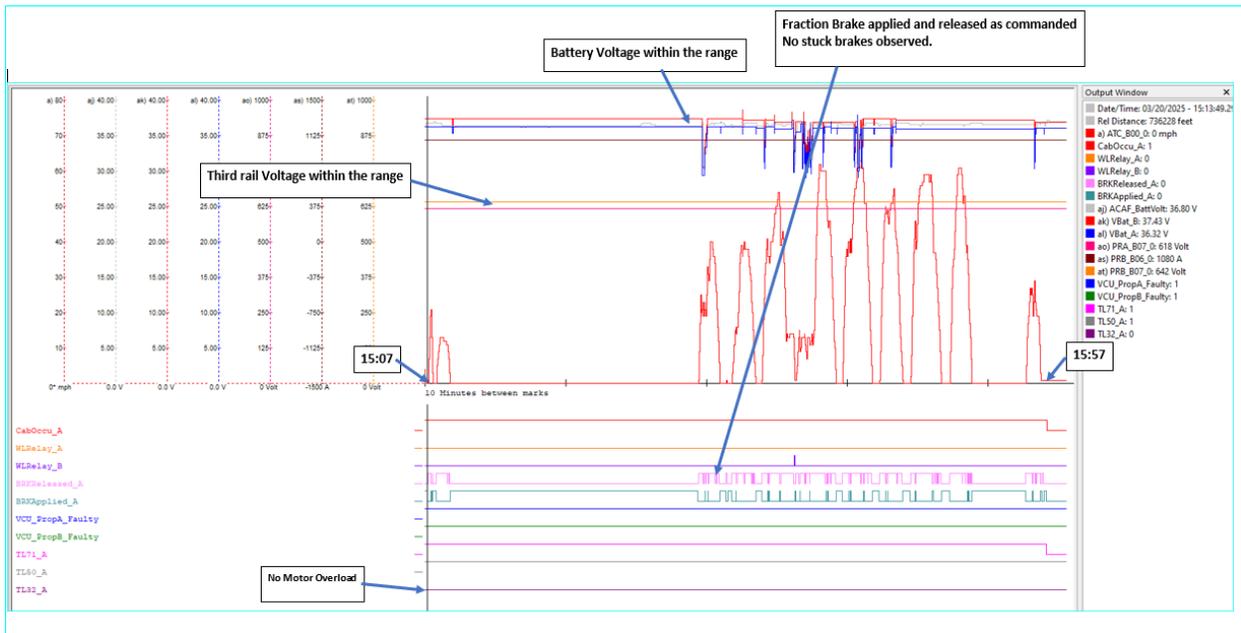
IIT performed a Vehicle Monitoring System (VMS) data review of Train ID 603 from 15:07 hours to 15:57 hours. No abnormalities were found, with all train signals within specification. The propulsion sub-system was not communicating with VMS, however, Motor Overload (MOL) Trainline displayed no motor overload during that timeframe.

Alexandria Service and Inspection (S&I) shop performed an undercarriage inspection and did not find any issue with car 3110.

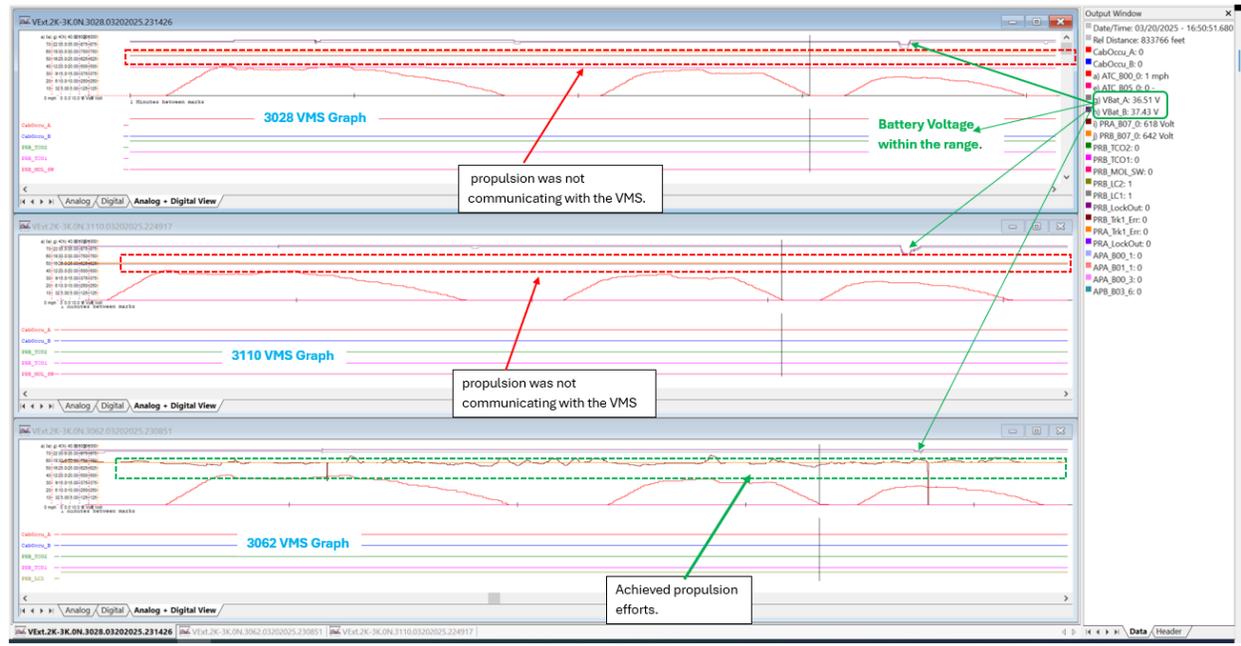
Car Maintenance personnel at the Alexandria Rail Yard completed the undercar inspection on cars **3110/11x3062/63x3028/29**. The inspection revealed no evidence of smoke, flashing, or arching. All brake discs were inspected for odor and discoloration, and no irregularities were detected. Additionally, no damaged cables or equipment were identified. A comprehensive Daily Inspection (DI) and functional check was conducted on all cars, with no issues reported.
