W-0419 – Red Signal Overrun near Eastern Market Station – April 20, 2025

Washington Metropolitan Area Transit Authority
Department of Safety
Office of Safety Investigations

FINAL REPORT OF INVESTIGATION A&I E25538

Eastern Market Station – Red Signal Overrun

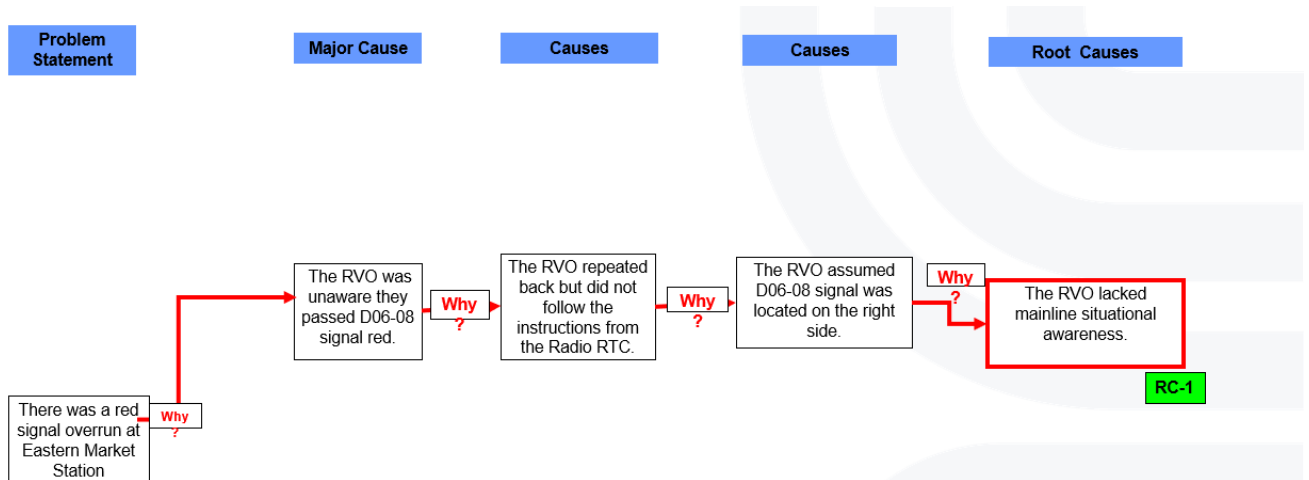
Appendix C – Why-Tree Analysis

The probable cause for the Red Signal Overrun that occurred at Eastern Market Station on April 20, 2025, was due to a lack of mainline situational awareness. Although the RVO repeated the instructions, they were unsure of what actions were required. A contributing factor was the Operator's misconception that there was only one left-side aligned signal in the system, Brentwood Yard; however, Eastern Market Station interlocking signal is on the left.
