W-0421 - Collision – New Carrollton Yard– July 1, 2025

FINAL REPORT OF INVESTIGATION A&I E25979

Date of Event:	July 1, 2025
Type of Event:	Collision
Incident Time:	04:28 Hours
Location:	New Carrollton Yard
Time and How received by Safety:	04:52 / SIO
Washington Metrorail Safety Commission (WMSC) Notification Time:	05:53 hours
Responding Safety Officers:	Office of Safety Oversight (OSO)
Rail Vehicle:	PM39, F533, PM47
Injuries:	None
Damage:	F533 step grab rails and sideboard holders PM47 hose reel
Emergency Responders:	None
Safety Universal Data System (SUDS) Number	20250701#127964

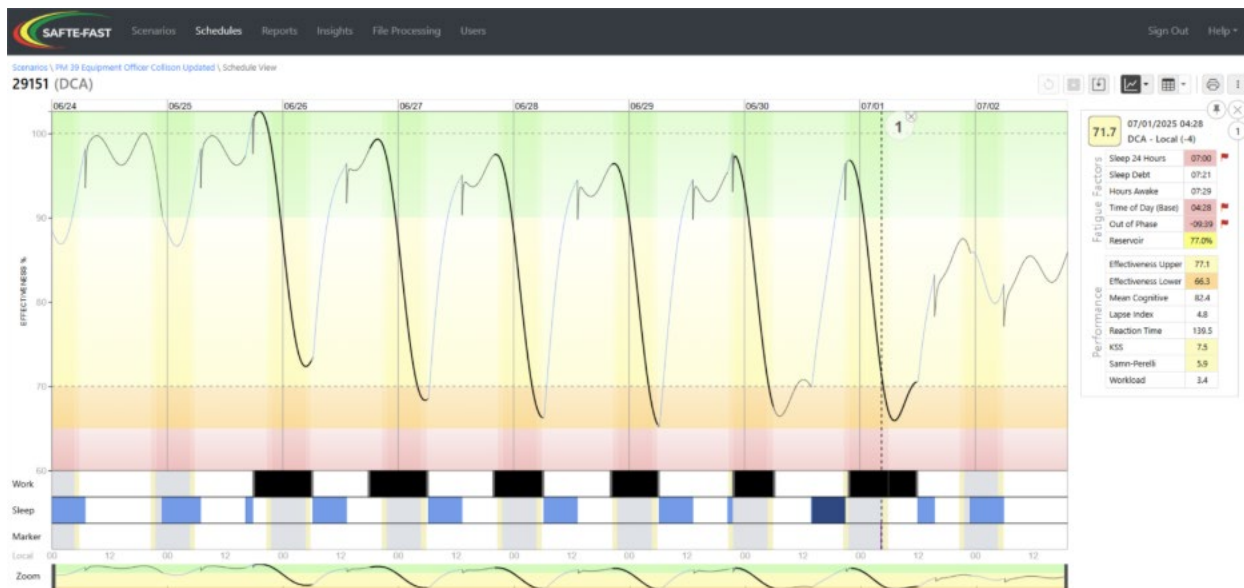
The employee had worked alternate day-to-night work schedules leading up to the incident. There was a total of 40 hours of overtime worked in the two weeks preceding the incident. It was noted that the employee had worked 10 consecutive days without a day off.

Modeling analysis output shows estimated performance effectiveness during the incident work shift and for the week leading up to the work shift, based on the employee work and reported sleep schedule. Estimates were based on the Train Operator's work schedule, reported sleep from the day preceding the incident, and reported habitual sleep durations (7 hours a day). Bold portions of the modeled curve show work (in black) and sleep times (in blue). Effectiveness is shown on the vertical axis, with colored fields in the chart background signifying ranges of effectiveness scores including high effectiveness (>90%) in green, and low effectiveness (<65%) in red. Time is shown on the horizontal axis. Markers for work and sleep times are shown in the lanes above the time of day on the horizontal axis.

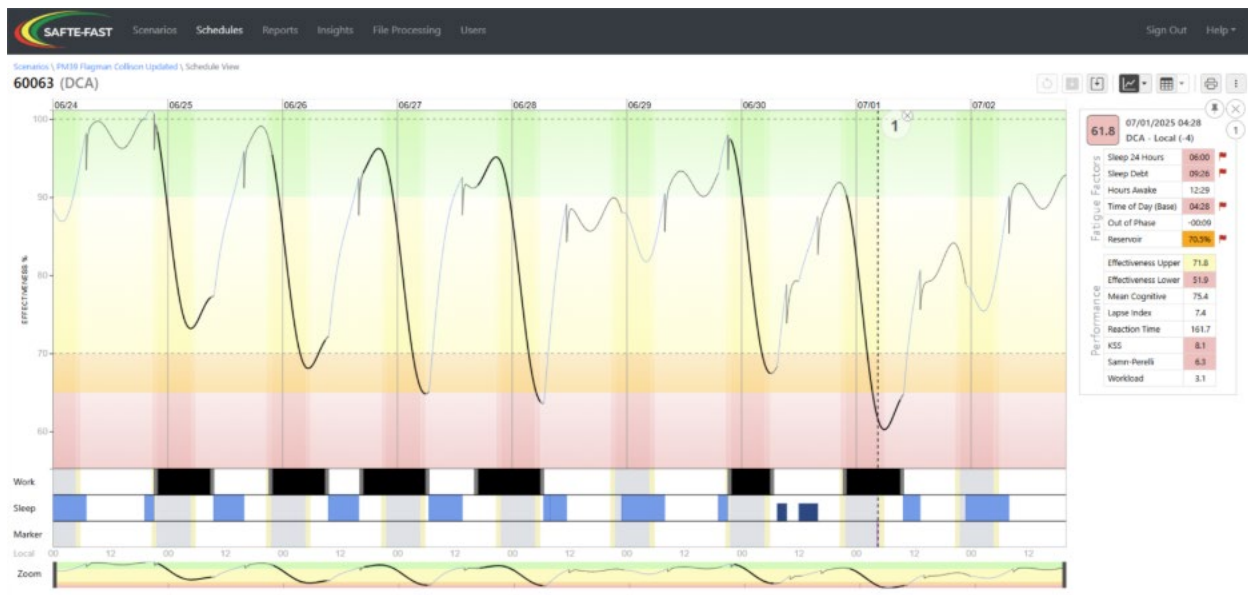
PM-39 Flagman

Modeling analysis output shows estimated performance effectiveness during the incident work shift and for the week leading up to the work shift, based on the employee work and reported sleep schedule. Estimates were based on the Train Operator's work schedule, reported sleep from the day preceding the incident, and reported habitual sleep durations (7 hours a day). Bold portions of the modeled curve show work (in black) and sleep times (in blue). Effectiveness is shown on the vertical axis, with colored fields in the chart background signifying ranges of effectiveness scores including high effectiveness (>90%) in green, and low effectiveness (<65%) in red. Time is shown on the horizontal axis. Markers for work and sleep times are shown in the lanes above the time of day on the horizontal axis.

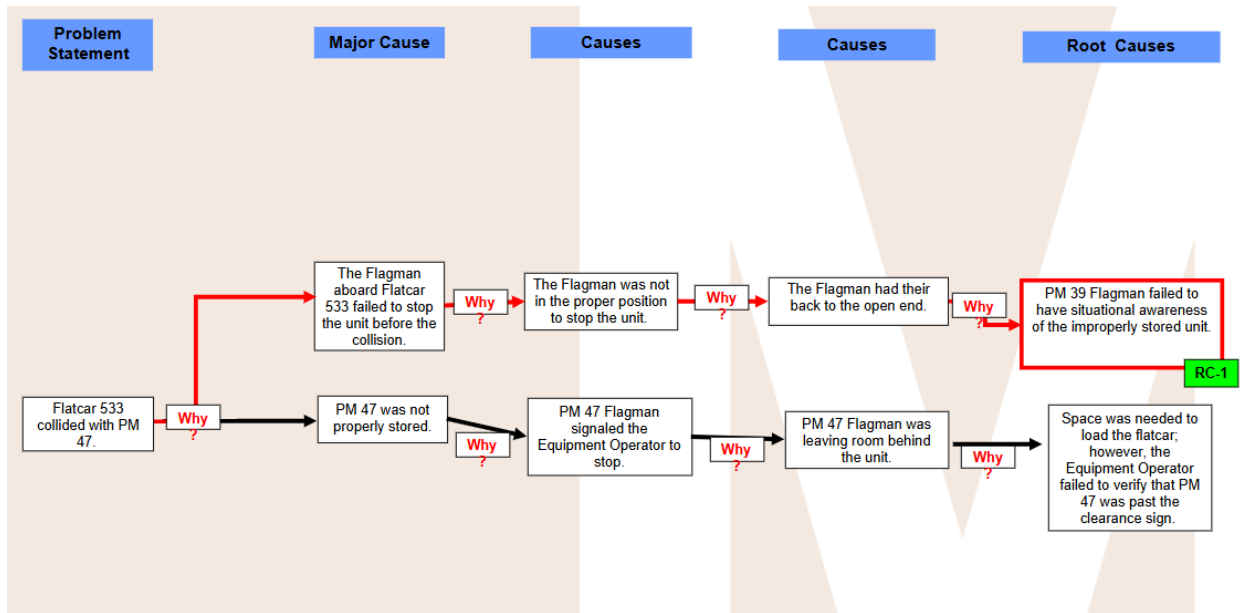
Appendix E – Why-Tree Analysis

- PM-47 was not properly stored behind the clearance sign and fouled the traverse track.
- PM-47 personnel failed to notify the tower of cleared and physically verify clear before alighting the unit.
- PM-39 Flagman was flagging the unit with their back to the stored unit.
- PM-39 EO did not have a clear line of sight and was solely depending on the Flagman's judgment.

The probable cause for the Collision at New Carrollton Yard on July 1, 2025, was the result of misjudgment by the Flagman. Specifically, the Flagman did not identify that PM 39 did not have enough clearance to make a safe move to the desired storage track. A contributing factor was that PM 47 was fouling the track by not being behind the clearance post sign located near D99-82 signal and the storage tracks.
