W-0423 – Derailment near Mount Vernon Square Station – June 9, 2025

FINAL REPORT OF INVESTIGATION A&I E25766

Mount Vernon Square Station – Derailment

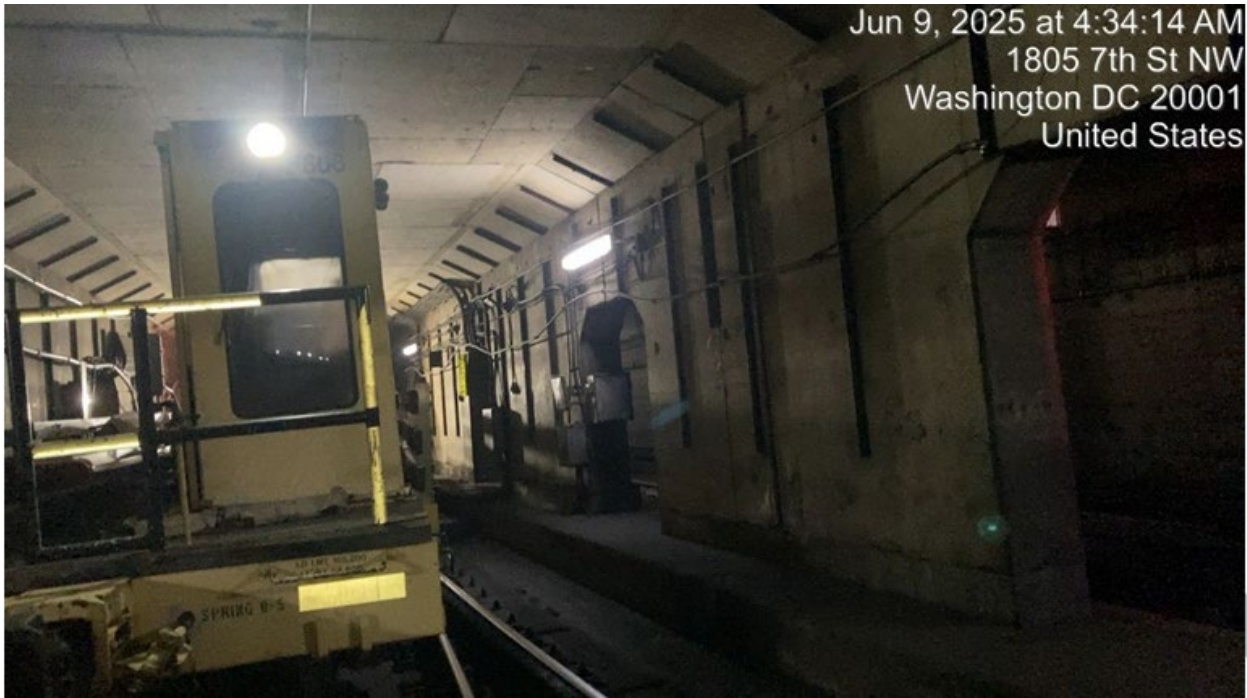
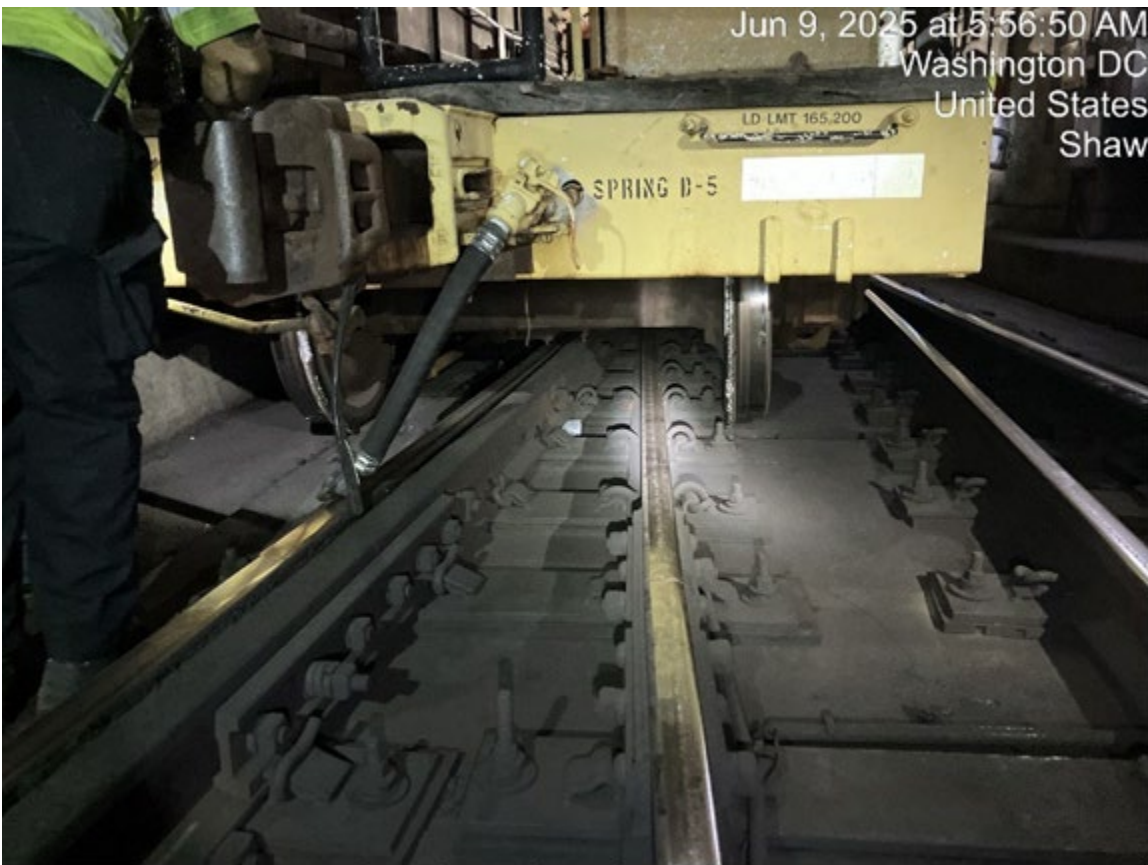
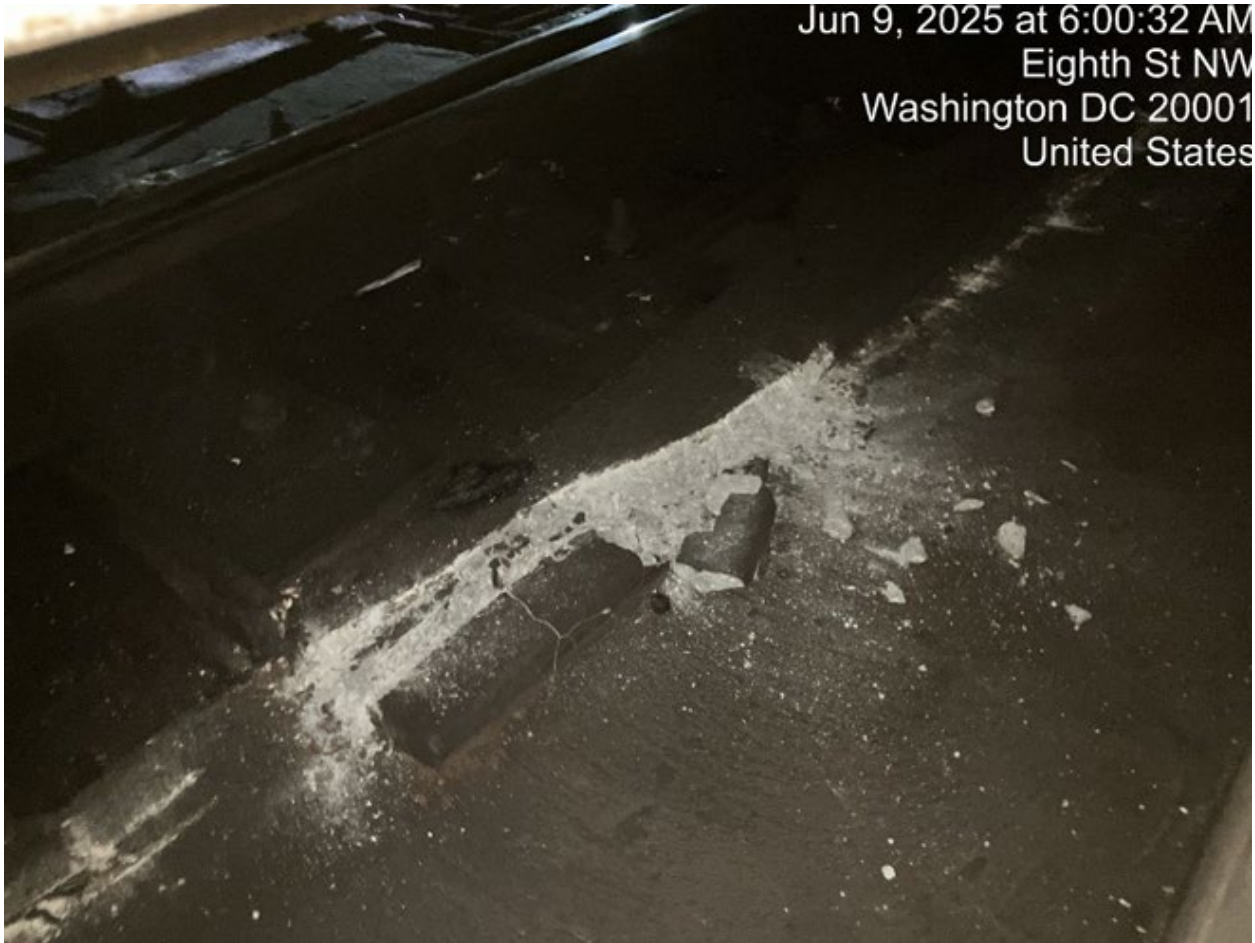
Appendix D – Scene Photographs

On the morning of June 9th, 2025, at approximately 0150 hours, Flat Car F606, being pushed in reverse by PM39, derailed its leading (B-end) truck exiting the Mt. Vernon pocket track (Figure 1). The derailment caused minor damage to the flatcar and infrastructure. No injury to personnel was reported.

Investigation revealed the cause of the incident to be the B-end of F606 traversing automatic derailer 13.
