W-0427- Collision – Columbia Heights Station – August 10, 2025

FINAL REPORT OF INVESTIGATION A&I

Columbia Heights Station, Track 2 – Collision

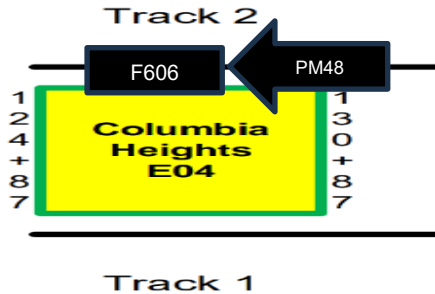
Field Sketch/Schematics

Columbia Heights Station is an indoor station with a center platform and direct fixation tracks. The collision occurred on track 2 as the train approached the station. Damage was discovered between Chain Markers (CM) E2 133+00 and E2 124+00.

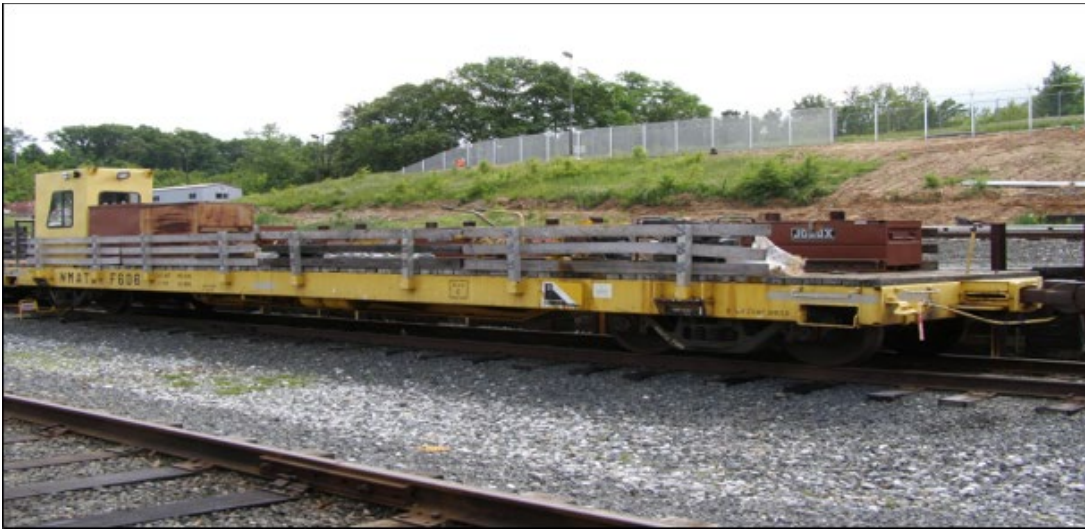
Based on the Signal Engineering Investigation data, PM-48 potentially collided with Wee-Z Bonds WZ-4 at CM E2-130+87 and WZ-5 at E2-124+87, on Track 2 of the platform. Track Circuits E2-131, E2-125, and E2-118 remained down after the unit had left the area. Inspections conducted by the Equipment Operator of PM-48, the Primary Responder, and the TRST Mechanic confirmed that the Wee-Z Bonds had been struck and dragged, resulting in additional damage at multiple points along the platform limits of the roadway. It was also discovered that a handbrake (brake rod) bar on Flatcar F606 had come loose, contributing to the collision.

Figure 5 - Actual image of Flatcar F606.

A pre-trip inspection was performed on PM-48 and Flatcar F606 by the Equipment Operator and Flagman before the unit left Greenbelt Rail Yard. Flatcar F606 was removed from service for further investigation and to make repairs. Flatcar F606 returned to service on August 27, 2025.

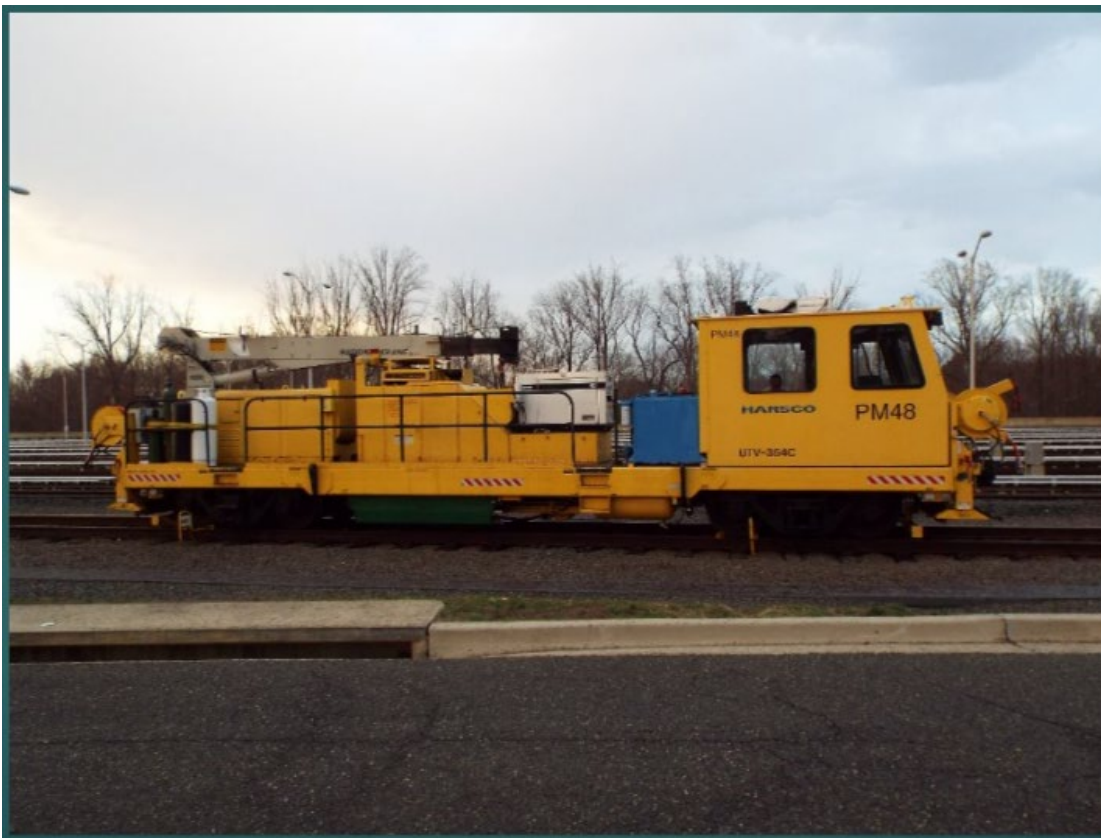
Figure 6 - Actual image of PM-48.
