## Evacuation for Life Safety Reasons

### At or Near Cleveland Park and Foggy Bottom-GWU and stations

**FINAL REPORT OF INVESTIGATION A&I E25569**

# Cleveland Park Station – Evacuation for Life Safety Reasons

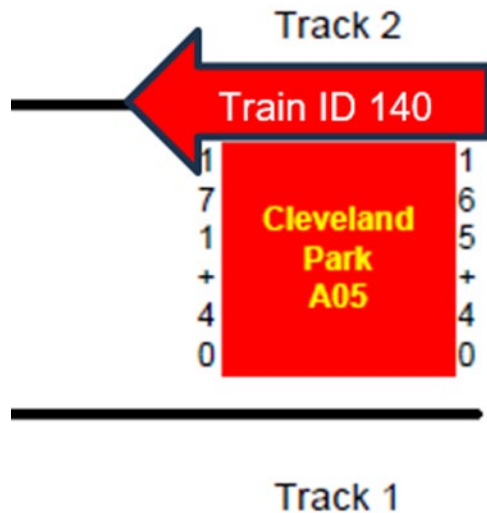
Cleveland Park Station is an indoor station with a center platform and direct fixation tracks. There is no interlocking or turnback at this location.

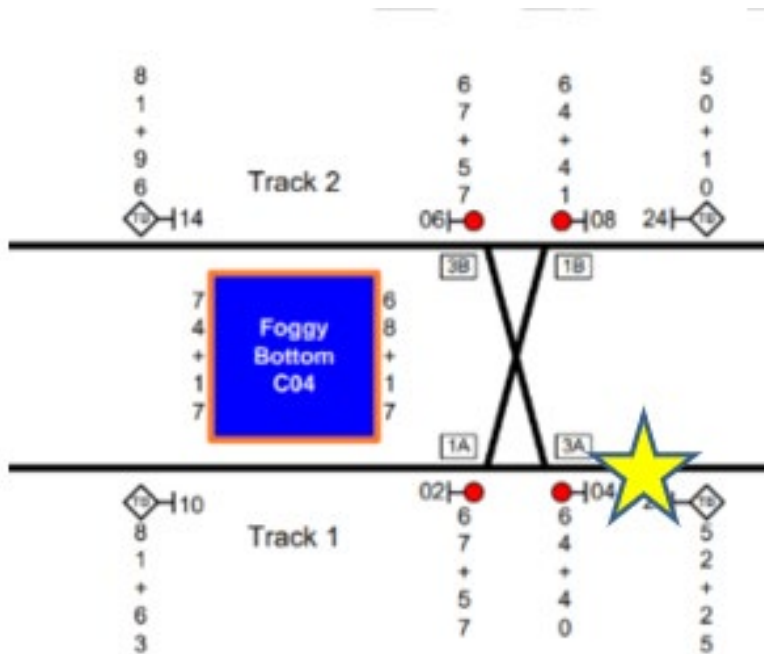
Foggy Bottom Station is an indoor station with a center platform and direct fixation tracks. There is an interlocking on the inbound end of the station. The fire occurred on Track 1 outside of the interlocking.

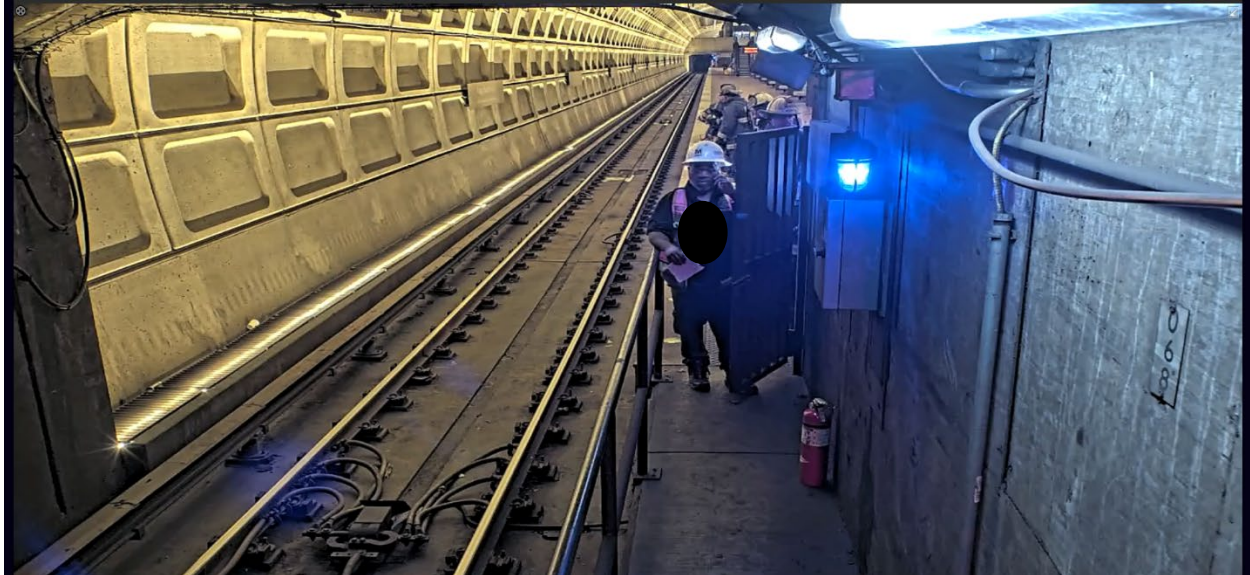
Figure 3 - DCFEMS is standing by on the platform.

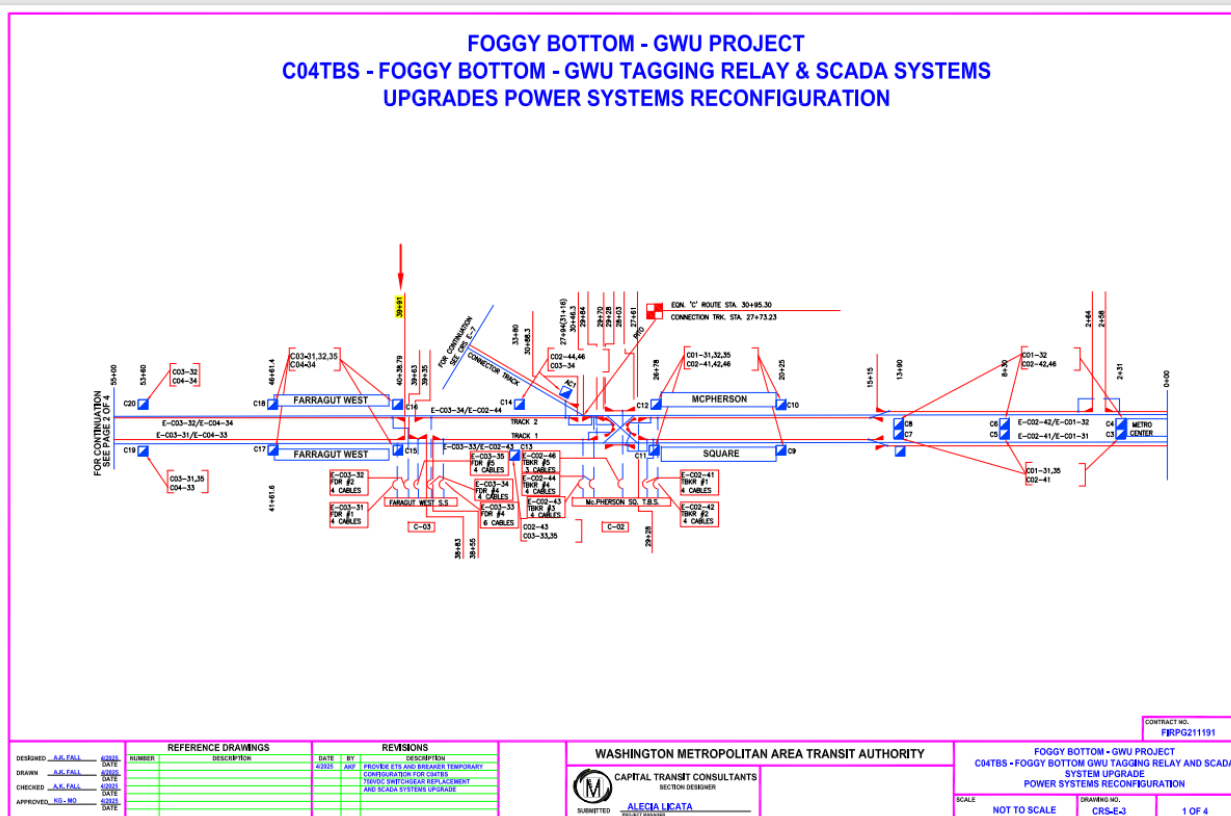
Figure 12 - Foggy Bottom-GWU Project C04TBS - Foggy Bottom-GWU Tagging Relay and SCADA Systems Upgrades Power Systems Reconfiguration Page 1 of 4

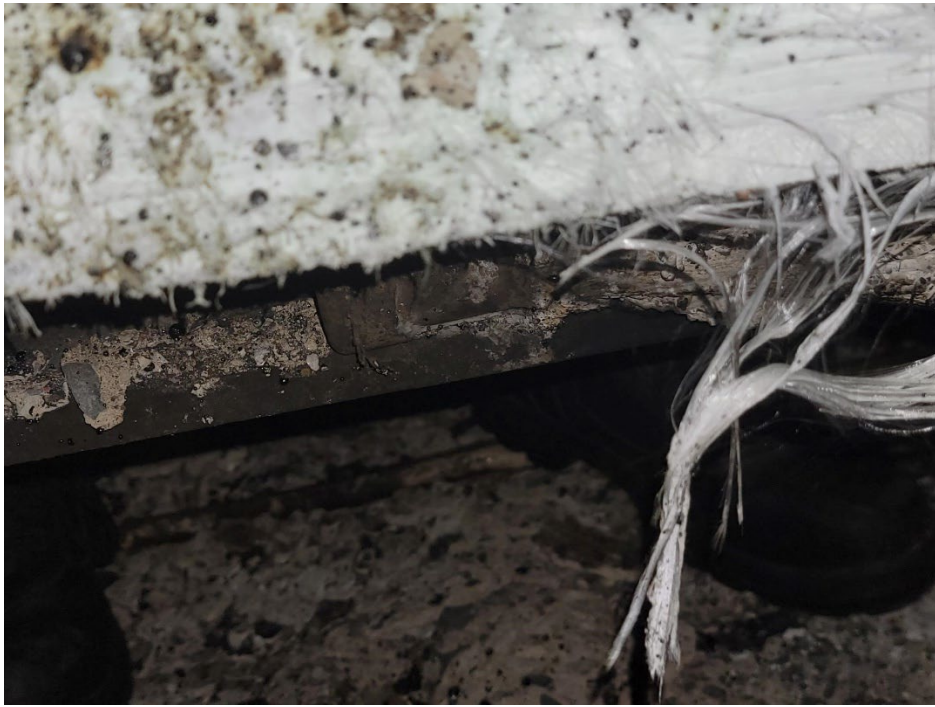
Figure 18 - A close-up of a white feather.

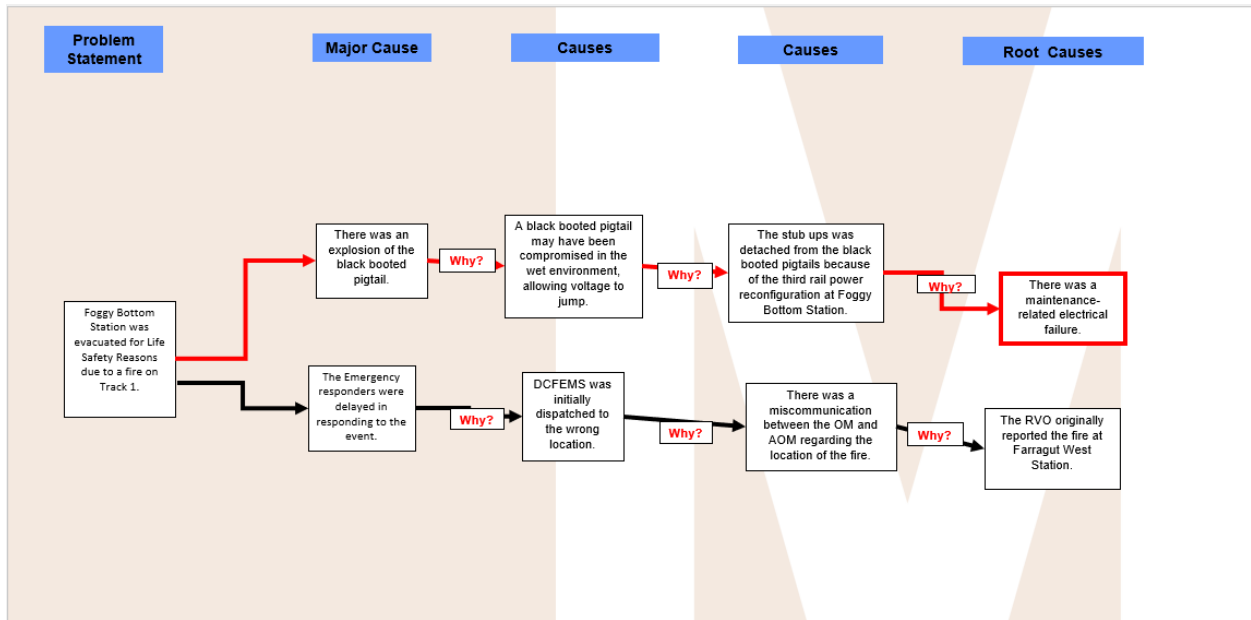
Figure 20 - Why Tree Analysis.
