W-0426 – Improper Roadway Worker Protection at Anacostia Station – August 28, 2025

FINAL REPORT OF INVESTIGATION A&I E251460

Anacostia Station – Improper RWP

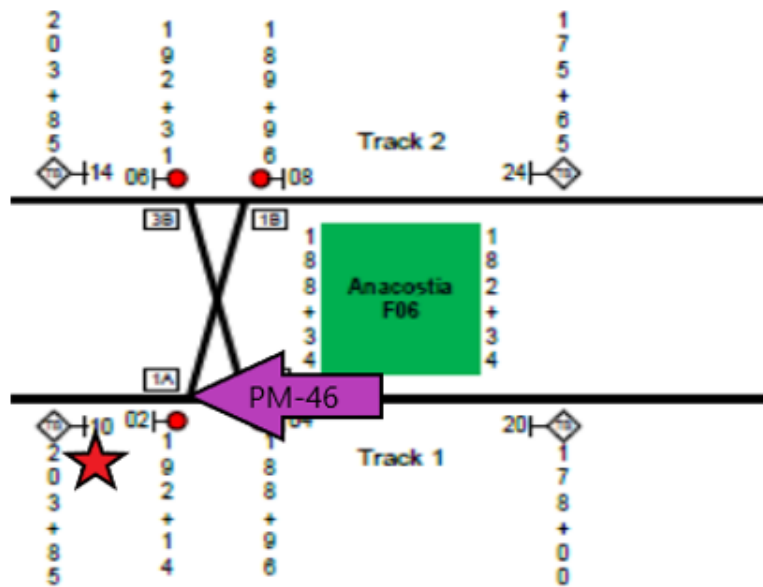
Field Sketch/Schematics

Anacostia Station is a below-ground station with a center platform and direct fixation tracks. There is an interlocking on the outbound end of the station and turnbacks at both ends of the station.
