## W-0430 – Red Signal Overrun at Brentwood Rail Yard – September 15, 2025

**FINAL REPORT OF INVESTIGATION A&I E251606**

**Brentwood Yard – Red Signal Overrun**

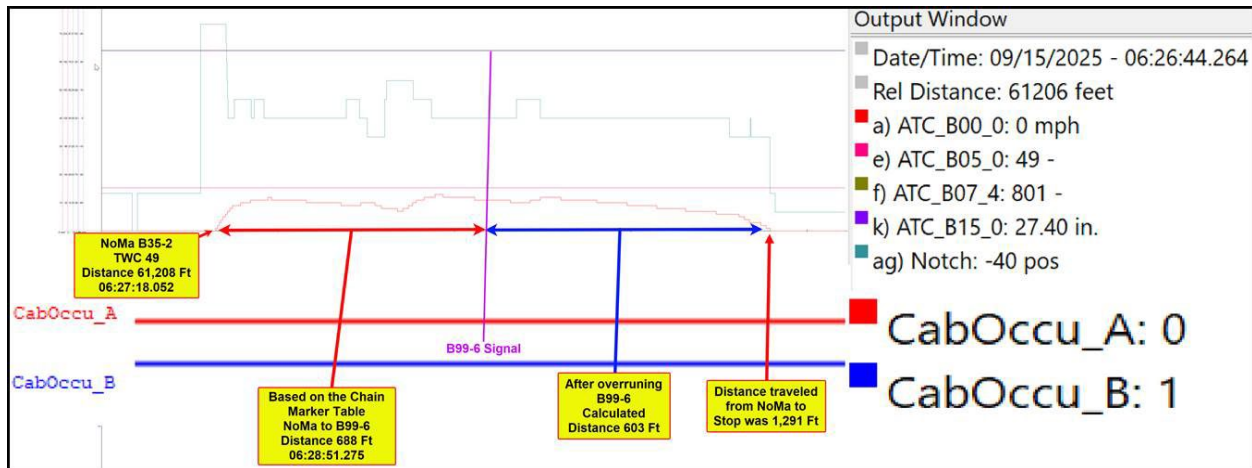
IIT completed the downloads and analysis of the data. Based on the data, there was no fault or mechanical defect that could have contributed to the cause of this incident. The train operated as designed and responded to the commands entered by the Master Controller.

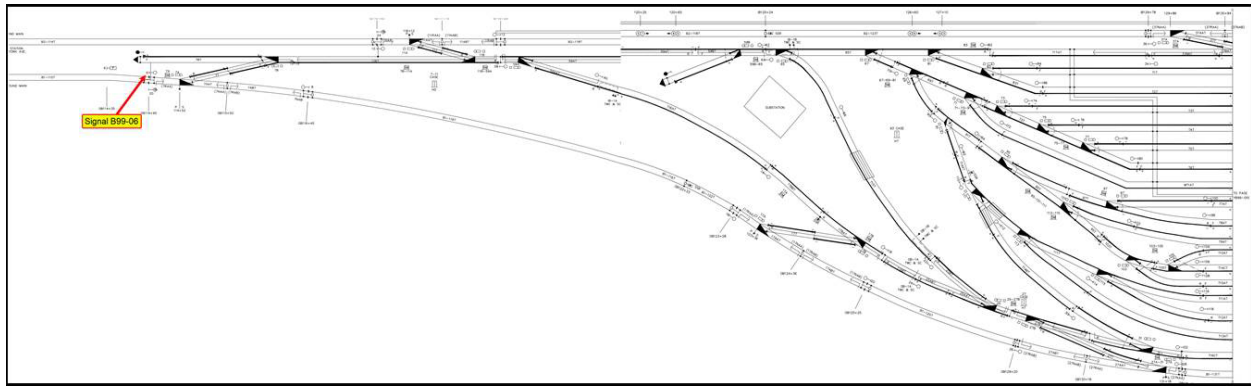
Below is the Double Line Track Map showing Signal B99-06.

On September 15, 2025, Train 801 overran red signal B99-06 in approach to Brentwood Rail Yard. Brentwood Rail Yard is located between NoMa-Gallaudet U and Rhode Island Ave-Brentwood stations, nestled between tracks 1 and 2. There were no passengers aboard Train 801, and it was operated in manual mode.

As a result, the RVO accidentally passed the B99-06 red signal. The mistake was not immediately noticed by the operator but was later confirmed by Radio RTC, which verified the red signal violation.

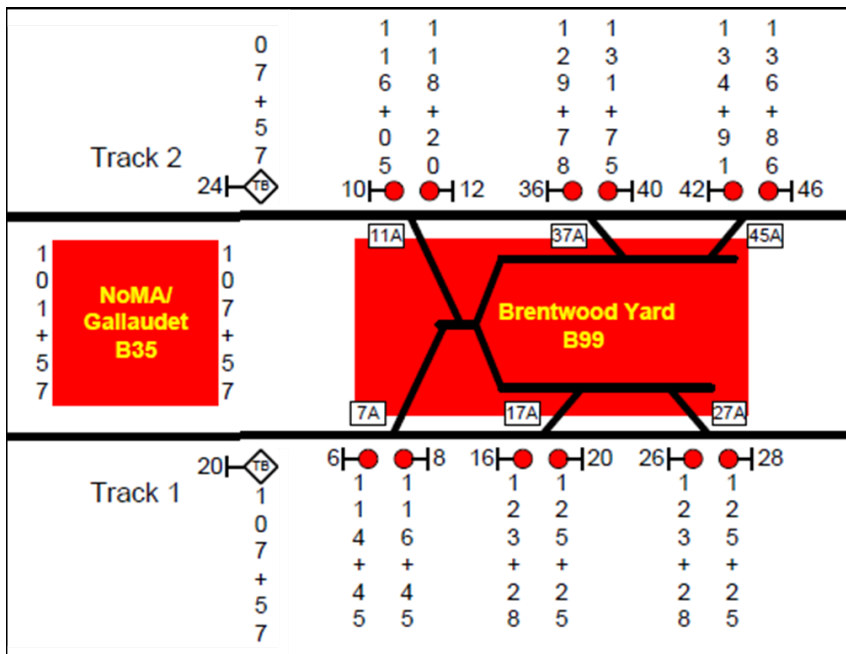
**VMS Signal of Events**

VMS Time	Event Description	Master Controller	Train Speed	Train Marker
06:27:15	Train moving	P5	0 MPH	
06: 27:18	TWC 49, NoMa	P5	1 MPH	10757 Ft
06:28:45	Approaching Switch B99-6	B1	6 Mph	
06:28:48	MC moved	Coast	3MPH	
06:28:49	MC moved	B1	3 MPH	
06:28:52	MC moved	B4	1 MPH	
06:28:57	Executive Traffic Passing B99-6			11445 Ft
06:28:52	Train stopped	B4	0 MPH

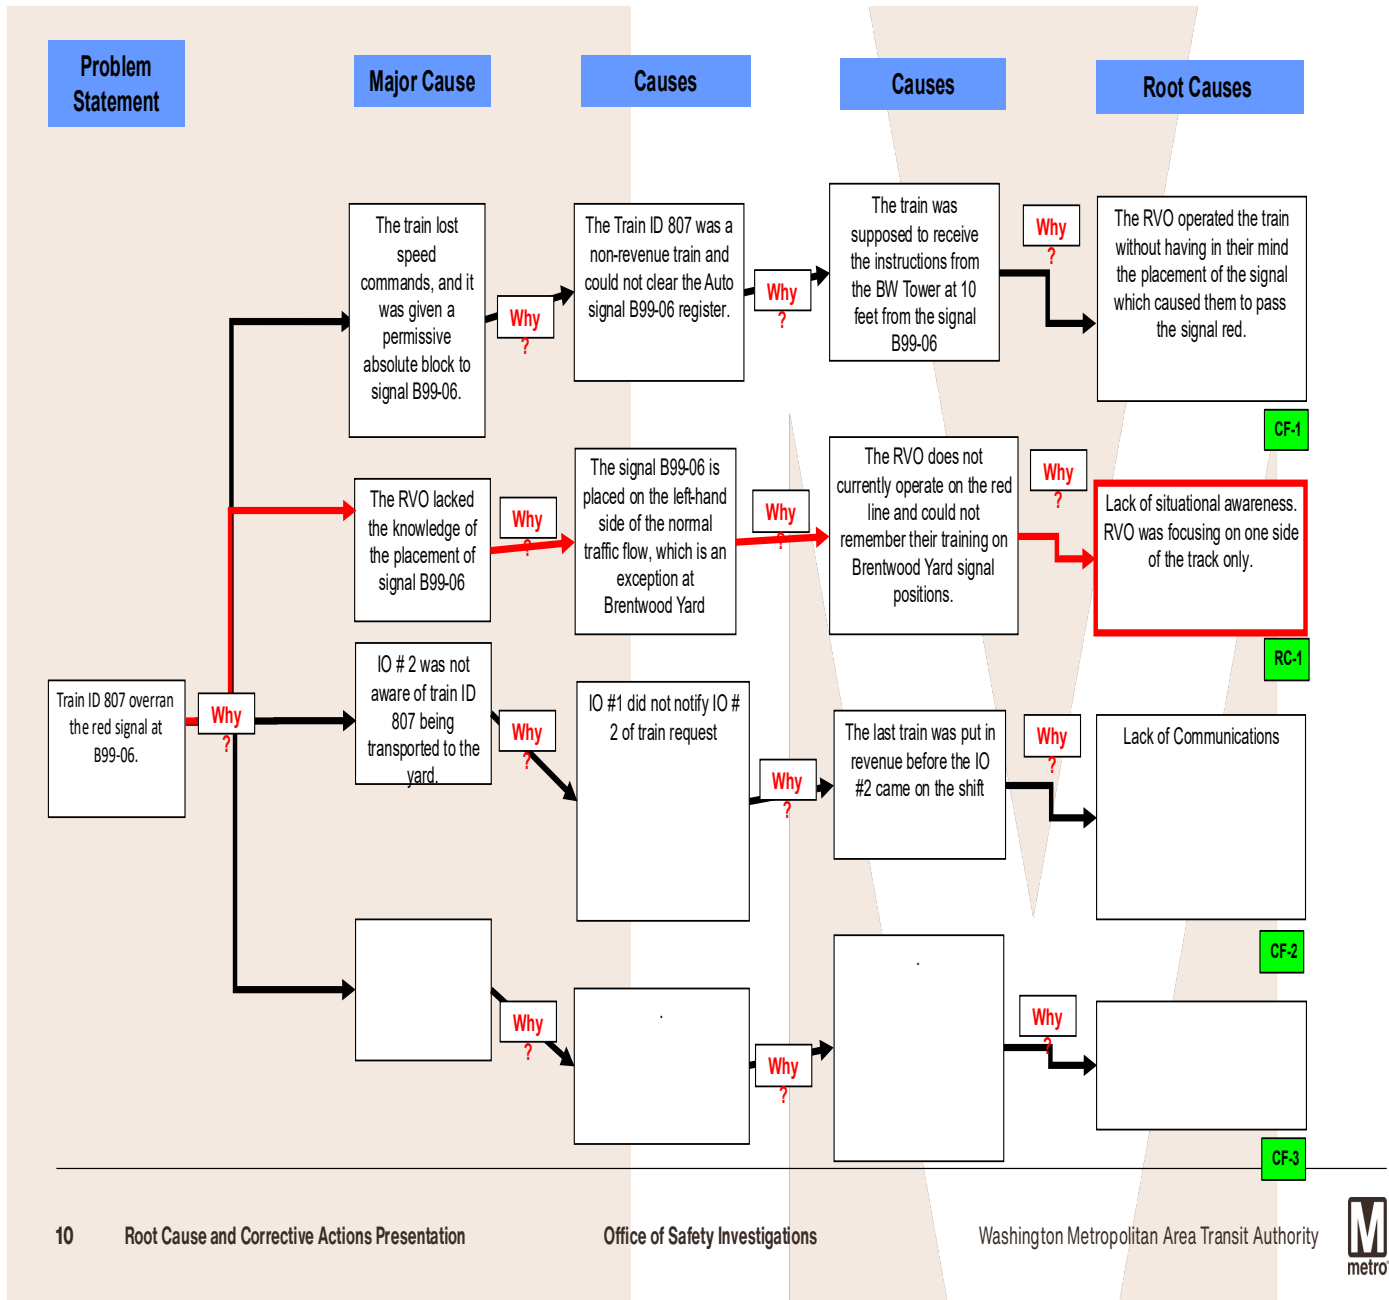
# Appendix H – Why Tree Analysis

The probable cause of the Red Signal Overrun event at Brentwood Yard on September 15, 2025, was the lack of situational awareness. The RVO was focusing on one side of track only.
