**W-0433 – Collision at Shady Grove Station – August 21, 2025****Document Purpose**

**FINAL REPORT OF INVESTIGATION A&I E251408**

## Shady Grove Station – Collision

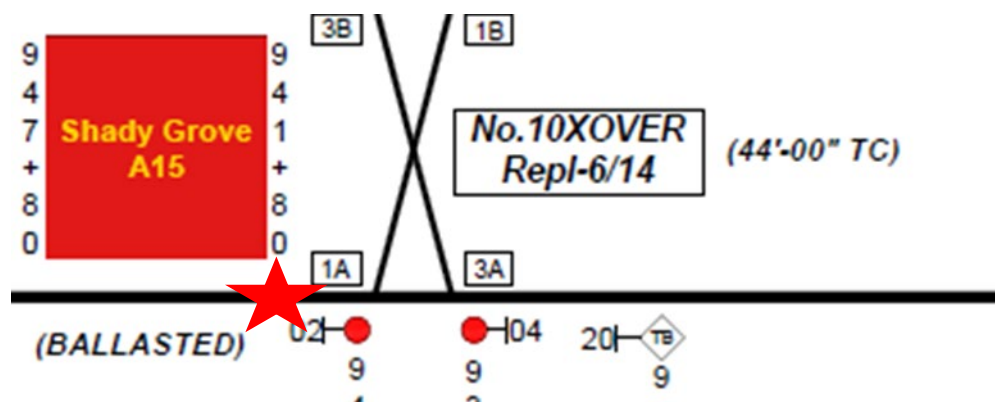
## Field Sketch/Schematics

The Closed-Circuit Television (CCTV) showed that at 01:42 hours, ST-04 collided with the platform edge of Shady Grove Station on track 1. The tamper head extension became wedged into the concrete area beneath the platform edge, causing damage.
