## **W-0434 – Collision at West Falls Church Yard - September 18, 2025**

**FINAL REPORT OF INVESTIGATION A&I E251634**

## West Falls Church Yard – Collision

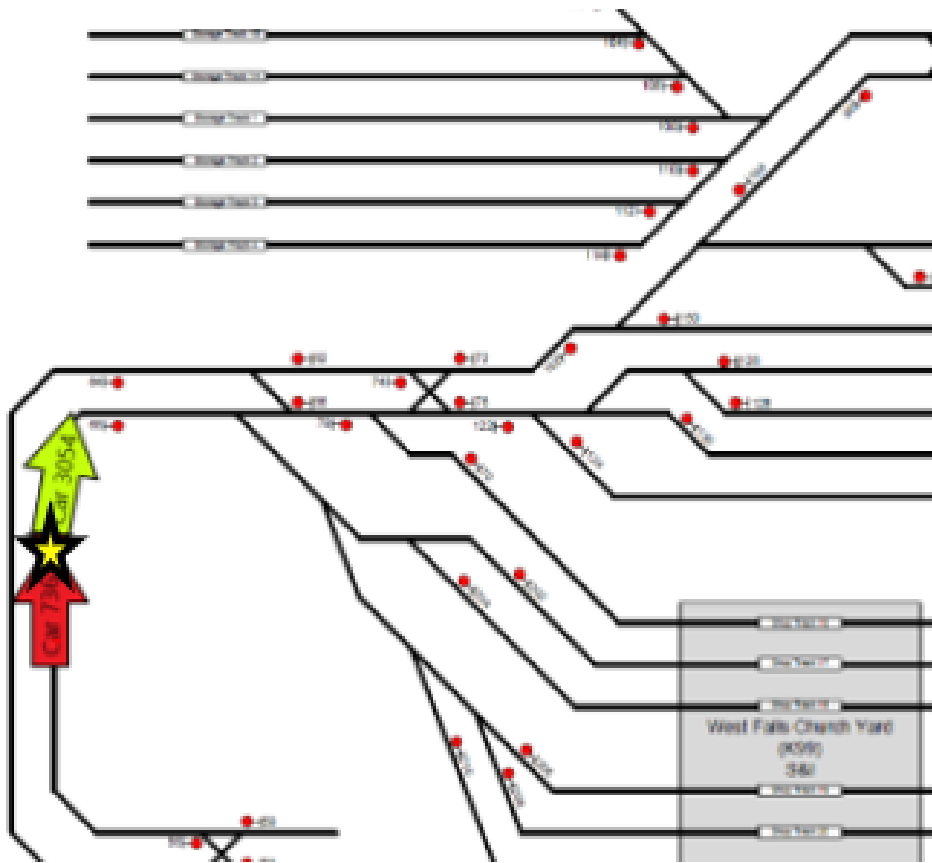
## Field Sketch/Schematics

A collision occurred on September 18, 2025, at approximately 11:19 p.m., when a train operator (Operator #1) operating a four car consist in West Falls Church Yard, attempted to get close to a two car consist that was holding at signal K99-68. The operator of the two car consist (Operator #2) was experiencing poor radio communication, so the West Falls Church Interlocking Operator instructed Operator #1 to move their train no closer than 2 feet to the two car consist to give Operator #2 their instructions. Operator #1 intended to stop their consist 2 feet from the other consist, open the bulkhead door, and step across to the stationary consist to verbally explain the next yard move to Operator #2. Operator #1 was operating with the Hostler controller<sup>1</sup> in the coast position at 5 miles per hour (mph), before coming to a complete stop 4 feet from the stationary consist, and then moved to a power mode again, traveling at approximately 1 mph. Operator #1 then set the Hostler controller to the highest braking mode (B4/B5) as it moved on a decline and collided with the stationary consist. Operator #1 reported the collision to the interlocking operator who then reported it to the control center and a supervisor.

The coupler pins of railcar 3054 on the 2-car stationary consist sustained damage. There were no injuries as a result of this event.

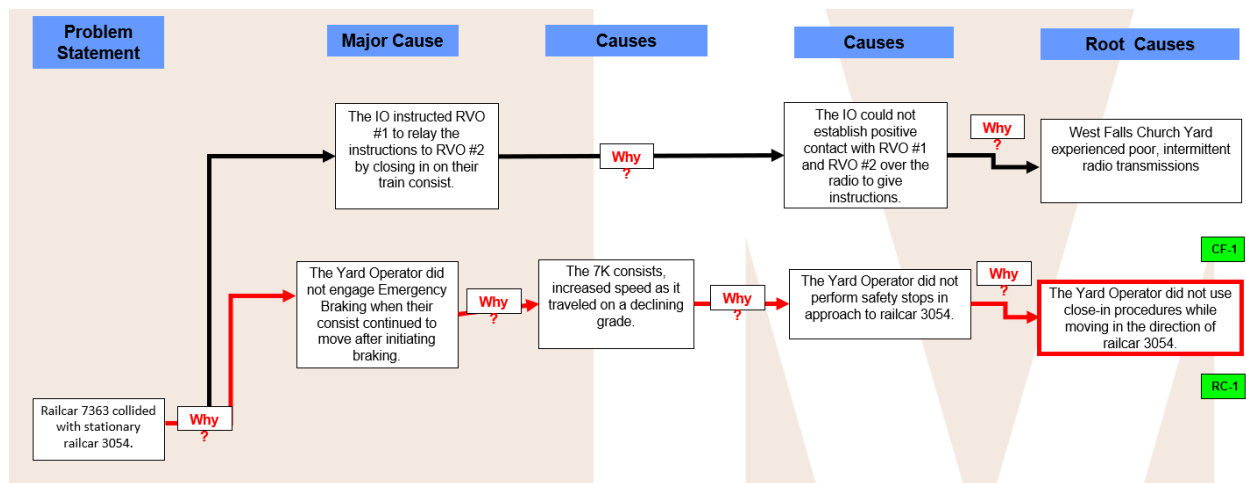
## Appendix E – Why-Tree Analysis

The probable cause of the Collision event at the West Falls Church Yard on September 18, 2025, was human error – procedural non-compliance. Specifically, the RVO #1 omission of required safety stops during a close-proximity yard movement.

In addition, RVO #1 did not initiate the emergency braking when they observed that the train was not coming to a stop in the “B4” braking mode. Contributing to the event was intermittent poor radio communication at West Falls Church Yard during the event.
