## **W-0438 – Improper Rail Vehicle Movement at Shady Grove Station – January 22, 2026**

**FINAL REPORT OF INVESTIGATION A&I E26341**

# Shady Grove – Improper Rail Vehicle Movement

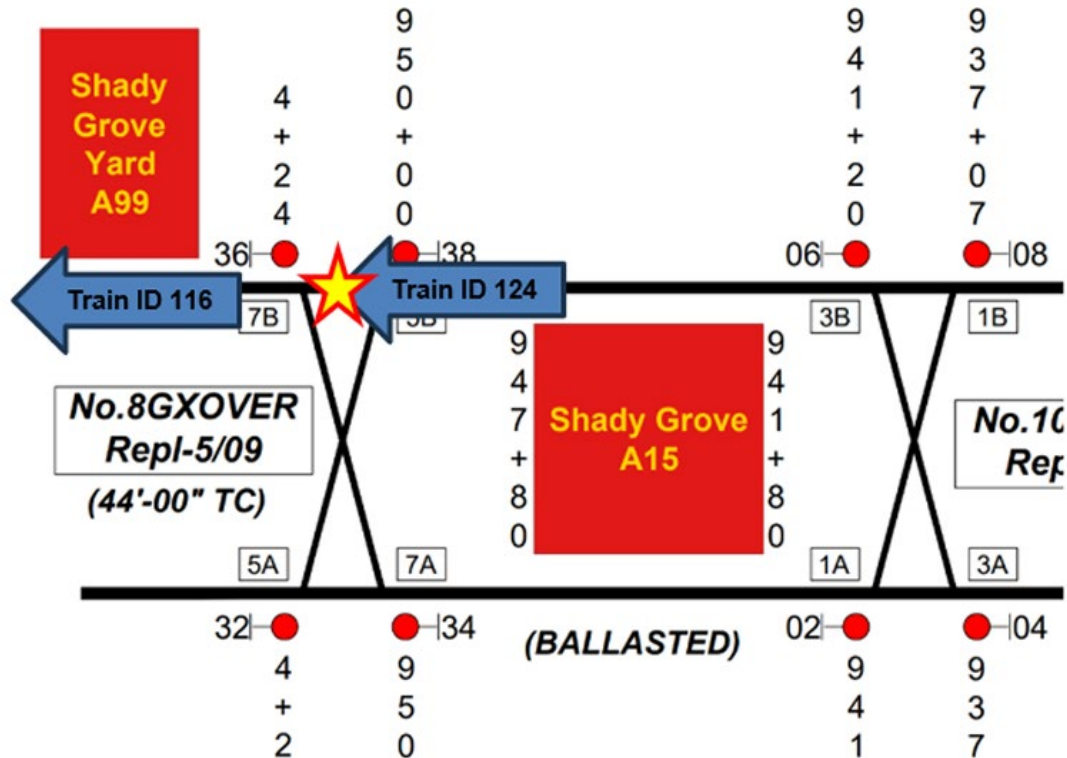
## Field Sketch/Schematics

Train ID 124 entered the interlocking and stopped after the Rail Vehicle Operator (RVO) observed Train ID 116 ahead, maintaining a separation distance of approximately 100 feet from the trailing car.

Shady Grove Station Tail Track, Track 2 (Signal A-15-38)
