**W-0454 – Red Signal Overrun at New Carrollton Rail Yard - December 8, 2025****Document Purpose**

**FINAL REPORT OF INVESTIGATION A&I E252481**

# New Carrollton Yard – Red Signal Overrun

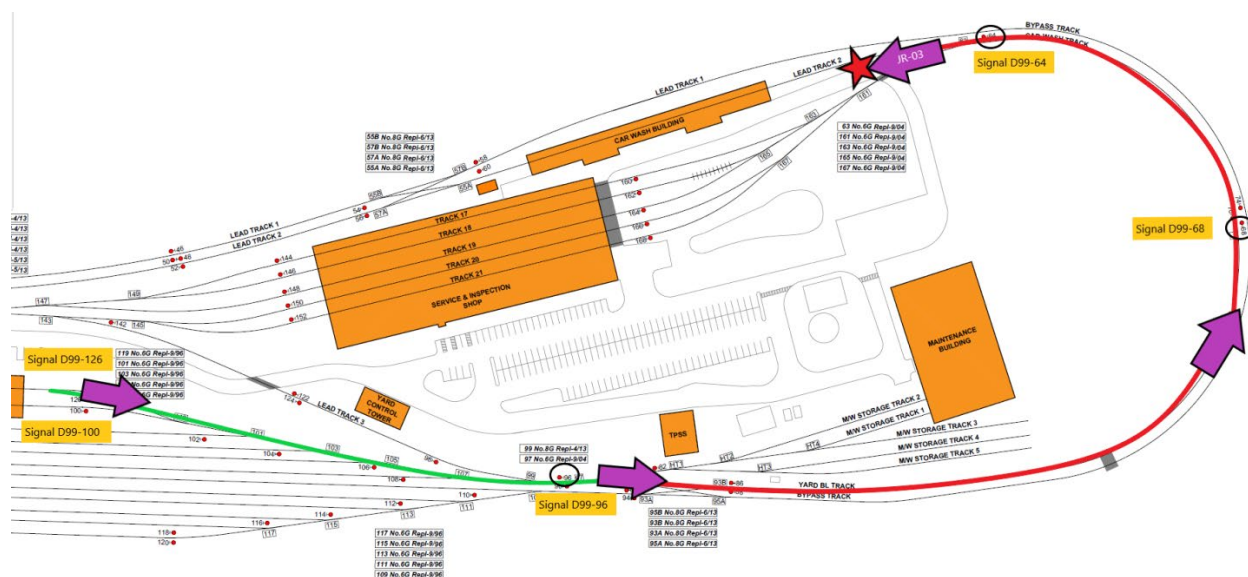
### Field Sketch/Schematics

On December 8, 2025, at 10:21 a.m., a red signal overrun occurred at New Carrollton Rail Yard. Car Track Equipment Maintenance Mechanic (CTEM) #2, operating Harsco Jet Rodder 03 (JR-03), which is used to clean drains, moved the Roadway Maintenance Machine (RMM) beyond its absolute block<sup>1</sup> and passed two red signals, D99-68 and D99-64.

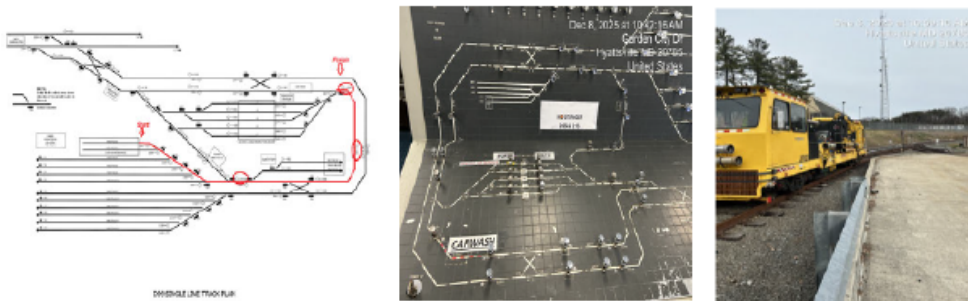
**INCIDENT PHOTOS:** ATTACH ANY SIGNIFICANT PHOTOS BASED ON THE INITIAL INCIDENT INVESTIGATION.

At approximately 10:24 am, Track Unit JR-03 overran signals D99-64 & D99-68 in New Carrollton Yard. Track personnel, CTEM #2 was operating JR-03, and Track personnel CTEM #1 was the flagman. Both Track personnel and the Interlocking Operator were removed from service. No damage to switch #63 was reported by ERT.
