## **W-0455 – Red Signal Overrun at Ballston-MU Station - January 17, 2026**

**FINAL REPORT OF INVESTIGATION A&I E26255**

# Ballston-MU Station – Red Signal Overrun

January 17, 2026

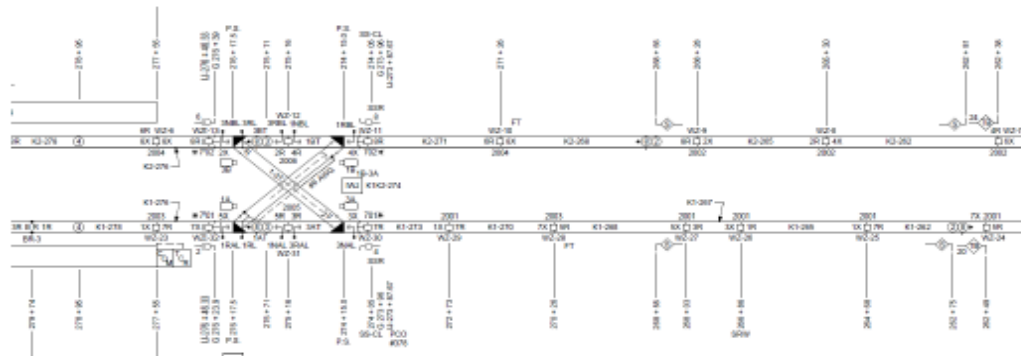
At 19:02:27, Train 940 proceeded further, trailing Switch 3B resulting in an out-of-correspondence condition and occupying Track Circuit K2-276, which is located beyond Signal 6. The train subsequently passed the insulated joint (IJ) associated with Signal 6.

In summary, Train 940 overran Signal 8 and continued beyond multiple fouling limits, including passing the insulated joint at Signal 6, resulting in an overrun violation of signal and switch compromise.
