# The Washington Metrorail Safety Commission

## Safety Audit

of the Washington Metropolitan  
Area Transit Authority

## Audit of Emergency Management and Fire and Life Safety Programs

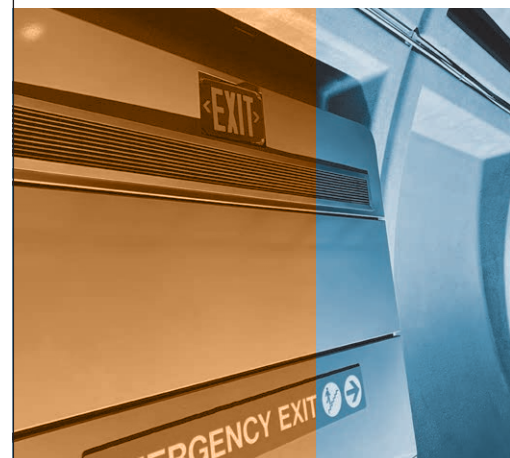
**Emergency equipment  
in station medical  
cabinets is expired and  
covered in dirt.**

Concerning its physical assets, emergency equipment in station medical cabinets is expired and covered in dirt. There is no inspection procedure or responsible party assigned to inspect and maintain this safety equipment. Metrorail does not conduct systematic underground inspections to ensure safe egress and fire and life safety response, and has set minimum tunnel emergency lighting levels that are not compliant with NFPA minimum standards. Metrorail does not consistently inspect and maintain current certification status of all fire extinguishers, particularly those on the roadway. Metrorail does not consistently perform or document all elements of its Fire & Intrusion Alarm System Inspection Preventive Maintenance Instructions.

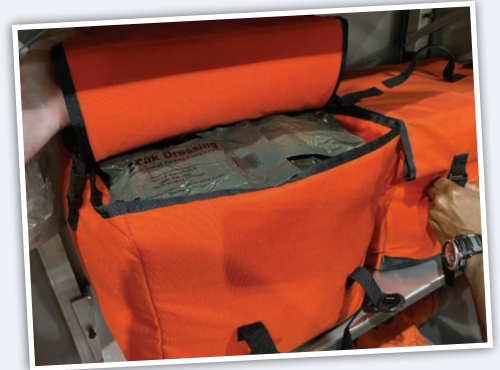
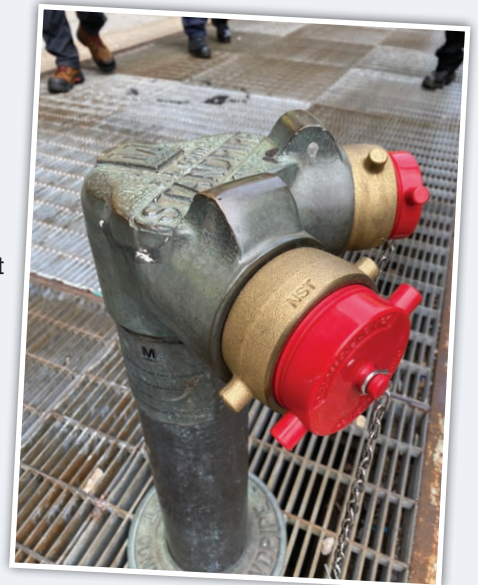
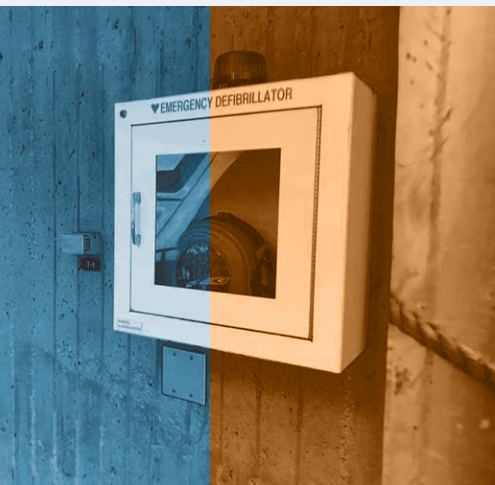
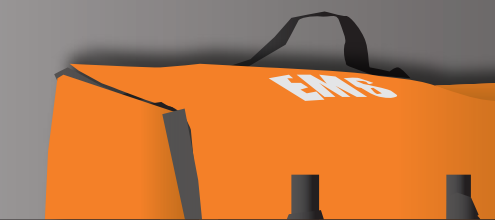
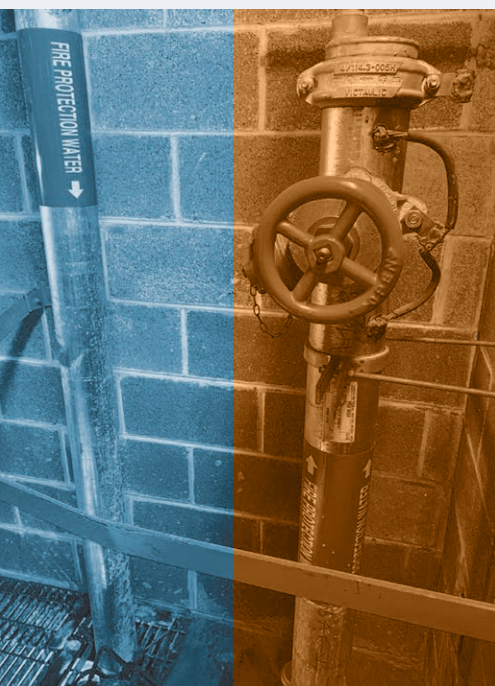
- Metrorail recently updated its Fire Watch Manual in April 2021. It clearly identifies responsible parties, necessary information and procedures.
- Metrorail has replaced metal caps with plastic caps on numerous standpipes in an effort to reduce theft of the metal caps so that the standpipes remain in service without disruption.

- Site visits identified working emergency exit bars next to fare gates.
- Site visits identified the proper use of spill pallets in ancillary rooms at stations.

- Site visits identified a good solid barrier around a fire protection pipe in exit stairs at Navy Yard-Ballpark Station's Half Street exit to properly direct people through an exit door.

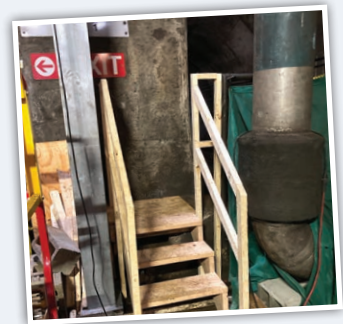
National Fire Protection Association (NFPA) 130 (Standard for Rail Fixed Guideway Transit and Passenger Rail Systems), introducing flammable material into the tunnel environment by placing wooden stairs to temporarily resolve the initial egress issue identified during site visits for this audit.

The WMSC identified this subsequent violation of NFPA 130, and directed Metrorail to remove the untreated wooden stairs, to expedite the construction of permanent concrete or steel stairs that had been removed from final designs despite being in initial drawings created prior to the project award to a contractor, and to ensure that trained Metrorail personnel are present in the area to assist with an evacuation if needed until an adequate egress path is restored. During follow-up discussions on this issue, Metrorail stated that they had sought steel stairs as an immediate temporary mitigation after the WMSC identified and communicated the obstructed egress issue, but they could not procure them within days, so the WMATA Fire Marshal suggested a possible alternative of fire-treated wood. When WMATA could not immediately procure fire-treated wood, project management and safety certification personnel said that they took it upon themselves to decide to install regular wood stairs with a plan to add fire resistant paint several weeks later. The Fire Marshal was not consulted. No other fire and life safety experts, nor the Authority Having Jurisdiction (AHJ) were consulted either, demonstrating continued siloing within the Metrorail organization.

For example, in relation to the Tunnel Ventilation Pilot Project, project staff and Metrorail's safety certification team stated that they installed a hazard – combustible wooden stairs in the tunnel despite the Fire Marshal's instructions that the stairs at minimum had to be made of fire treated wood. The project team and safety certification team stated that they installed the combustible materials, contrary to NFPA 130 requirements and the Fire Marshal's instructions, in part because the Fire Marshal was on vacation when they encountered difficulty acquiring the specified materials, and they did not find it necessary to contact anyone else for guidance.

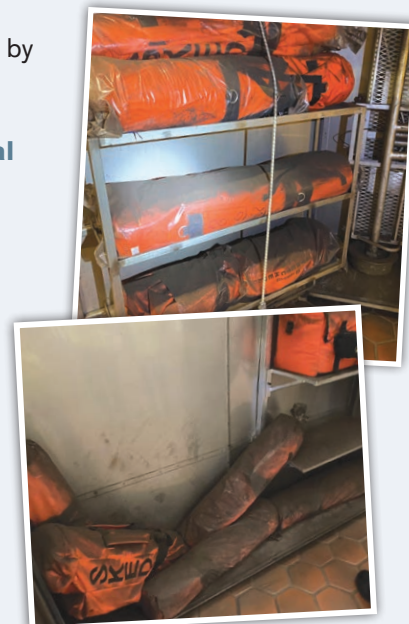
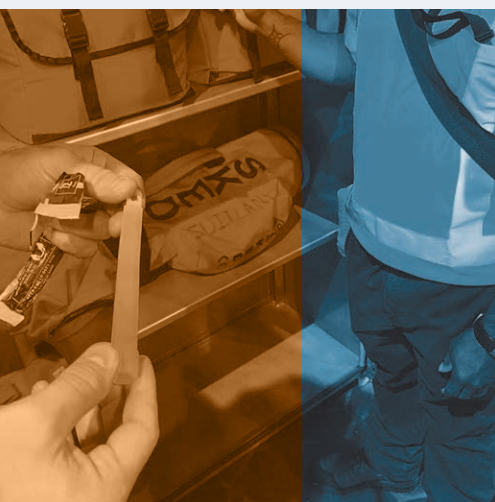
Site visits for this audit identified that the emergency equipment in Metrorail's station medical cabinets is covered in dirt and has expired at each of the stations examined. This includes bags with bandages, Sked emergency rescue stretchers, and glow sticks that are used to help guide customers out of a dark tunnel in an emergency.

**The glow sticks, for example, had expired in 2019.**

The bags for the equipment in medical cabinets are orange, and would be more visible in low-light conditions if they were not covered in dirt. Gaskets on the cabinets do not appear to create the necessary seal to keep out brake dust and other contaminants and keep supplies clean.

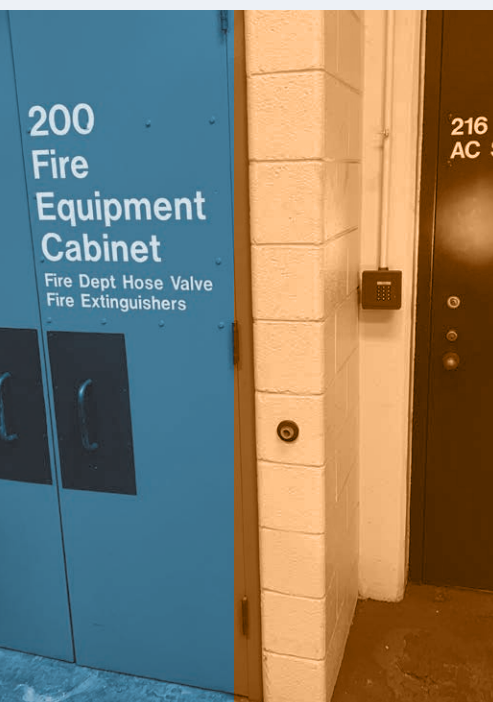
**In Room 200 at Anacostia Station, there is not an exit sign posted on any of the multiple doors that workers might take to depart the room, which could lead to workers fleeing into a high voltage area in an emergency rather than using the emergency exit path, which is unmarked.**

For example, in Room 200 at Anacostia Station, there is not an exit sign posted on any of the multiple doors that workers might take to depart the room, which could lead to workers fleeing into a high voltage area in an emergency rather than using the emergency exit path, which is unmarked. As with other safety deficiencies identified during this audit, the WMSC raised this immediately with the Metrorail personnel who accompanied the WMSC on that site visit including the Fire Marshal.

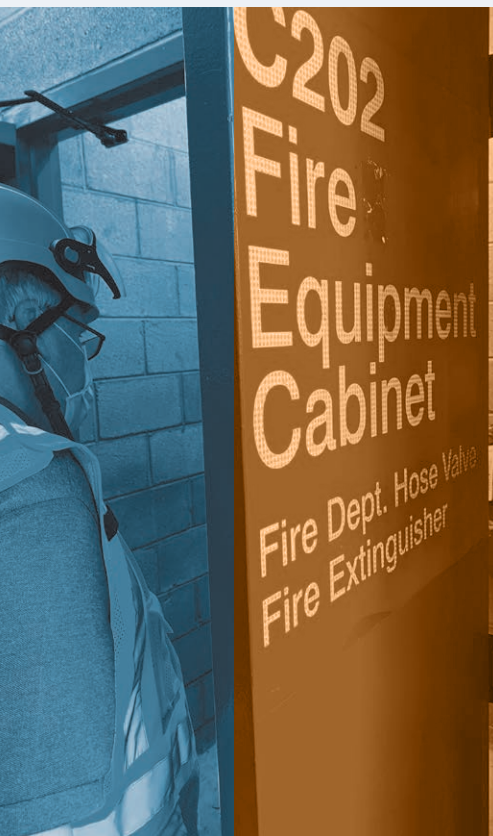
- An obstructed egress path at Forest Glen Station through the emergency exit around one of the roll-down fire doors
- Chair and other debris further blocking egress path in shafts where work was being conducted on tunnel ventilation project
- Obstructed signage
- Chains placed in an effort to extend the protective handrail at Fort Totten Station that obstructed an exit path

- Broken fire alarm pull box in the area of refuge (AOR) at Forest Glen Station and a station manager kiosk at Navy Yard-Ballpark Station
- Ladders obstructing the entry to the AOR at Forest Glen Station
