The Washington Metrorail Safety Commission

Safety Audit

of the Washington Metropolitan Area Transit Authority
Audit of Emergency Management and Life Safety Programs

Final Report:
January 29, 2025

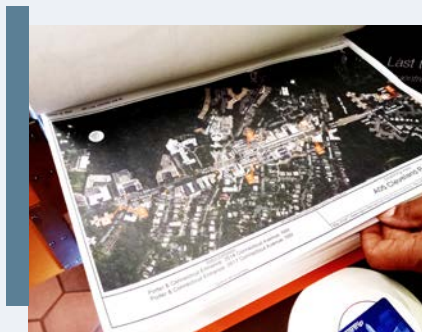
Master Location Repository / Signage Improvements

The finding that resulted in corrective action plan C-0178 noted that "Metrorail's fire and life safety signage is not consistent through the system." Metrorail created a master location repository to ensure accurate addresses for all stations and their respective entrances. Metrorail also coordinated with each jurisdiction to ensure that all jurisdictions had the same (and correct) addresses for Metrorail facilities and buildings. All stations now feature signs within each kiosk that provide the street address so that personnel, along with first responders, can quickly reference the correct address.

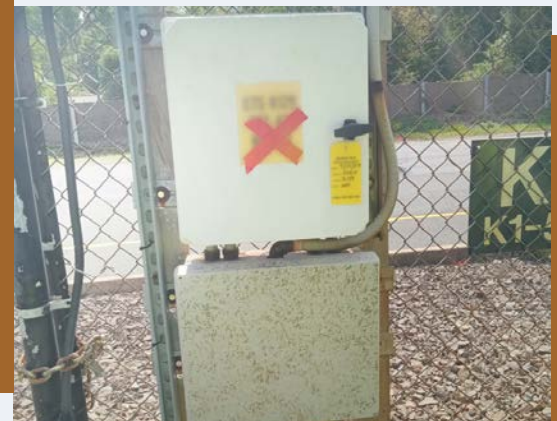
Metrorail's asset list shows 2000 Emergency Trip Stations (ETS) throughout the Metrorail system. There are ETS located every 800 feet along the roadway. ETS have two life safety critical features, which can be used independent of each other: A phone that provides a direct connection to the control

center and a red push button capable of de-energizing third rail power in a pre-defined segment of the roadway. Responsibilities for inspection, preventive maintenance, and corrective maintenance are assigned to multiple departments including Safety and Readiness, the Office of Power, Digital Modernization, and Facilities Maintenance. As of September 9, 2024, there were open work orders for 55 ETS boxes, which had varying functionality issues.

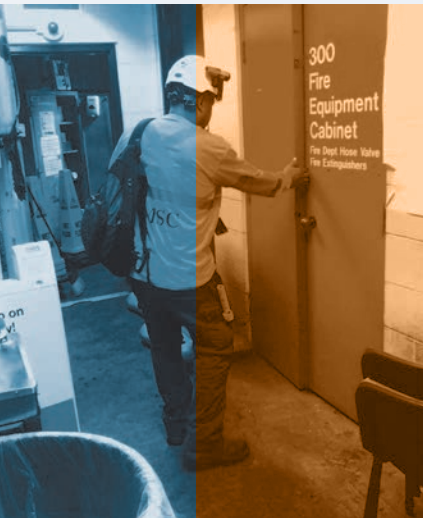
During an interview, a power desk controller stationed at the control center, who is responsible for power energization, was unaware of what a "Red X" taped over a box meant and stated that if any boxes were out of service, personnel would need to stand by until those boxes were fixed. This was similar to discussions with the Office of Emergency Management personnel who indicated that if a fire and life safety asset was out of commission, personnel were required to stand by until the condition was remedied or mitigated.

TRPM-SOP-14-03, Inoperable Emergency Trip Station Procedure (Rev. 3, 12/7/2022), section 6.2 states "the inoperable ETS is repaired as soon as possible, schedule and ensure standby coverage in rooms and platforms as described in this policy until remediation and ensure that the Assistant Superintendent/Superintendent is notified of the ETS issue." Section 6.1.2 states "TRPM personnel shall affix a Red "X" and Red Tag on each ETS box where the ETS is found to be inoperable."

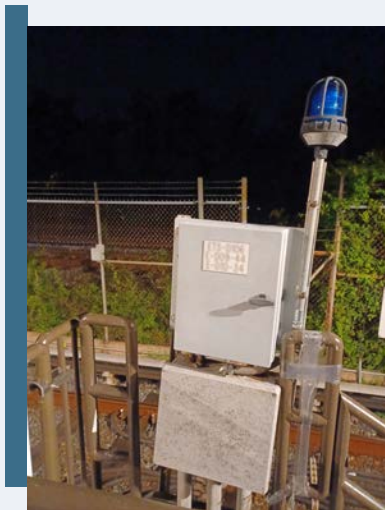
Metrorail has two different preventive maintenance inspections for ETS box enclosure inspection and trip verification testing: PWR 1241.1 is for all ETS boxes excluding the Silver Line and PWR 1241.2 applies only to the Silver Line’s ETS boxes. The Silver Line’s emergency trip stations differ from ETS on the rest of the Metrorail system in that they have a remote monitoring system with specific instructions stated in PWR 1241.2 that do not exist in PWR 1241.1. This ETS Remote Monitoring (ETSRM) system is provided in a separate box adjacent to the ETS box.

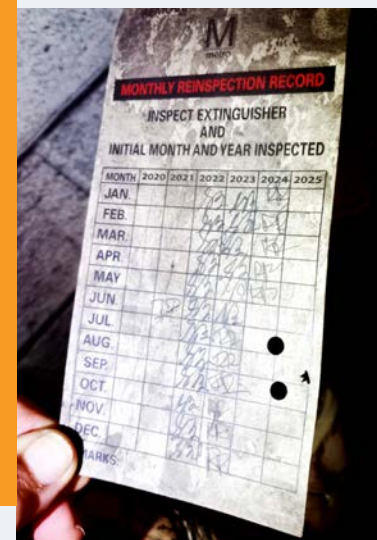
Maintaining fire and life safety equipment and assets in a state of good repair is essential to the safety of riders, employees, and first responders as such equipment and assets are expected to be available in good repair whenever a safety event or emergency occurs. Metrorail is not consistently inspecting and maintaining these assets as required. For example, during onsite observations for this audit, some emergency egress routes were blocked by debris and areas of refuge were being used as storage. Blocked egress routes decrease the probability of survival during an emergency.

- Fire Extinguishers:
 - Not inspected or signed off.
 - Not properly stored.
 - Not properly replaced after use.
- Station Fire Life Safety Equipment:
 - Backflow prevention equipment not inspected.
 - Backflow prevention equipment inspected but listed as failing.
 - Storage of equipment blocking fire cabinets.
- Egress, Areas of Refuge, and Areas of Rescue:
 - Egress routes blocked by debris and equipment.
 - Areas of Refuge or Rescue being used for storage.
 - Egress pathways containing debris.
 - Blocked signage.
