# **Safety Audit**

of the Washington Metropolitan Area Transit Authority

Audit of Roadway Maintenance Machine Inspection, Maintenance and Training

Final Report: March 9, 20<mark>21</mark>

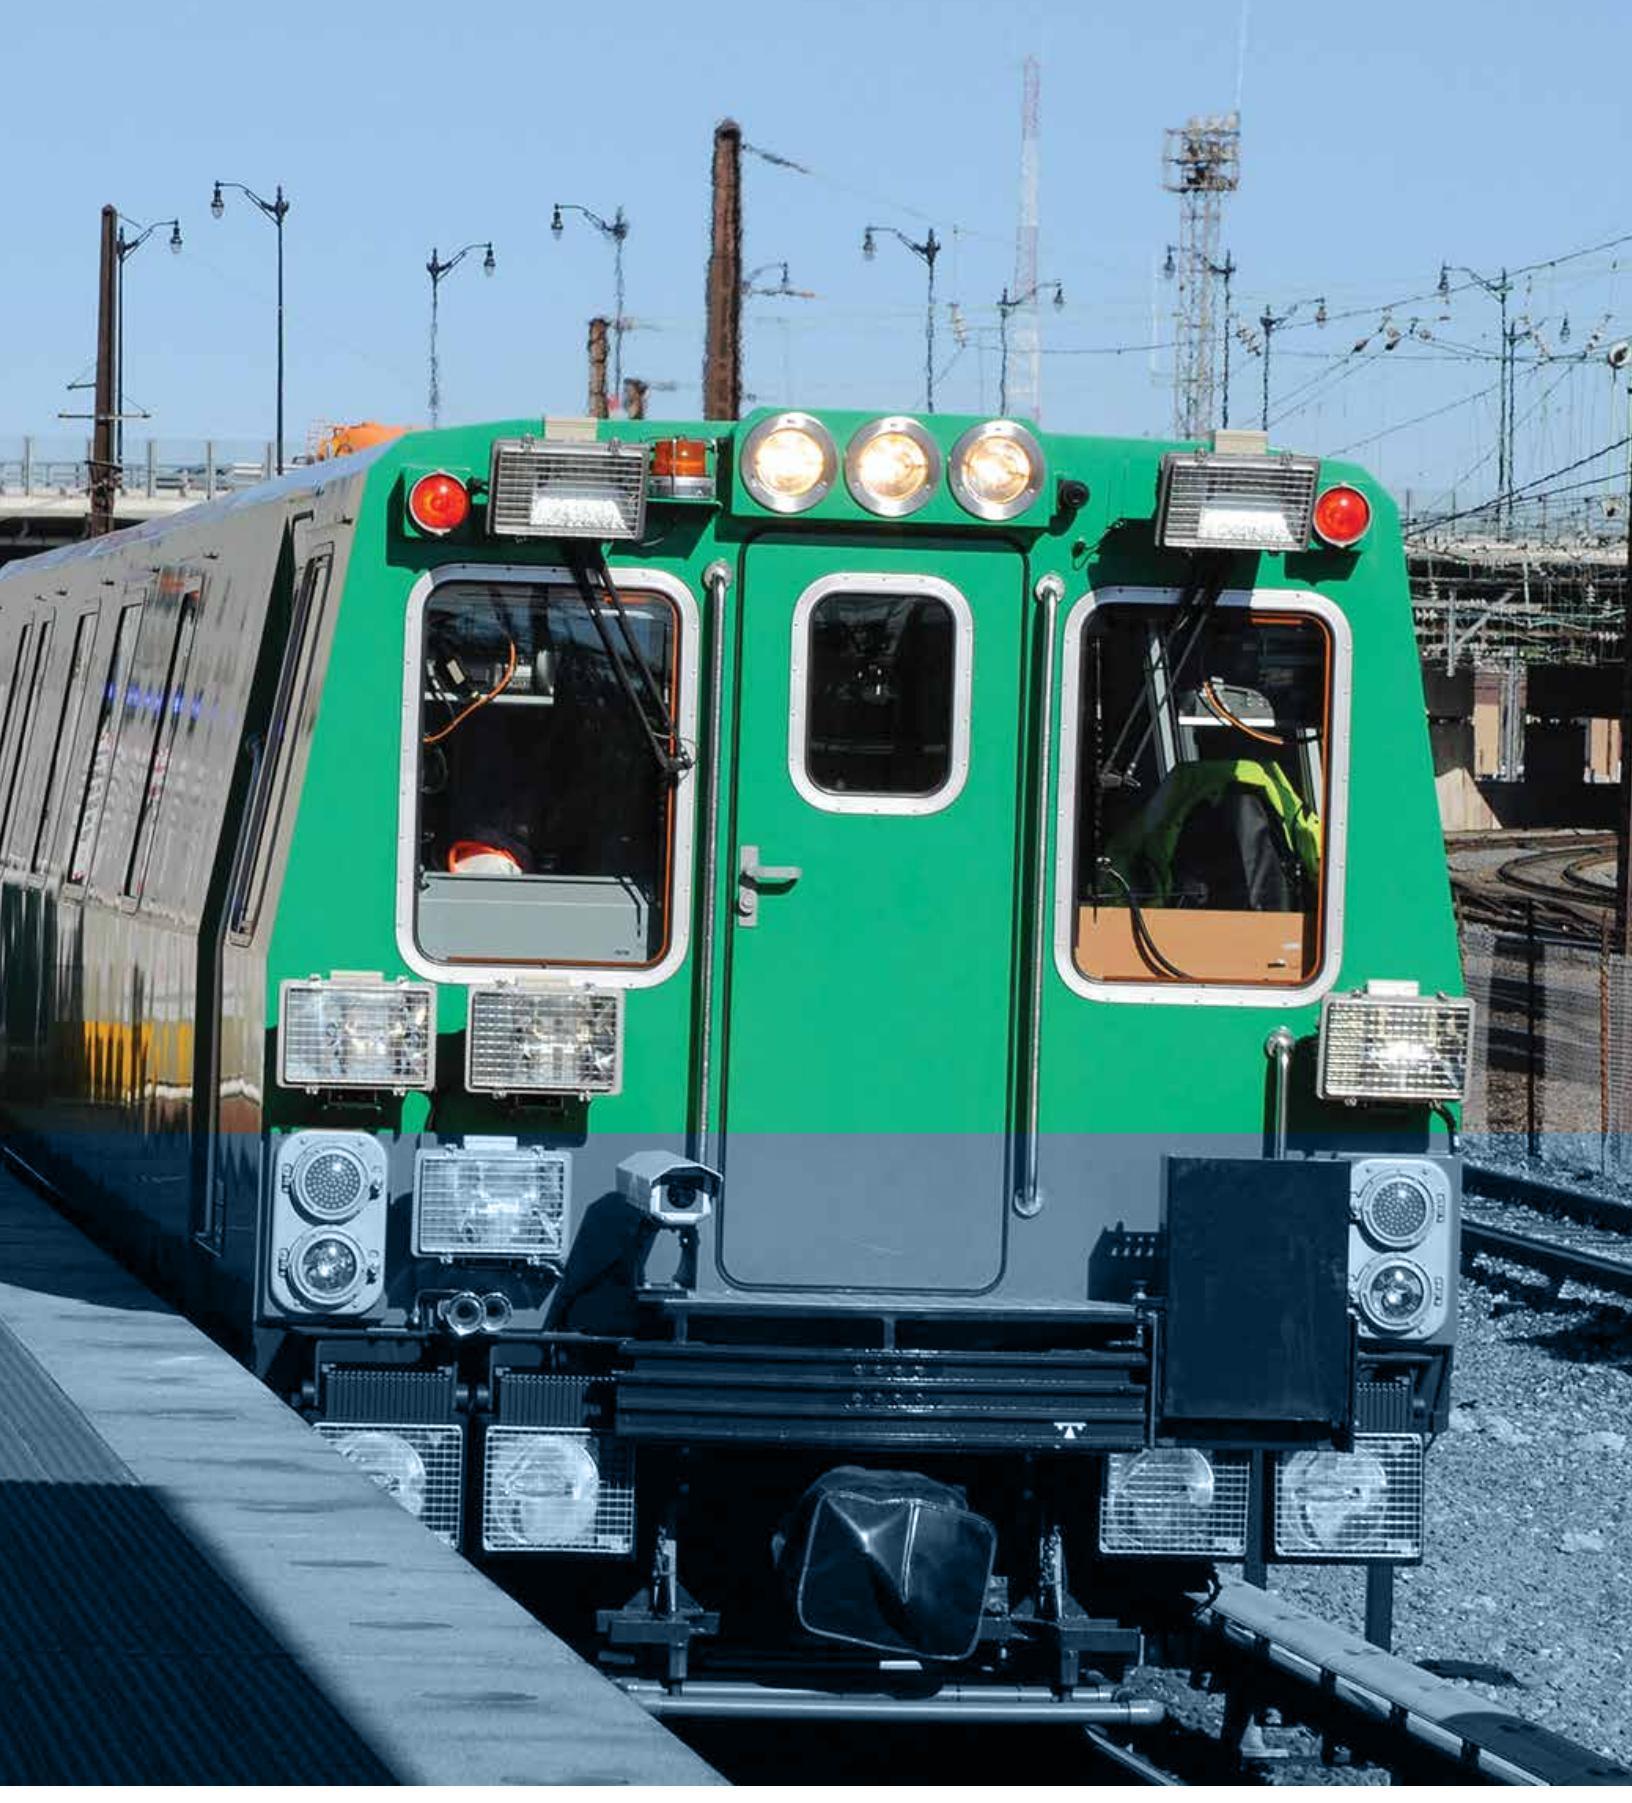
Track Geometry Vehicle (TGV)

The last RMM for which the safety certification process was properly completed was the Track Geometry Vehicle. The vehicle was purchased in 2012.
