## Inspection Form

Washington Metrorail Safety Commission

<b>Inspection Date</b>	YYYY	MM	DD	<b>Report Number</b>	20200715-WMATA-LBW-1		
	2020	07	15				
<b>Rail Agency Name</b>	Washington Metropolitan Area Transit Authority			<b>Rail Agency Department</b>	Operations	<b>Sub-Department</b>	Stations
<b>Rail Agency Department Contact Information</b>	<b>Name</b>		<b>Email</b>		<b>Office Phone</b>		<b>Mobile Phone</b>
	[REDACTED]		[REDACTED]		[REDACTED]		[REDACTED]
	[REDACTED]		[REDACTED]		[REDACTED]		[REDACTED]
	[REDACTED]		[REDACTED]		[REDACTED]		[REDACTED]
<b>Inspection Location</b>	Judiciary Square (B02)

<b>Inspection Activity #</b>	1	<b>Inspection Subject</b>	Station Assessment – Judiciary Square (B02)				<b>Activity Code</b>	RTRA	GEN	RR	
<b>Job Briefing Employee Name/Title</b>	NA		<b>Accompanied Inspector?</b>	NA	<b>Out Brief Conducted</b>	NA	<b>Time</b>	NA	<b>Outside Shift</b>	NA	
<b>Related Reports</b>	N/A		<b>Related CAPS / Findings</b>		NA						
<b>Related Rules, SOPs, Standards, or Other</b>	Ref		Rule or SOP		Standard		Other / Title		Checklist Reference		
<b>Inspection Location</b>	Main Track	Yard	Station	OCC	RTA Facility	WMSC Office	<b>Track Type</b>	At-grade	Tunnel	Elevate

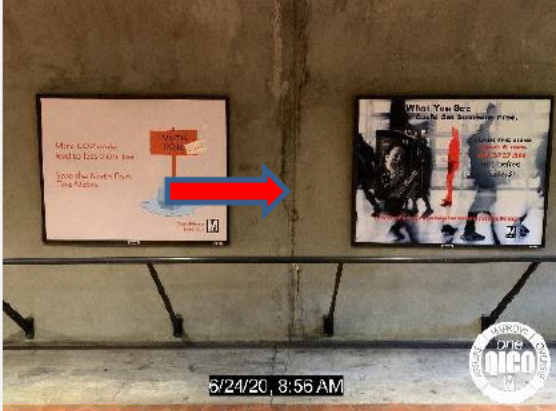
<p>Due to COVID-19 and social distancing, this inspection was completed without entering Judiciary Square (B02) and without interacting with any Metrorail personnel.</p> <p>Discrepancies Identified for further review and follow up:</p> <ol style="list-style-type: none"> <li>Concrete wall cracked/leaking (east entrance tunnel Mezzanine level) Risk – Moderate (3,3) – TRST</li> </ol>

<p>The Inspector recommends reinspection of Judiciary Square (B02) to reassess the discrepancies identified in this report and open work orders.</p>	<p><b>Remedial Action Required?</b></p> <p><b>Recommended Reinspection?</b></p>	<p>No</p> <p>Yes</p>
<p><b>Remedial Action</b></p>	<p>N/A</p>

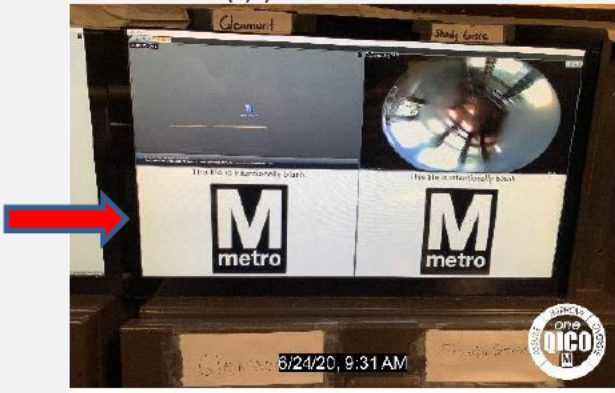
<ol style="list-style-type: none"> <li>Elevator (B02N02) camera not displaying in Kiosk (Mezz #22) Risk – Moderate (3,3) – COMM</li> </ol>
