Inspection Form

Washington Metrorail Safety Commission

Inspection Activity #	1	Inspection Subject	Station Assessment – Arlington Cemetery (C06)				Activity Code	RTRA	GEN	RR	
Job Briefing Employee Name/Title	NA		Accompanied Inspector?	NA	Out Brief Conducted	NA	Time	NA	Outside Shift	NA	
Related Reports	N/A		Related CAPS / Findings		NA						
Related Rules, SOPs, Standards, or Other	Ref		Rule or SOP		Standard		Other / Title		Checklist Reference		
Inspection Location	Main Track	Yard	Station	OCC	RTA Facility	WMSC Office	Track Type	At-grade	Tunnel	Elevated	N/A
			X			X		X			
Line(s)	Charlie		Track Number		Chain Marker and/or Station(s)		From		To		
Vehicles	Head Car Number		Number of Cars		Equipment						
Description	The WMSC Inspector conducted an inspection of the Service Restoration Station Condition Rollup Report. In preparation for the return to service of Arlington Cemetery (C06), QICO and SAFE assessed station readiness. Additionally, Maximo maintenance records were queried by QICO to							Number of Defects		8

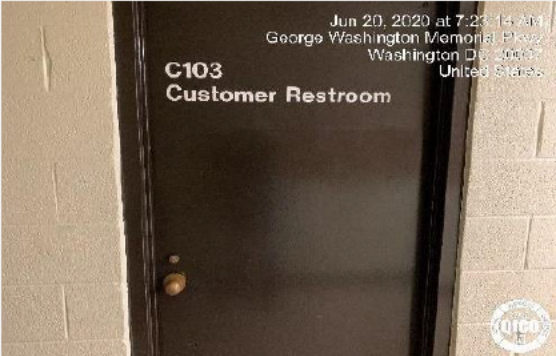
<p>identify documented and outstanding items. A risk rating was assigned for all discrepancies identified during field assessments.</p> <p>Due to COVID-19 and social distancing, this inspection was completed without entering Arlington Cemetery (C06) and without interacting with any Metrorail personnel.</p> <p>Discrepancies Identified for further review and follow up:</p> <ol style="list-style-type: none"> Customer restroom re-keyed and inaccessible by station manager (Room C103) Risk – Elevated (4,3) – PLNT

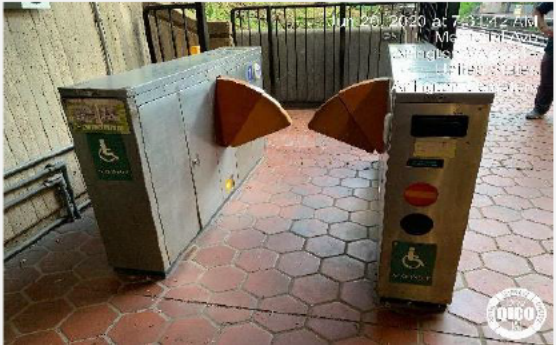
<ol style="list-style-type: none"> ADA faregate not functional (Platform, track 2 – right off-street elevator north entrance) Risk – Elevated (4,3) – AFC

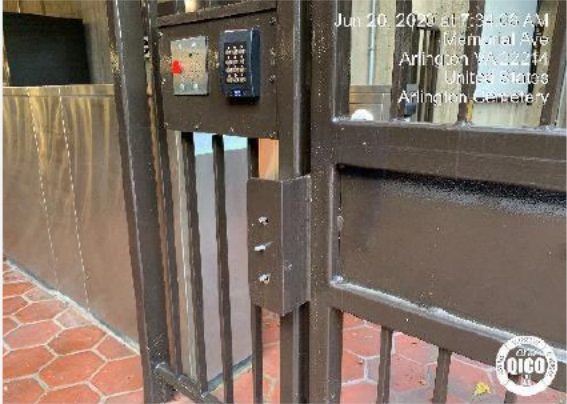
<ol style="list-style-type: none"> Gate not secured and nuts missing (Platform – right off-street elevator north entrance) Risk – Elevated (4,3) – PLNT

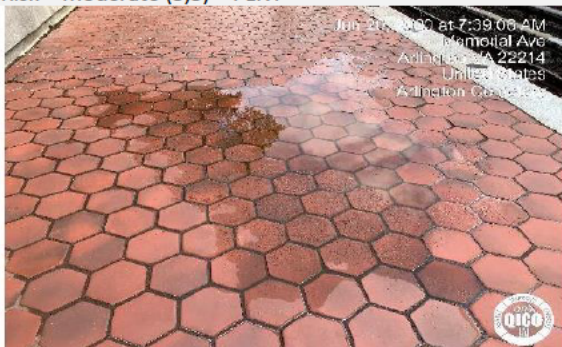
4. Ponding water on platform (Various locations)

Risk – Moderate (3,3) – PLNT

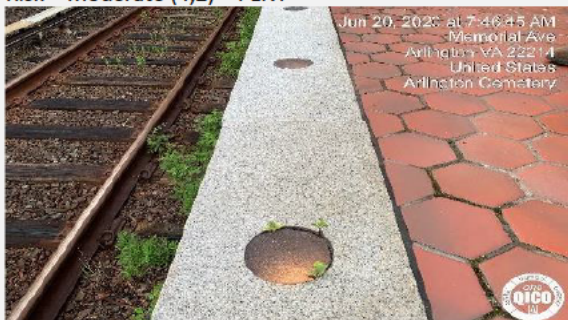
5. Granite edge offset, leaning towards track (multiple locations)

Risk – Moderate (4,2) – PLNT

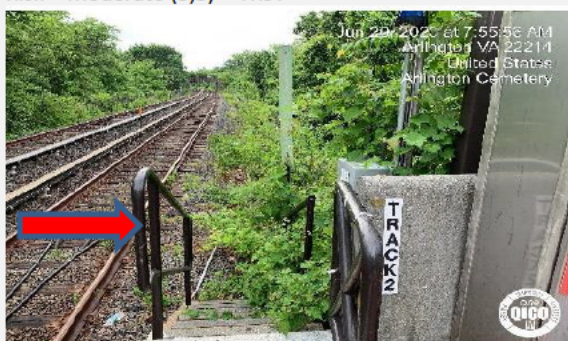
6. Overgrown vegetation at the end of the platform (Track 2, north end – ETS Box C2194129)

Risk – Moderate (3,3) – TRST

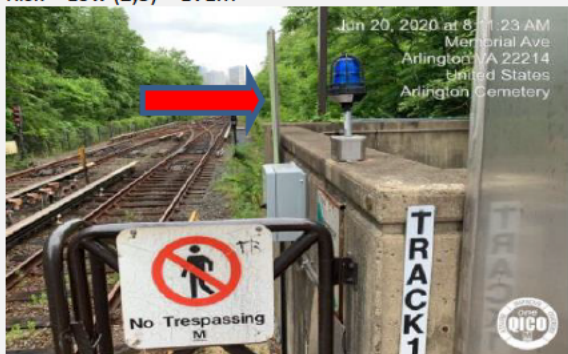
7. Four ETS lights out (Track 1 and Track2)

Risk – Low (2,3) – LVEM

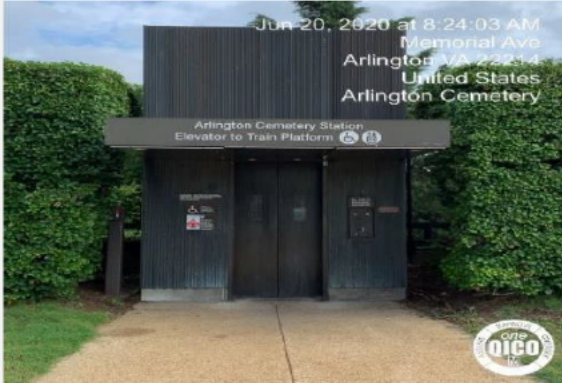
<p>8. Both elevators are inoperative (C06X01 and C06X02) Risk – Elevated (4,4) – ELES</p> <div style="text-align: center;">

</div> <p>The Inspector recommends reinspection of Arlington Cemetery (C06) to reassess the discrepancies identified in this report and open work orders.</p>		
Remedial Action	N/A
