## Inspection Form

Washington Metrorail Safety Commission

| <b>Inspection Location</b> | Eisenhower Avenue (C14) | | | | | | |

| <b>Inspection Activity #</b> | 1 | <b>Inspection Subject</b> | Station Assessment – Eisenhower Avenue(C14) | | | | <b>Activity Code</b> | RTRA | GEN | RR | |

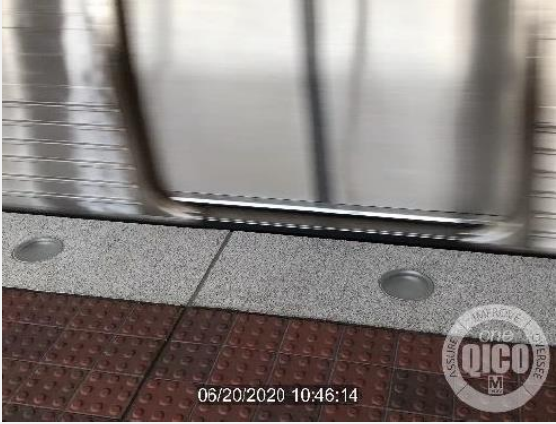
| | <p>Due to COVID-19 and social distancing, this inspection was completed without entering Eisenhower Avenue (C14) and without interacting with any Metrorail personnel.</p> <p>Discrepancies Identified for further review and follow up:</p> <ol style="list-style-type: none"> <li>Train Approach Warning (TAW) lights did not flash as train transited the station<br/>Risk – Moderate (3,3) – LVEM</li> </ol> | <b>Remedial Action Required?</b> | No |

| | <p>06/20/2020 10:53:41</p> <p>The Inspector recommends reinspection of Eisenhower Avenue (C14) to reassess the discrepancies identified in this report and open work orders.</p> | | |

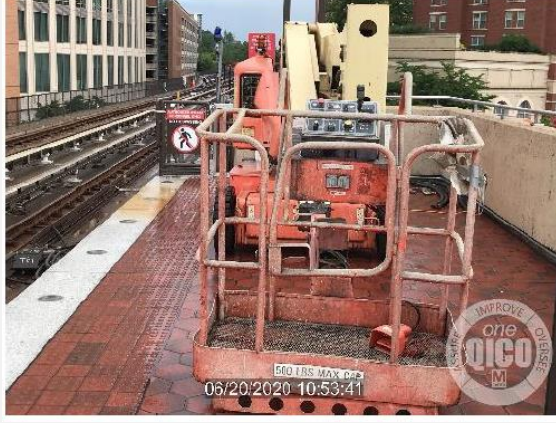
| | <p>06/20/2020 10:46:14</p> <ol style="list-style-type: none"> <li>Miscellaneous equipment on platform (Track 1 north end)<br/>Risk – Moderate (3,3) – PLNT</li> </ol> | <b>Recommended Reinspection?</b> | Yes |
