Inspection Form

Washington Metrorail Safety Commission

Inspection Date	YYYY	MM	DD	Report Number	20200813-WMATA-LBW-1		
	2020	08	13				
Rail Agency Name	Washington Metropolitan Area Transit Authority			Rail Agency Department	Operations	Sub-Department	Stations
Rail Agency Department Contact Information	Name		Email		Office Phone		Mobile Phone
	[REDACTED]		[REDACTED]		[REDACTED]		[REDACTED]
	[REDACTED]		[REDACTED]		[REDACTED]		[REDACTED]
	[REDACTED]		[REDACTED]		[REDACTED]		[REDACTED]
Inspection Location	Federal Center SW (D04)

Inspection Activity #	1	Inspection Subject	Station Assessment – Federal Center SW (D04)				Activity Code		RTRA	GEN	RR
Job Briefing Employee Name/Title	NA		Accompanied Inspector?	NA	Out Brief Conducted	NA	Time	NA	Outside Shift	NA	
Related Reports	N/A		Related CAPS / Findings		NA						
Related Rules, SOPs, Standards, or Other	Ref		Rule or SOP		Standard		Other / Title		Checklist Reference		
Inspection Location	Main Track	Yard	Station	OCC	RTA Facility	WMSC Office	Track Type	At-grade	Tunnel	Elevated	N/A
			X			X			X		
Line(s)	Delta		Track Number		Chain Marker and/or Station(s)		From		To		
Vehicles	Head Car Number		Number of Cars		Equipment						
Description	The WM

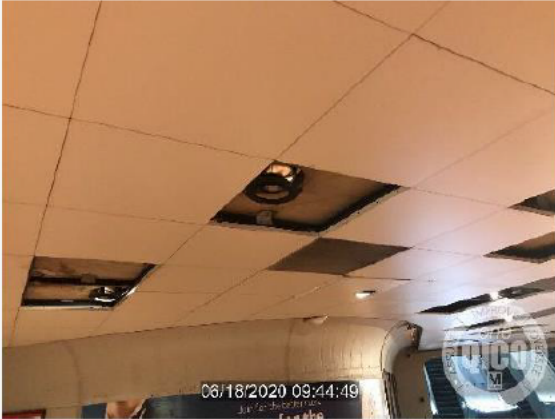
<p>Due to COVID-19 and social distancing, this inspection was completed without entering Federal Center SW (D04) and without interacting with any Metrorail personnel.</p> <p>Discrepancies Identified for further review and follow up:</p> <ol style="list-style-type: none"> Multiple ceiling lights are out – Mezzanine adjacent to escalator Risk – Elevated (3,3) – LVEM 	<p>Remedial Action Required?</p>	<p>No</p>

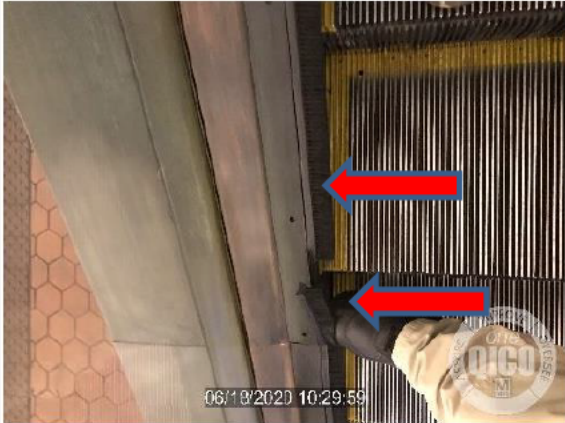
<ol style="list-style-type: none"> Escalator skirt bushes damaged, loose, and missing screws (Escalator D04X05) Risk – Moderate (3,3) – ELES
