# WMSC Inspection Report 20241209

Inspection of CTEM for Compliance with C-0096

New Carrollton CTEM Shop - Railyard (D99)

12/09/2024

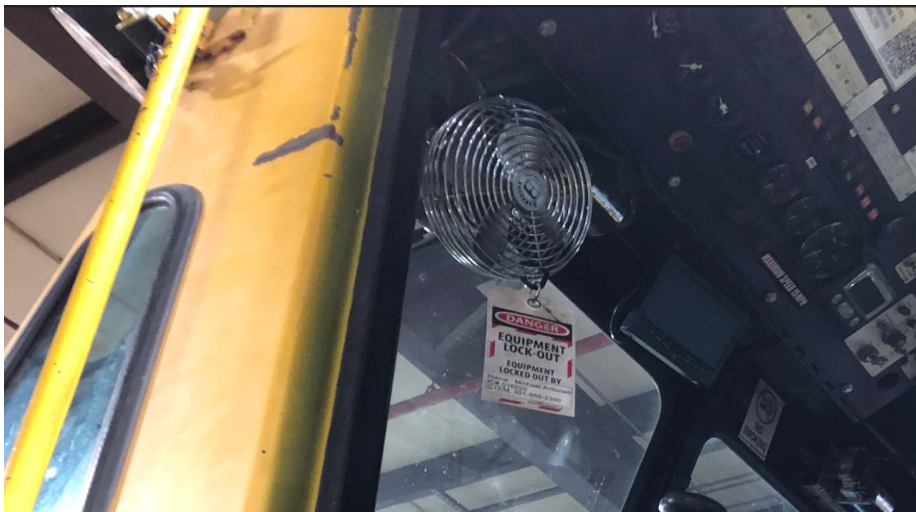
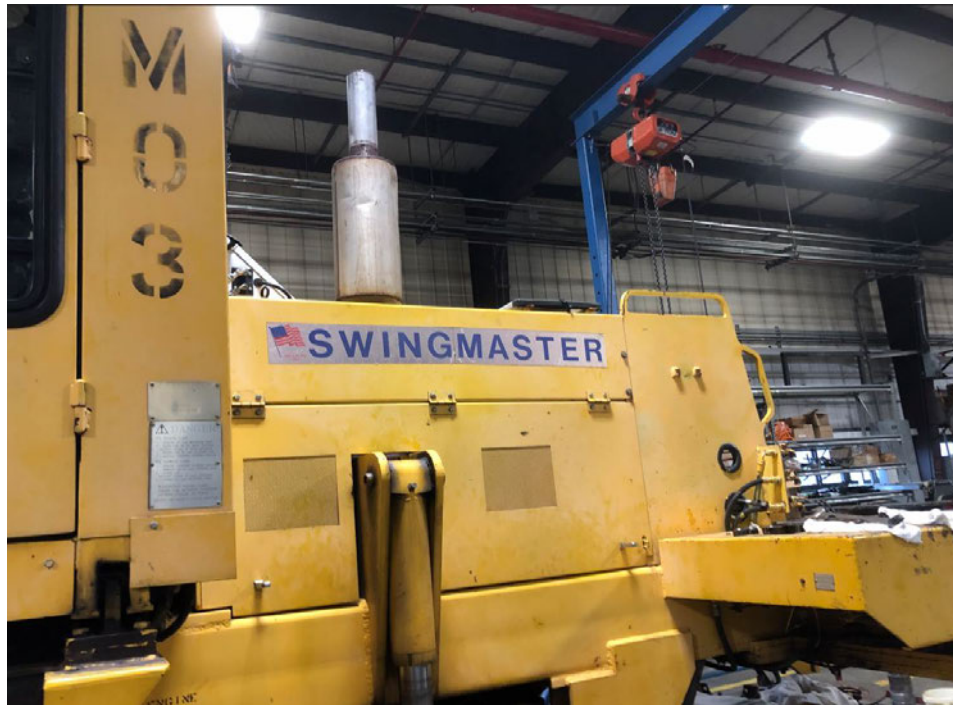
## Observation 1

Swing Master SM-03 compliantly displayed a clear lock-out tag. The axle was being repaired.

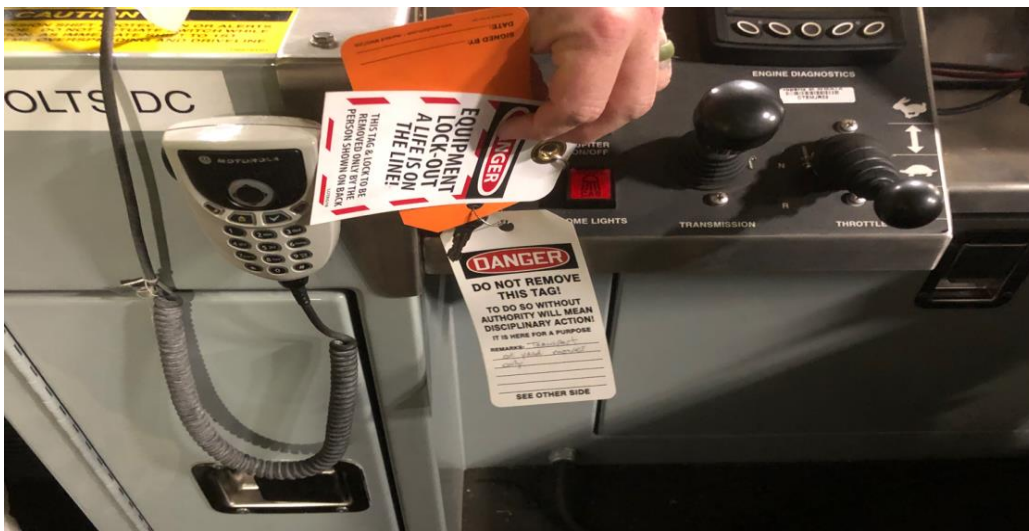
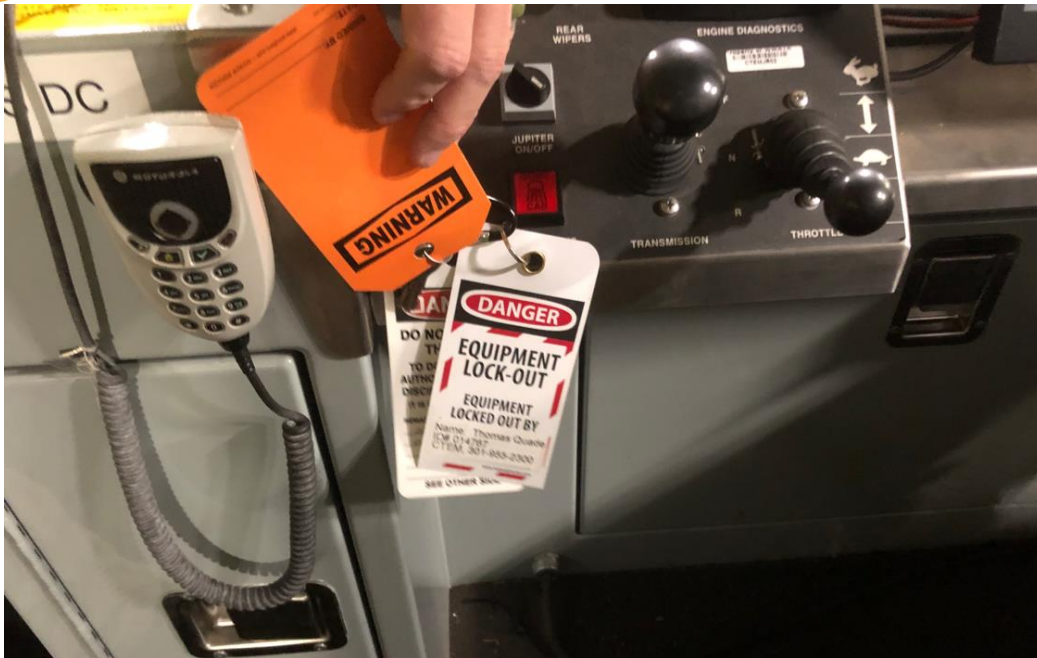
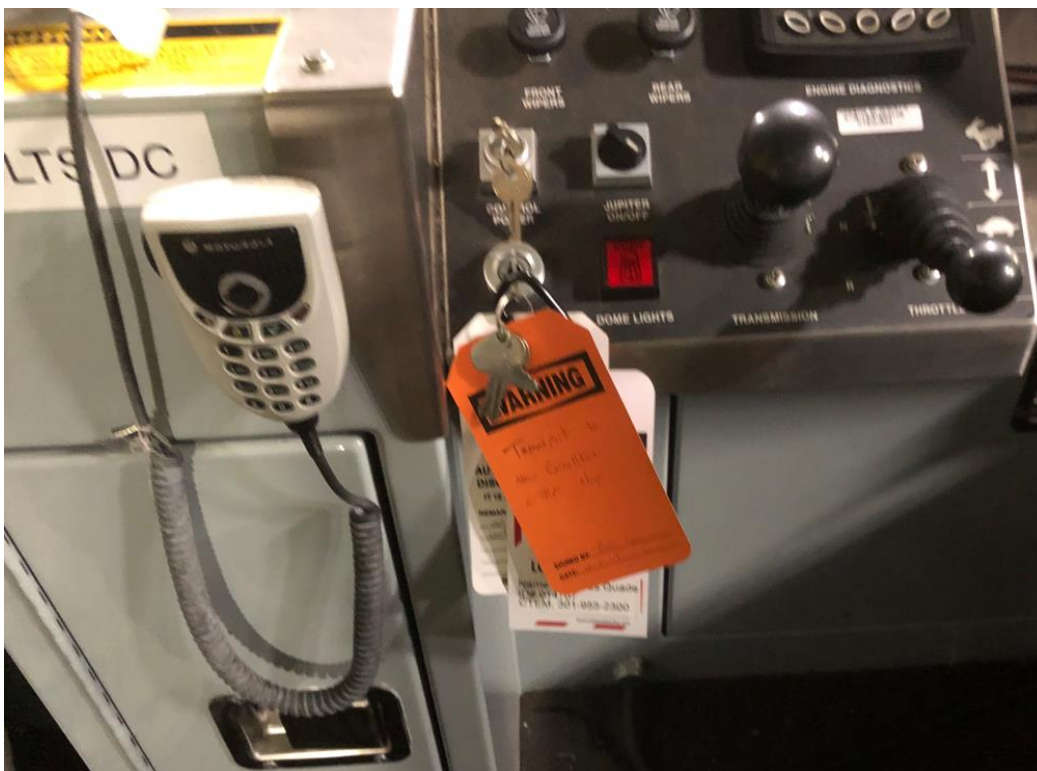
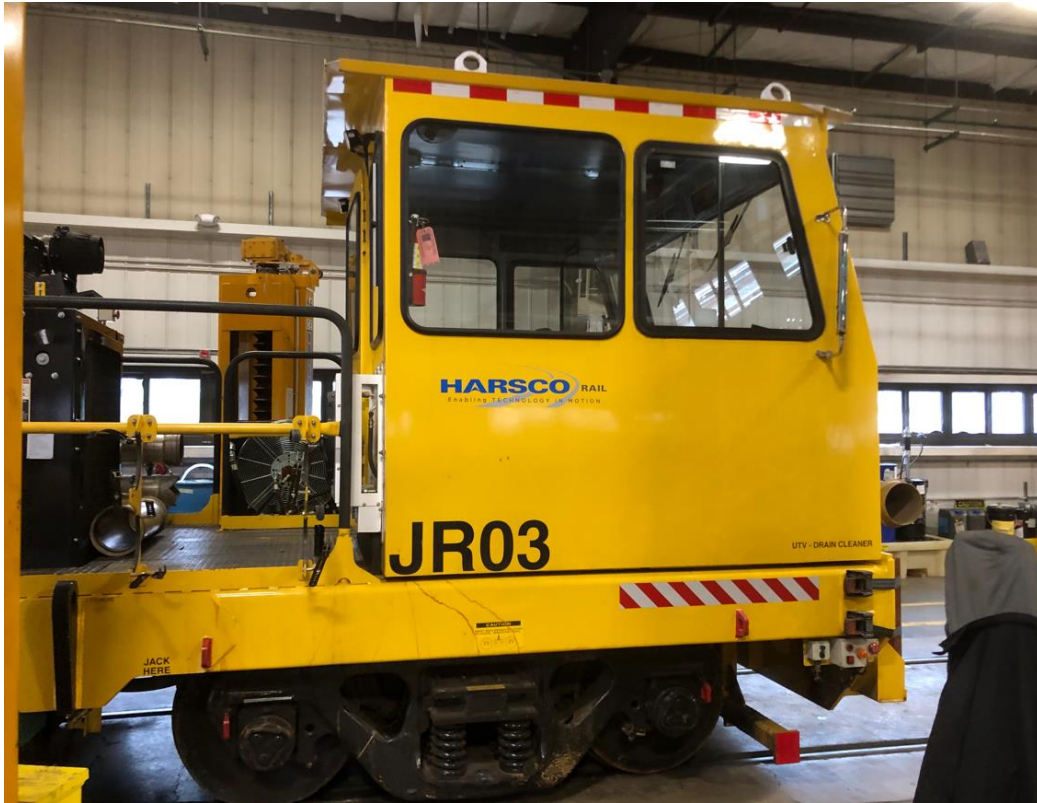
### Observation 2

Jet Rodder JR03 correctly displayed three tags, a danger tag, a lockout tag, and an orange warning tag. The waste tank was undergoing repair and therefore, the unit was out of service as noted on the Car Track Equipment Maintenance, Rail Fleet Status Report.

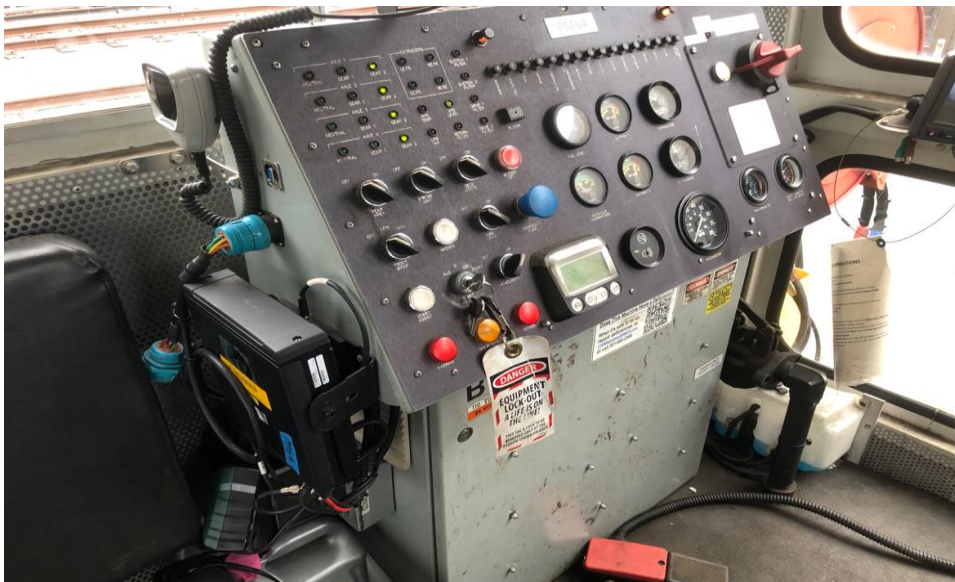
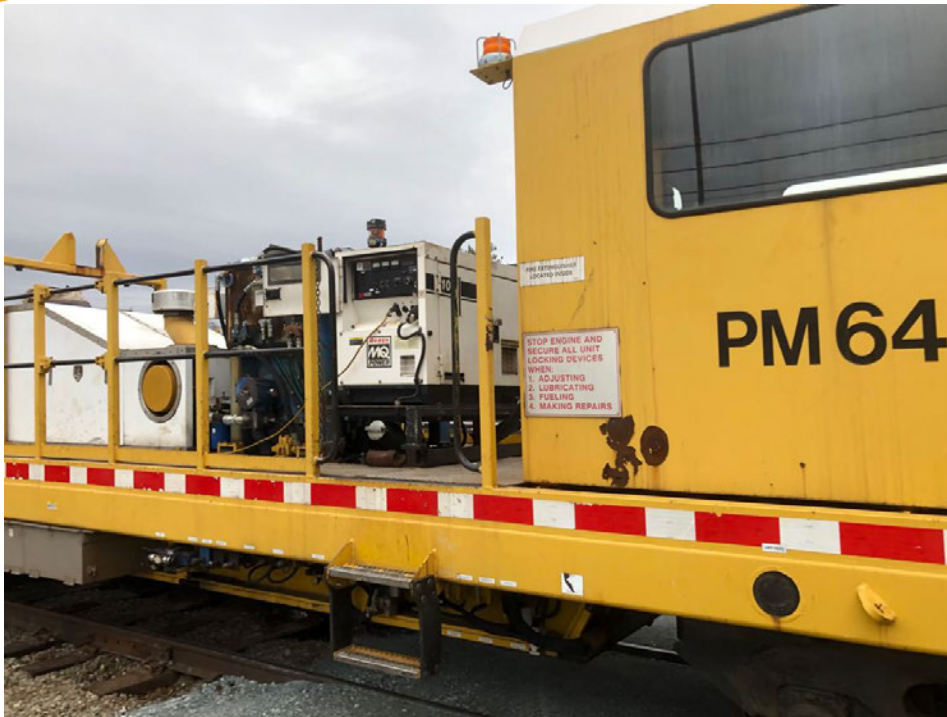
### Observation 3

Prime Mover PM64 accurately displayed a lock-out tag. PM64 was undergoing periodic maintenance repairs and therefore, the unit was out of service as noted on the Car Track Equipment Maintenance, Rail Fleet Status Report.

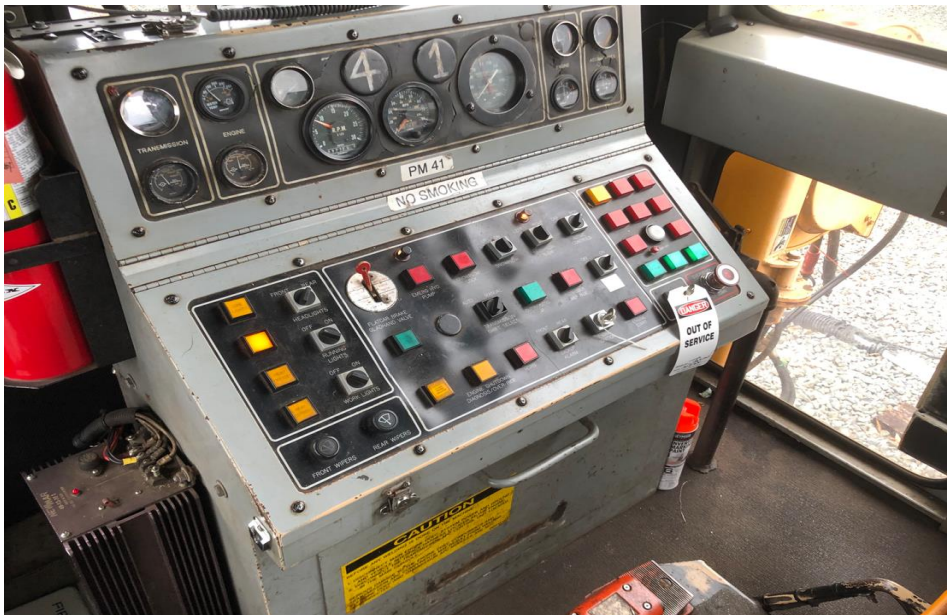
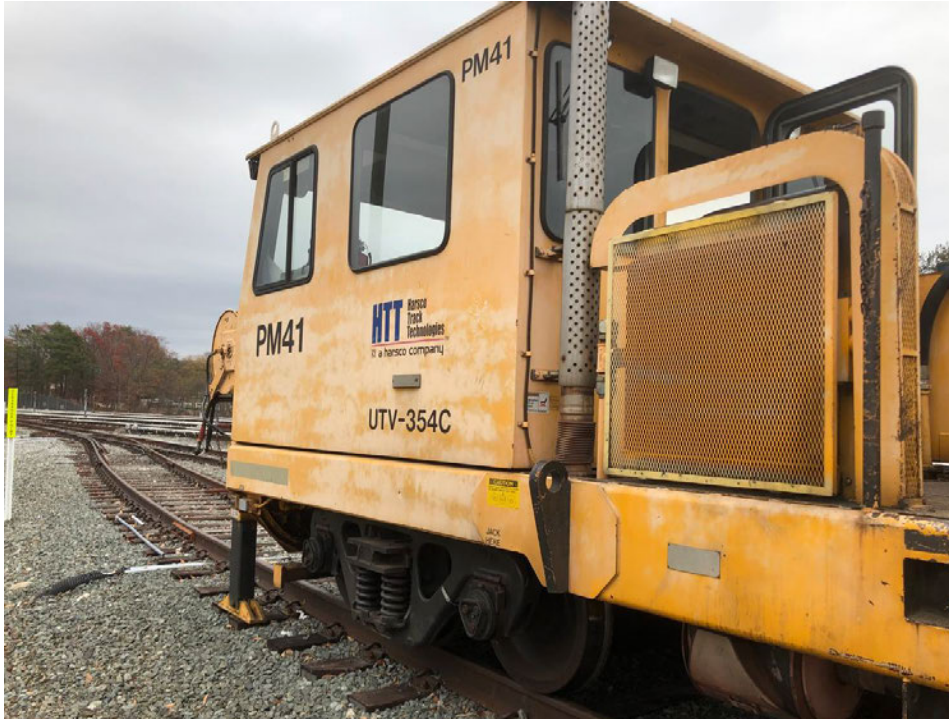
#### Observation 4

Prime Mover PM41 displayed an out of service tag. PM41 was also undergoing periodic maintenance repairs and therefore, the unit was out of service as noted on the Car Track Equipment Maintenance, Rail Fleet Status Report.

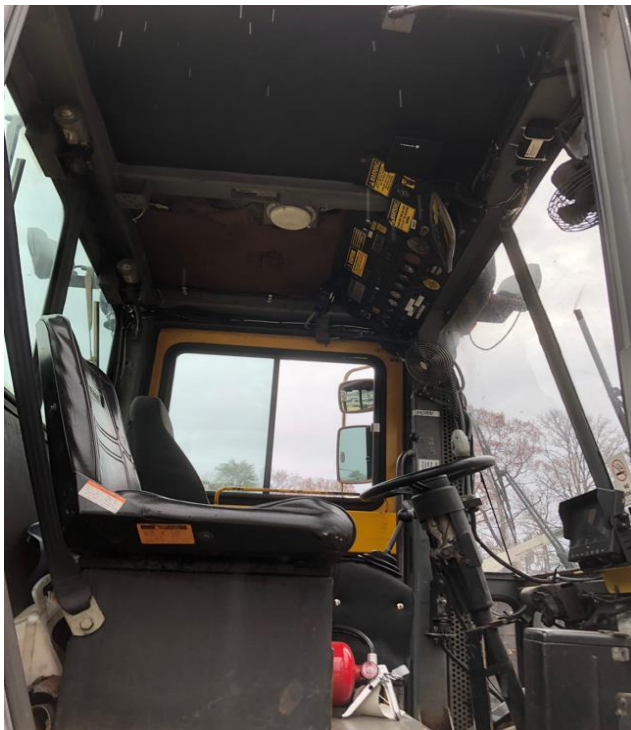
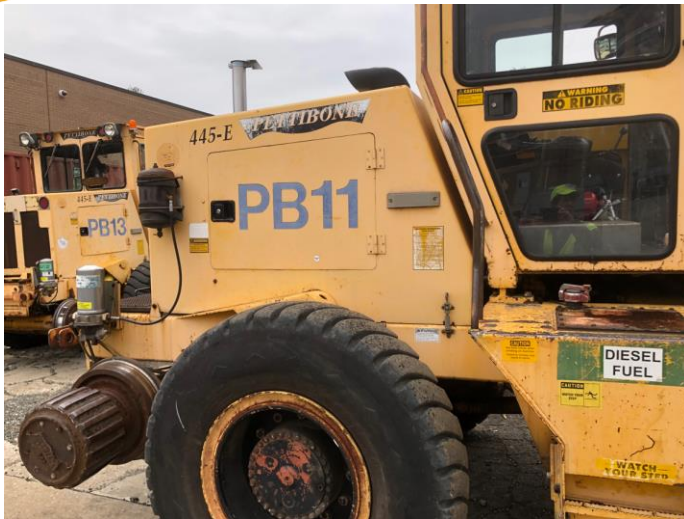
### Observation 5

Per review of the onsite vehicle failure report, the Inspector noted Pettibone PB11 is in service and ready for use; no equipment failure service tags were present.

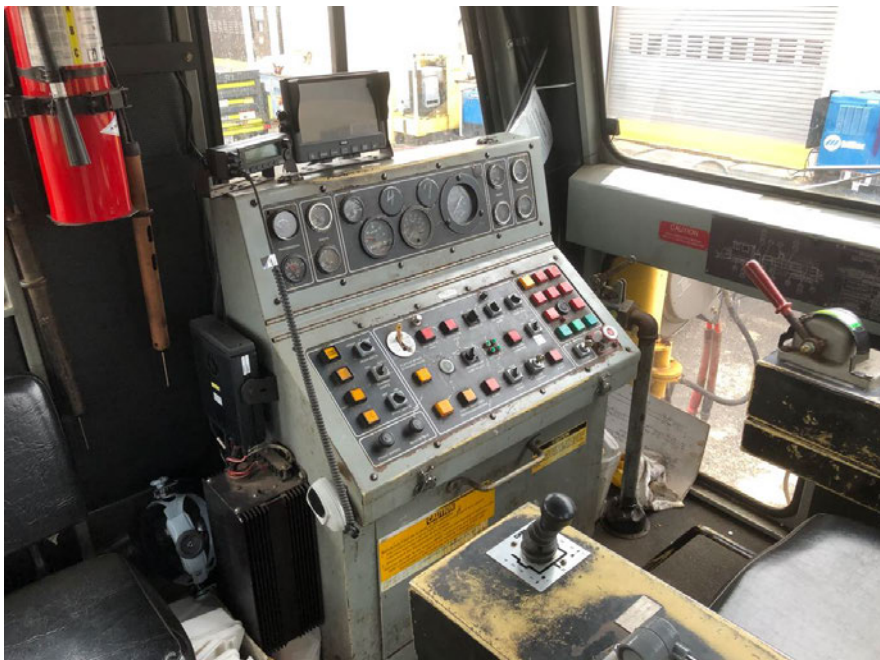
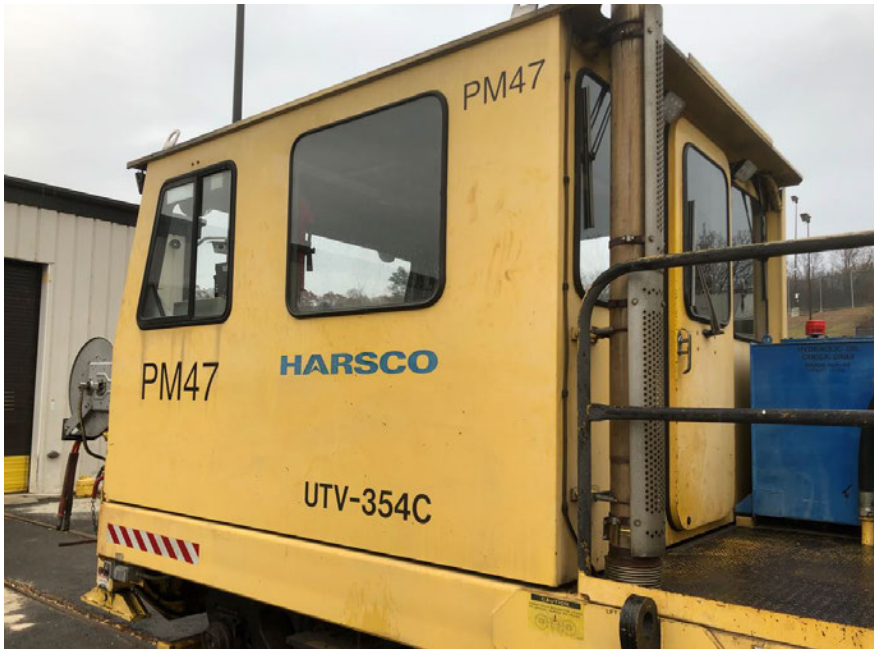
### Observation 7

Inspector confirmed Prime Mover PM 47 equipment is in service; no equipment failure service tags were present.

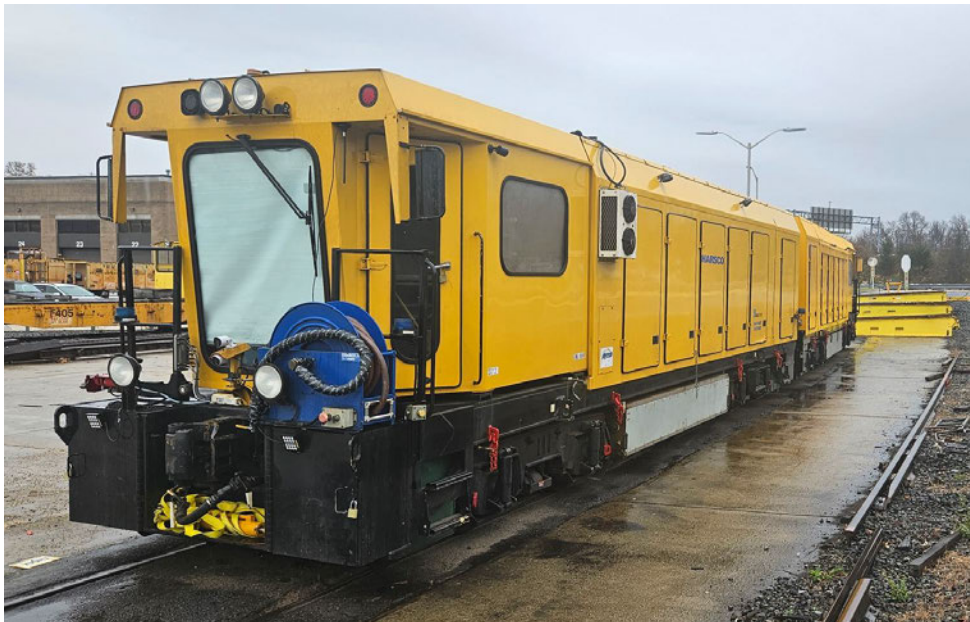
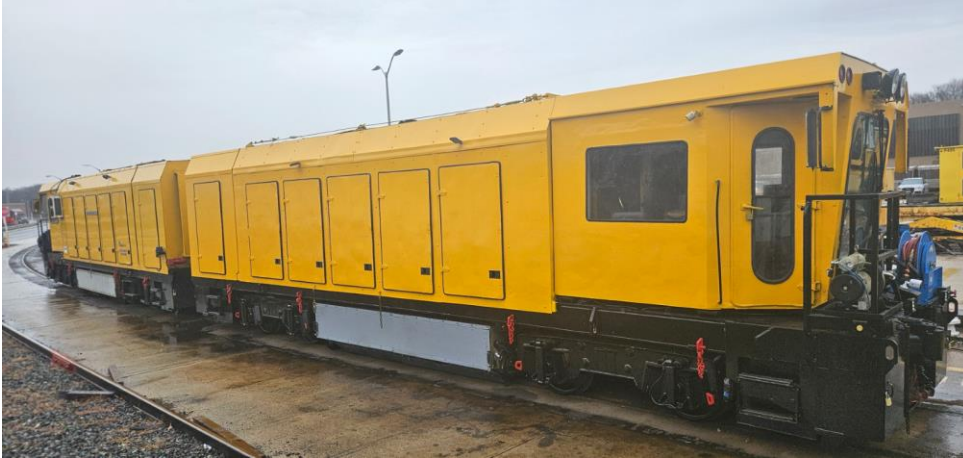
### Observation 8

A contractor vehicle, the Harsco Rail Grinder, is currently going through the contractor rail vehicle inspection process (OAP 101.02). Once approved, the contractor vehicle will display the Inspection Certification Sticker (ICS).
