Inspection Form

Washington Metrorail Safety Commission

Inspection Report 20240131-WMSC-CMNT- MAL-1 Attachments - Dulles

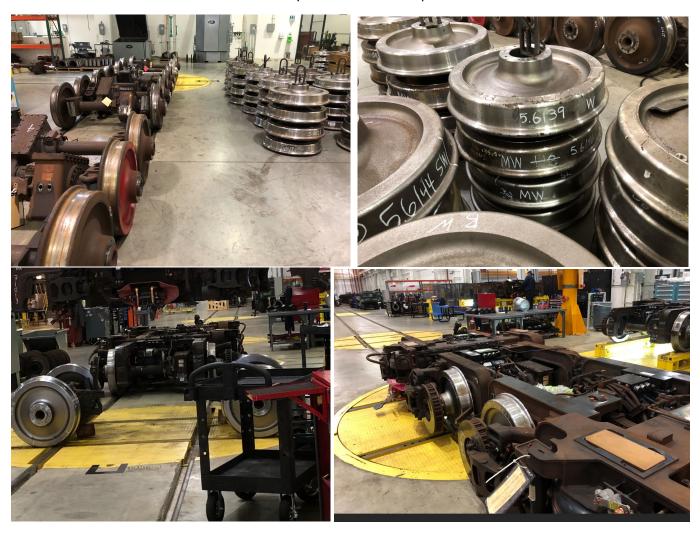
Wheels are currently being bored by the Okuma wheel boring machine at the Greenbelt Truck Shop and shipped to Dulles and Brentwood for the wheelset assembly and truck overhaul process.

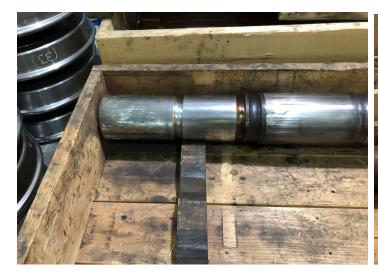
The high interference fit, and low lubrication process is causing new wheels and axles to get damaged during the demounting process.
