Evacuation for Life Safety Reasons

**At or Near L'Enfant Plaza Station, Foggy Bottom Station,
Eisenhower Avenue Headquarters and Benning Road Station
April 1, 2024, May 18, 2024, July 2, 2024 and July 22, 2024**

Document Purpose

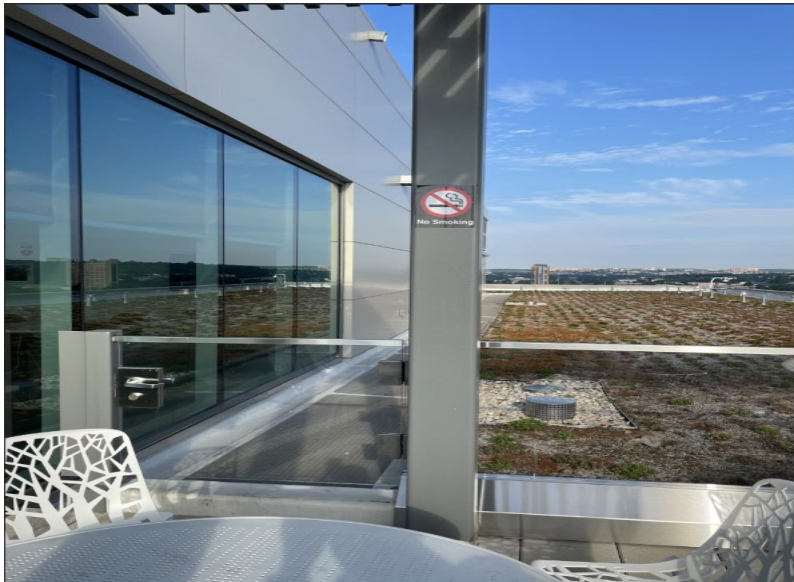
Image 15: A high visibility no smoking sign placed on the awning (post-fire).
